IMPERIAL SUGAR COMPANY CHAR FILTER HOUSE CONDITIONS ASSESSMENT

FINAL SUBMISSION TO
CITY OF SUGAR LAND ECONOMIC DEVELOPMENT

30 SEPTEMBER, 2020

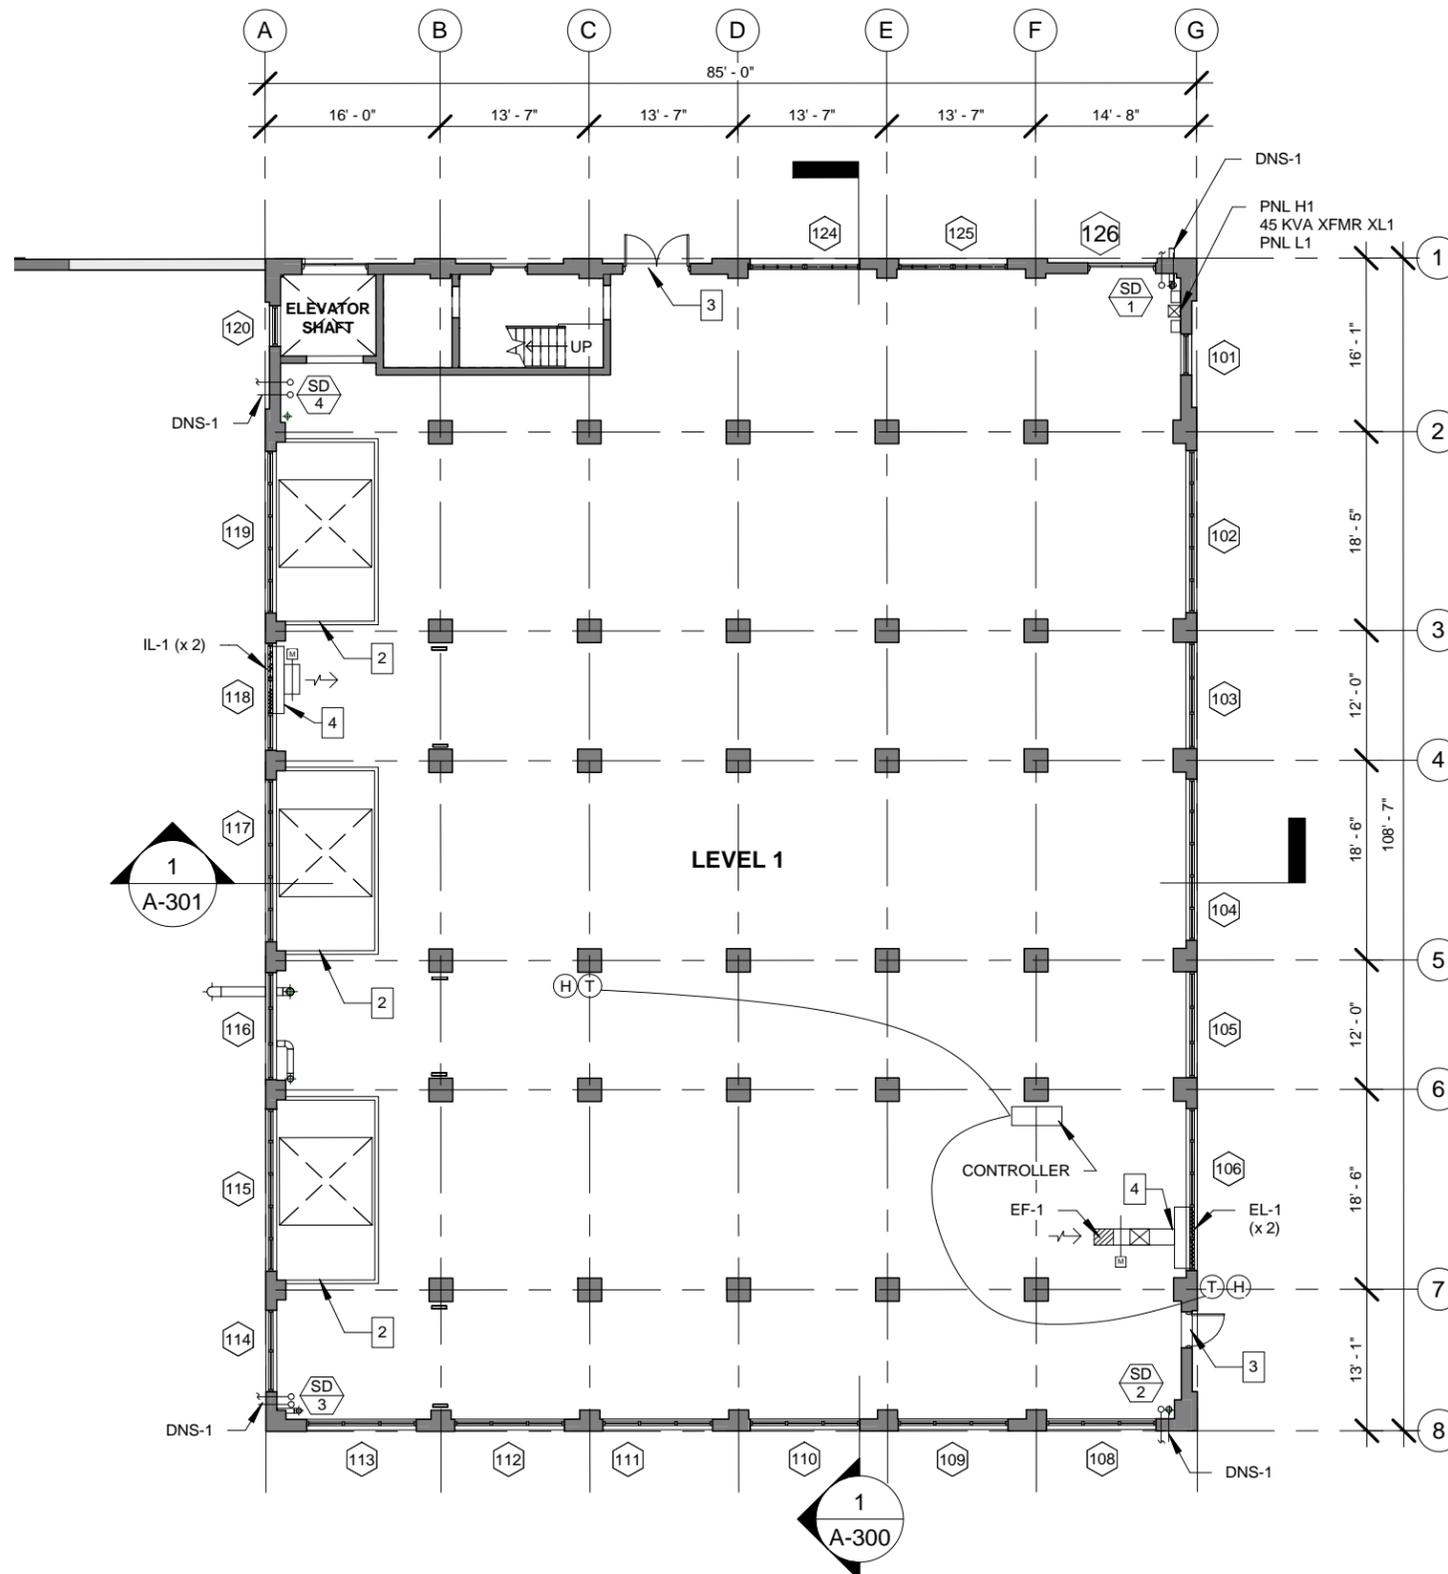
- (3) THREE APPROX. 8'-0" X 8'-0" SQUARE OPENINGS AT SLAB ALONG EAST FACADE FILLED WITH WATER (APPROX. 5'-0" DEEP) GRAFFITI AT MASONRY THROUGHOUT
- STAINING AND SOILING AT MASONRY THROUGHOUT
- VARIOUS CRACKS AT MASONRY COLUMNS (STRUCTURAL REPORT NOTES THESE ARE NOT OF STRUCTURAL CONCERN/ AESTHETICS ONLY)
- EVIDENCE OF DISPLACEMENT AT MASONRY WALLS
- VARIOUS AREAS OF CHIPPED MASONRY
- VARIOUS PENETRATIONS FROM PREVIOUS PLUMBING SYSTEMS
- SIGNS OF FORCED ENTRY
- EVIDENCE OF CORROSION AT STORM RISER PIPING AND VISIBLE LEAKS
- ALUMINUM WINDOWS: CRACKS AT GLAZING, MISSING WINDOW PARTS, MISSING SEALANT, INOPERABLE HARDWARE, CORROSION AND SOILING THROUGHOUT. VARIOUS OPENINGS BLOCKED WITH PLYWOOD
- STEEL WINDOWS: CRACKS AT GLAZING, MISSING WINDOW PARTS, MISSING SEALANT, INOPERABLE HARDWARE, CORROSION AND SOILING THROUGHOUT. VARIOUS OPENINGS BLOCKED WITH PLYWOOD

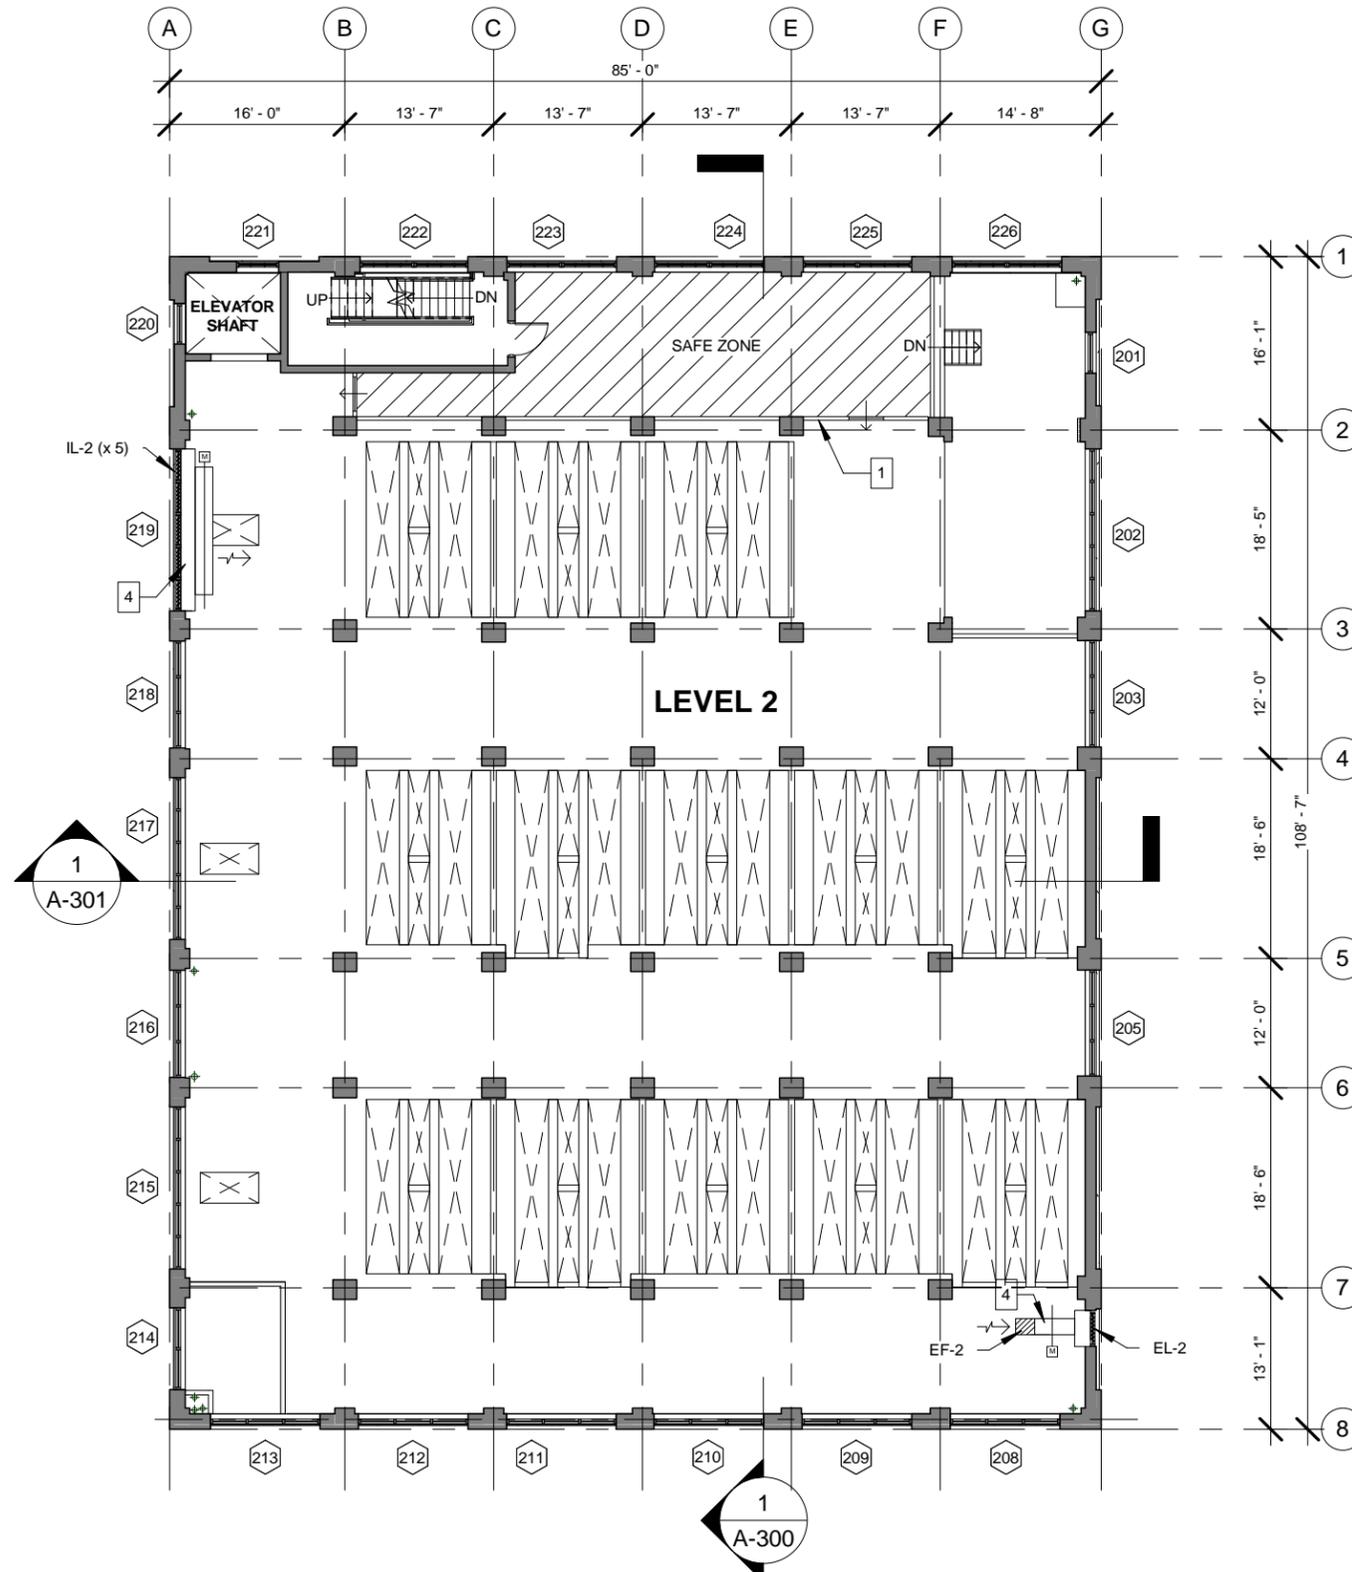
- VARIOUS LARGE OPENINGS AT CONCRETE SLAB
- CRACKS AND SOILING AT CONCRETE SLAB
- MISSING MASONRY AT VARIOUS COLUMNS FACING SLAB OPENINGS (APPROX. 22 SF EACH)

- STAINING AND SOILING AT MASONRY THROUGHOUT
- GRAFFITI AT MASONRY
- SPALLING, CRACKING AND SOILING AT UNDERSIDE OF CONCRETE SLAB ABOVE, WITH VISIBLE SIGNS OF CORROSION FROM EXPOSED REBAR

- EVIDENCE OF CORROSION AT STEEL BEAMS
- EVIDENCE OF CORROSION STAINS AT CONCRETE BEAMS FROM EXPOSED STEEL
- EVIDENCE OF CORROSION AT EXPOSED STEEL COLUMNS

- EVIDENCE OF CORROSION AT STORM RISER PIPING AND VISIBLE LEAKS
- ALUMINUM WINDOWS: CRACKS AT GLAZING, MISSING WINDOW PARTS, MISSING SEALANT, INOPERABLE HARDWARE, CORROSION AND SOILING THROUGHOUT. VARIOUS OPENINGS BLOCKED WITH PLYWOOD

- STEEL WINDOWS: CRACKS AT GLAZING, MISSING WINDOW PARTS, MISSING SEALANT, INOPERABLE HARDWARE, CORROSION AND SOILING THROUGHOUT. VARIOUS OPENINGS BLOCKED WITH PLYWOOD

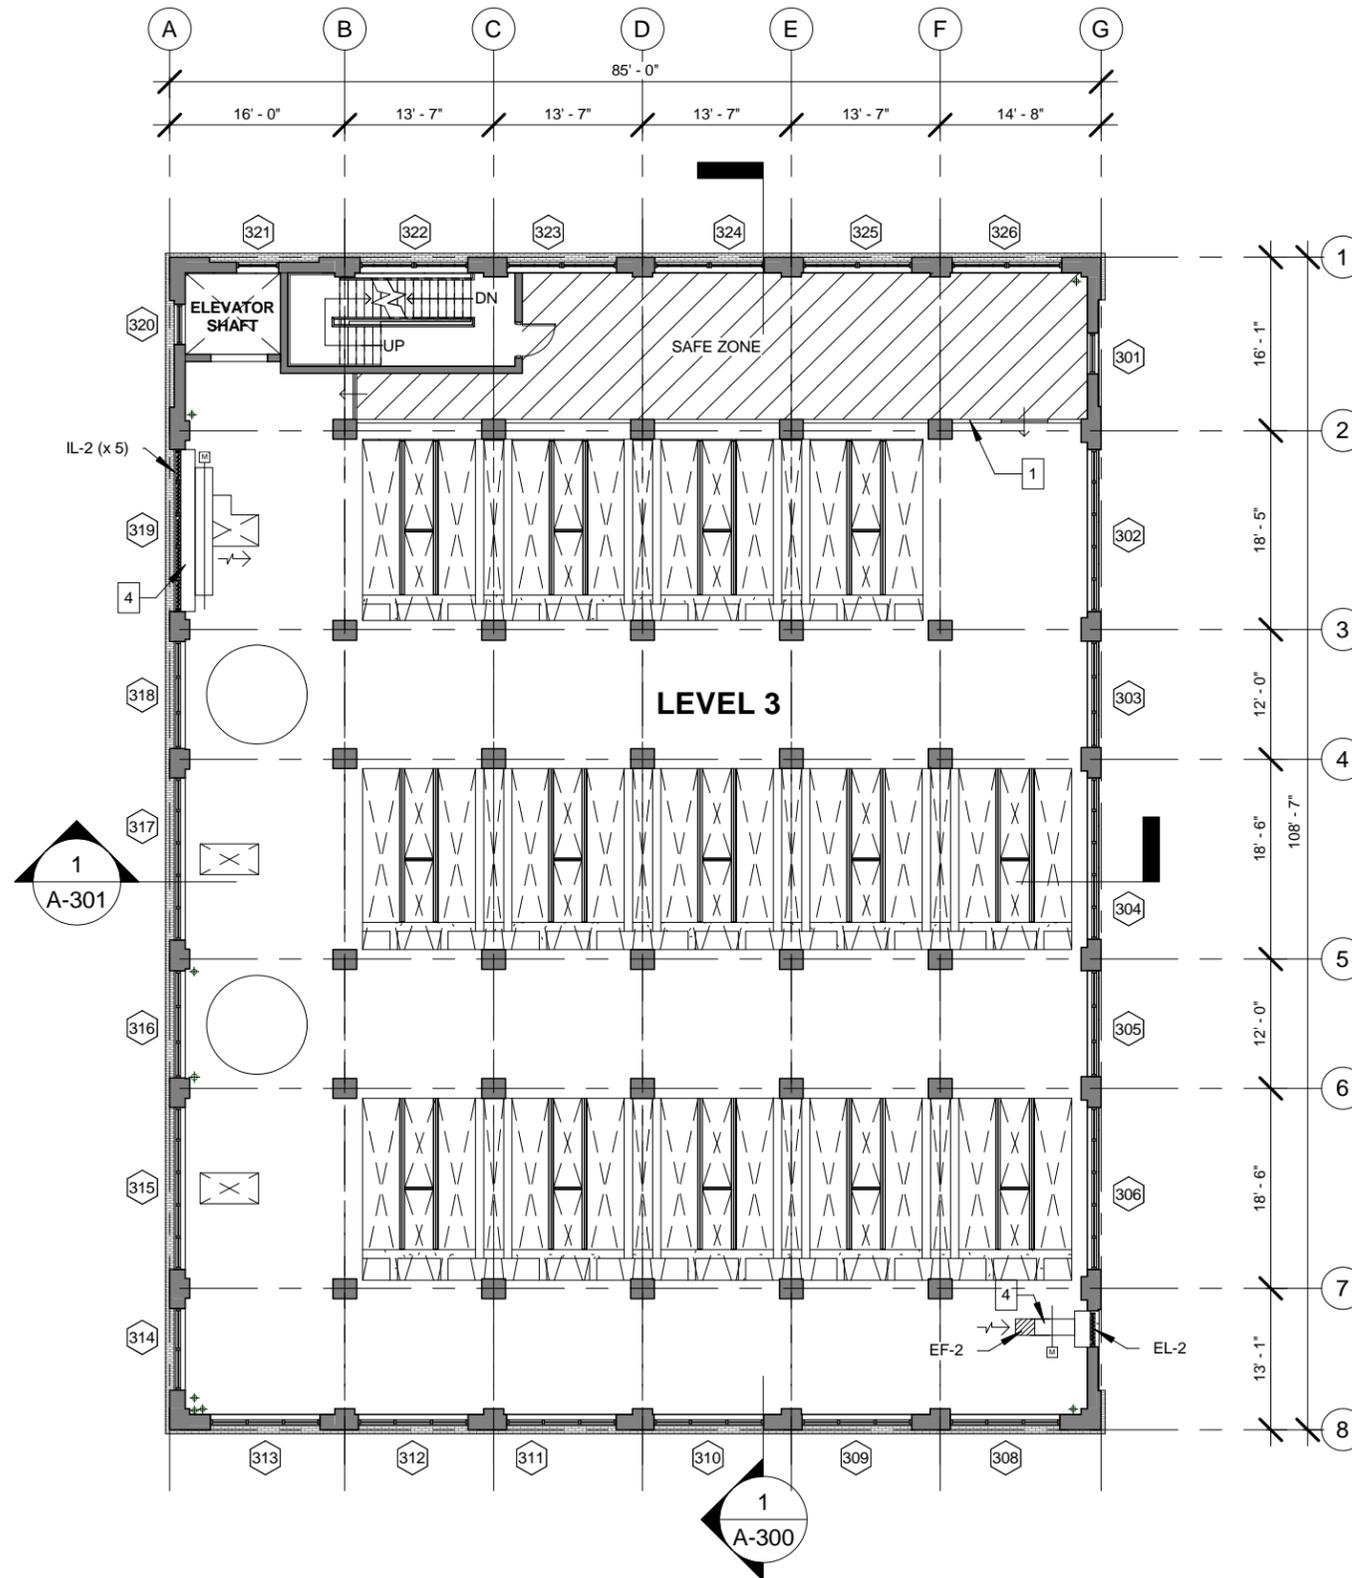
- VARIOUS LARGE OPENINGS AT CONCRETE SLAB
- VISIBLE SIGNS OF PONDING AND STAINING AT CONCRETE SLAB
- VARIOUS TERRACOTTA MASONRY INFILL AT COLUMNS THROUGHOUT
- STAINING AND SOILING AT MASONRY THROUGHOUT
- EVIDENCE OF CORROSION AT STORM RISER PIPING AND VISIBLE LEAKS
- SPRINKLER SYSTEM IN PLACE IS NON-FUNCTIONING, WITH EVIDENCE OF CORROSION
- ALUMINUM WINDOWS:** CRACKS AT GLAZING, MISSING WINDOW PARTS, MISSING SEALANT, INOPERABLE HARDWARE, CORROSION AND SOILING THROUGHOUT. VARIOUS OPENINGS BLOCKED WITH PLYWOOD
- STEEL WINDOWS:** CRACKS AT GLAZING, MISSING WINDOW PARTS, MISSING SEALANT, INOPERABLE HARDWARE, CORROSION AND SOILING THROUGHOUT. VARIOUS OPENINGS BLOCKED WITH PLYWOOD

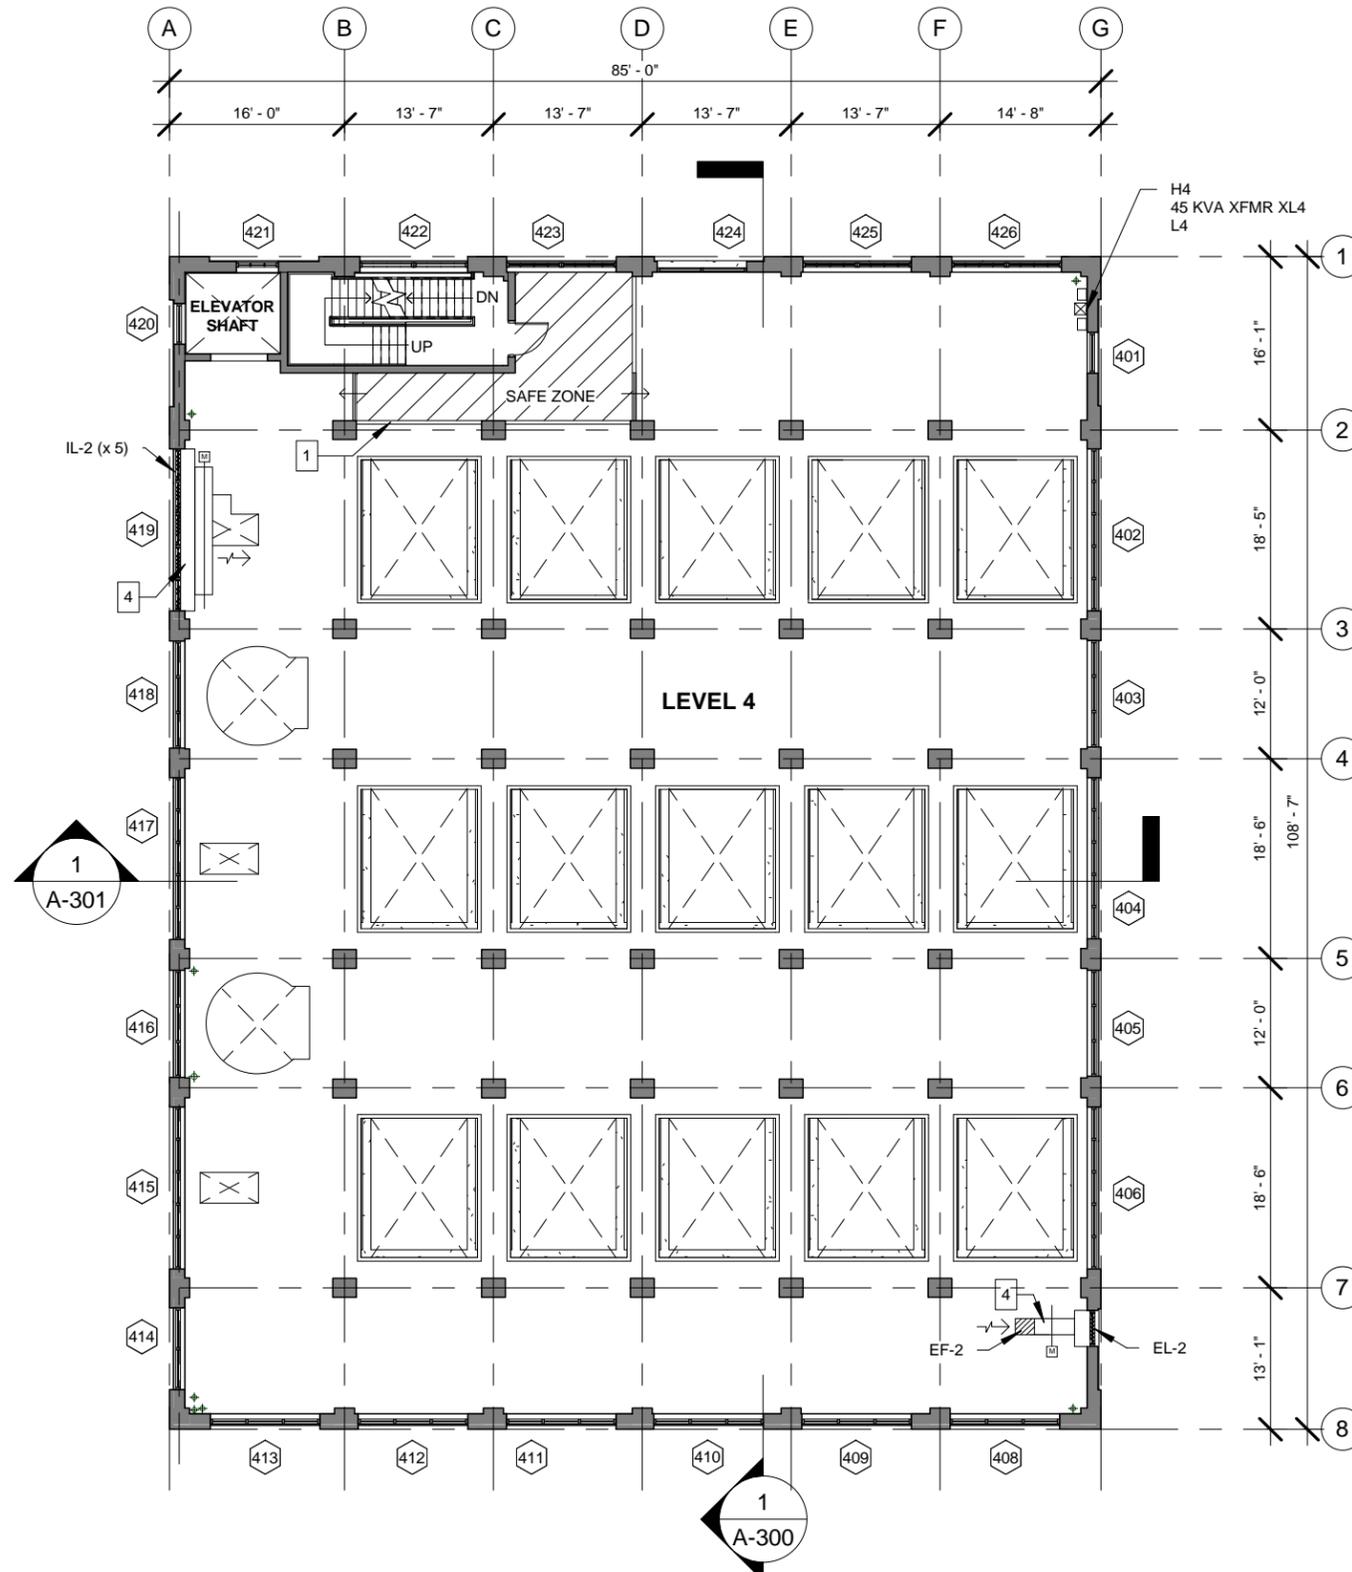
- VARIOUS LARGE OPENINGS AT CONCRETE SLAB
- VISIBLE SIGNS OF CRACKS, PONDING AND STAINING AT CONCRETE SLAB
- EXPOSED AGGREGATE AND REBAR AT CONCRETE SLAB THROUGHOUT
- SPALLING, CRACKING AND SOILING AT UNDERSIDE OF CONCRETE SLAB ABOVE, WITH VISIBLE SIGNS OF CORROSION FROM EXPOSED REBAR
- STAINING AND SOILING AT MASONRY THROUGHOUT
- ADDITIONAL REINFORCEMENT AT LOWER AREA OF MASONRY COLUMNS APPEARS TO HAVE BEEN INSTALLED
- EVIDENCE OF CORROSION AT STORM RISER PIPING AND VISIBLE LEAKS
- ALUMINUM WINDOWS: CRACKS AT GLAZING, MISSING WINDOW PARTS, MISSING SEALANT, INOPERABLE HARDWARE, CORROSION AND SOILING THROUGHOUT. VARIOUS OPENINGS BLOCKED WITH PLYWOOD
- STEEL WINDOWS: CRACKS AT GLAZING, MISSING WINDOW PARTS, MISSING SEALANT, INOPERABLE HARDWARE, CORROSION AND SOILING THROUGHOUT. VARIOUS OPENINGS BLOCKED WITH PLYWOOD

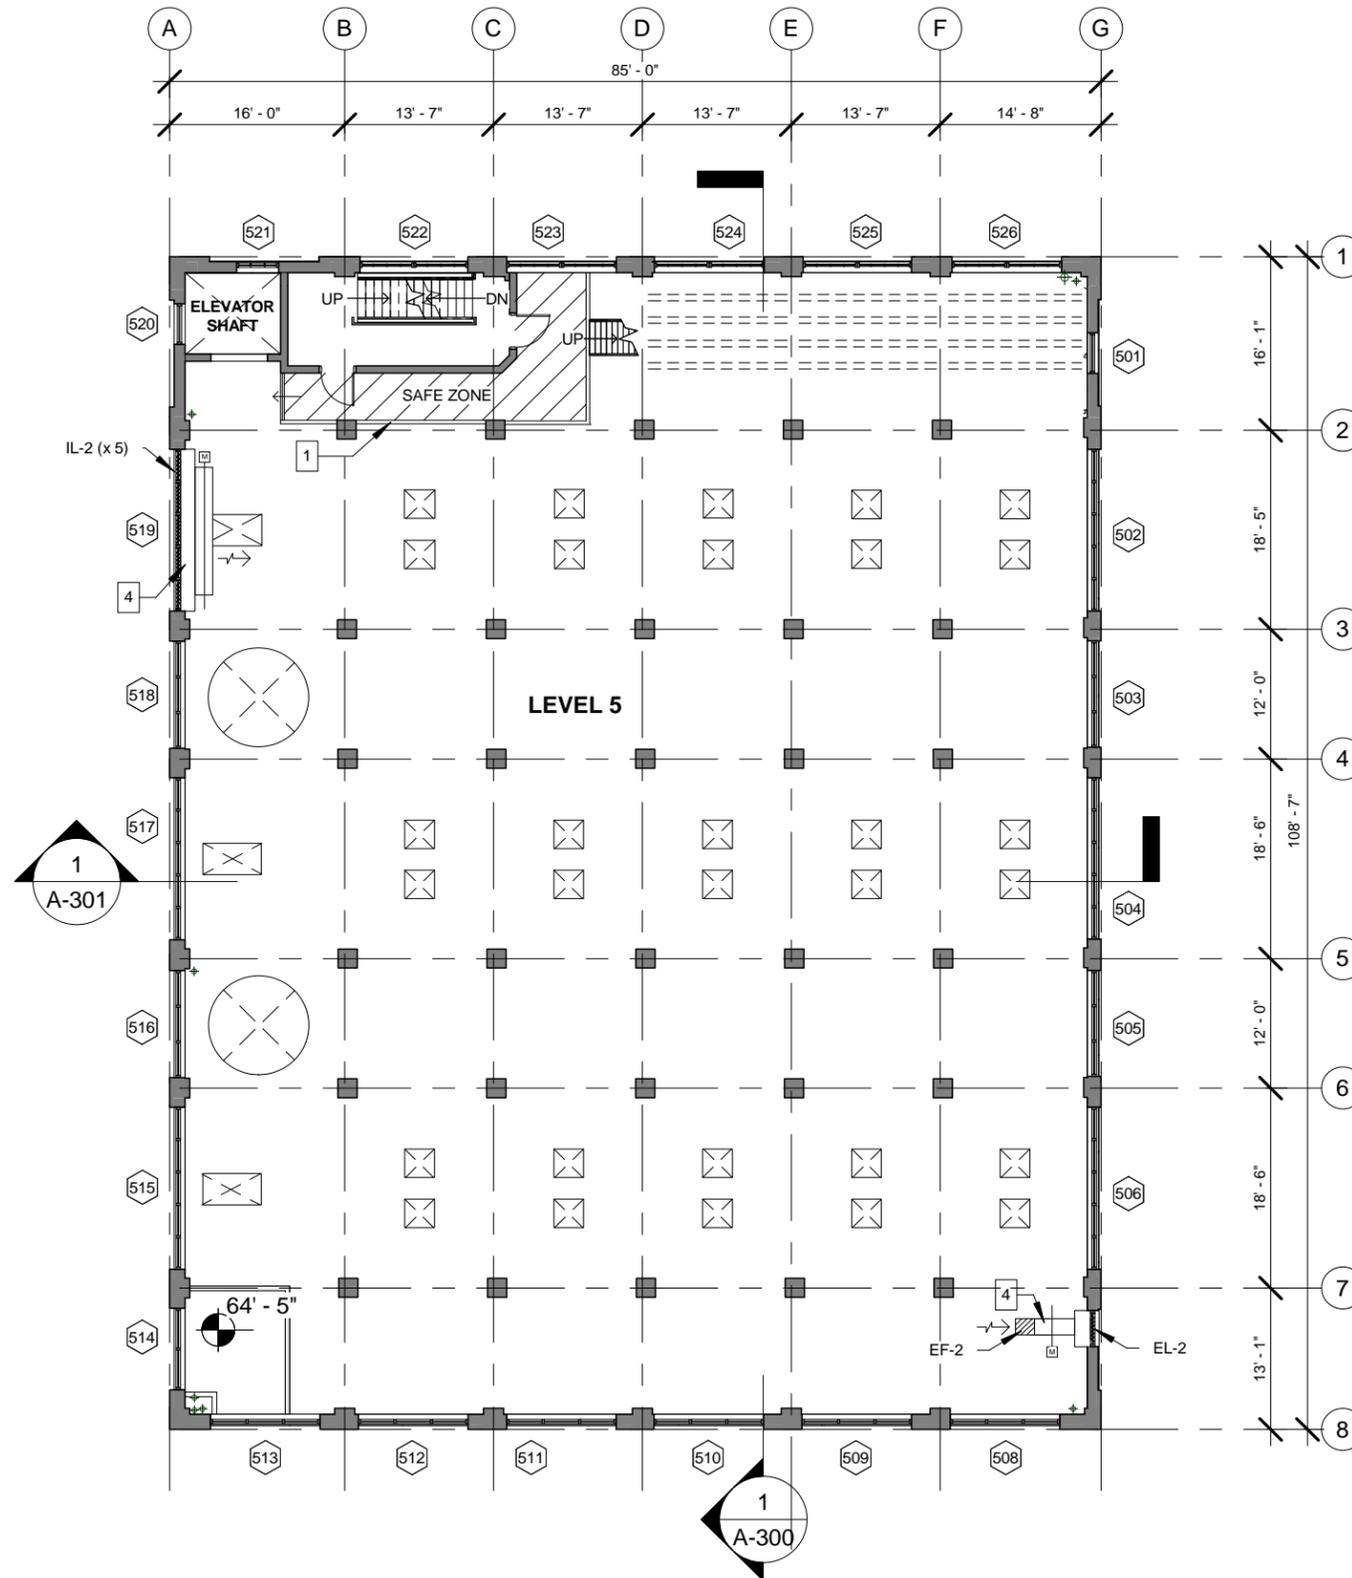
- VARIOUS LARGE OPENINGS AT CONCRETE SLAB COVERED WITH PLYWOOD
- EXPOSED AGGREGATE AND REBAR AT CONCRETE SLAB THROUGHOUT
- VISIBLE SIGNS OF PONDING AND STAINING AT CONCRETE SLAB
- STAINING AND SOILING AT MASONRY THROUGHOUT
- SPALLING, CRACKING AND SOILING AT UNDERSIDE OF CONCRETE SLAB ABOVE, WITH VISIBLE SIGNS OF CORROSION FROM EXPOSED REBAR
- GRAFFITI AT MASONRY
- EVIDENCE OF CORROSION AT STORM RISER PIPING AND VISIBLE LEAKS
- ALUMINUM WINDOWS: CRACKS AT GLAZING, MISSING WINDOW PARTS, MISSING SEALANT, INOPERABLE HARDWARE, CORROSION AND SOILING THROUGHOUT. VARIOUS OPENINGS BLOCKED WITH PLYWOOD
- STEEL WINDOWS: CRACKS AT GLAZING, MISSING WINDOW PARTS, MISSING SEALANT, INOPERABLE HARDWARE, CORROSION AND SOILING THROUGHOUT. VARIOUS OPENINGS BLOCKED WITH PLYWOOD

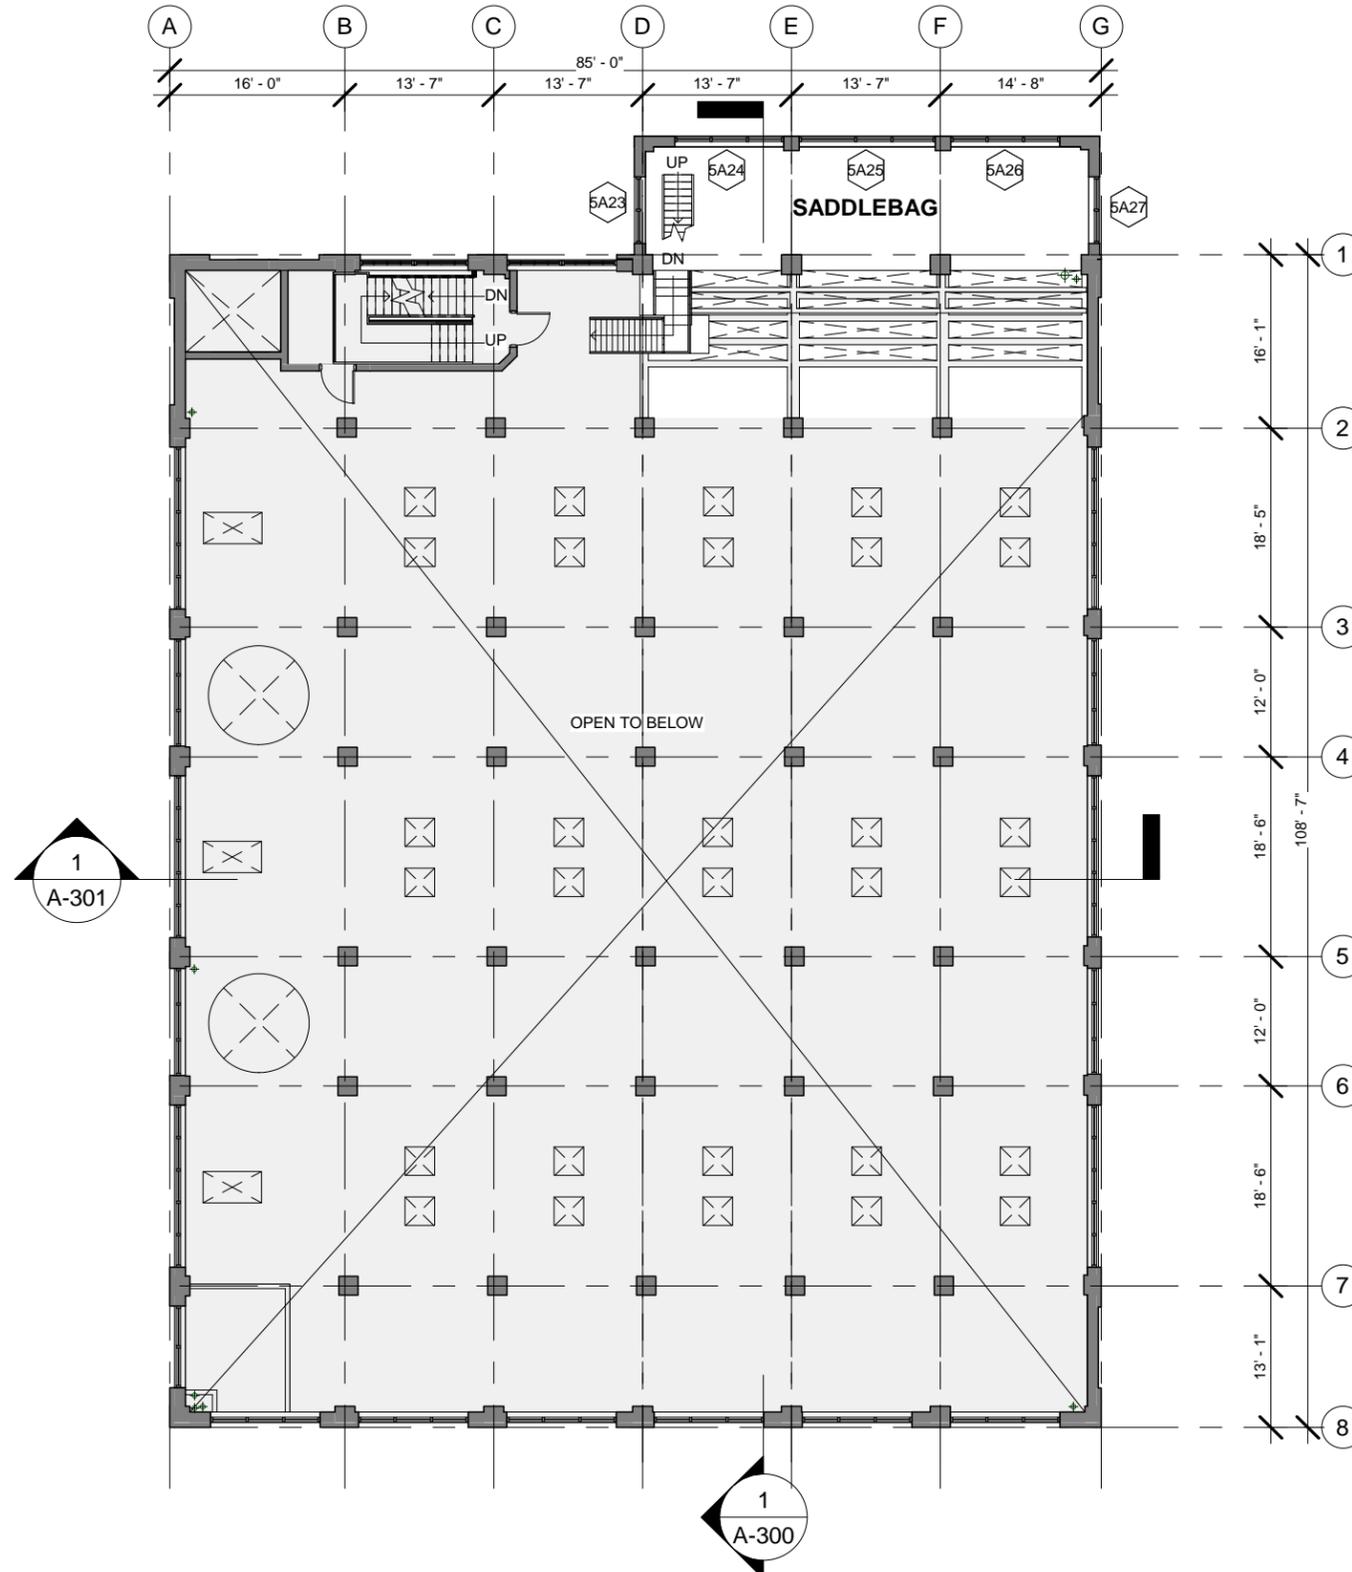
- THIS AREA WAS NOT ACCESSIBLE DUE TO SAFETY CONCERNS
- ROOF AT SADDLEBAG SHOWS SIGNS OF SAFETY CONCERNS WITH WATER DAMAGE THROUGHOUT
- SOME WINDOWS HAVE BEEN MODIFIED TO INCLUDE METAL PANELS
- ALUMINUM WINDOWS: CRACKS AT GLAZING, MISSING WINDOW PARTS, MISSING SEALANT, INOPERABLE HARDWARE, CORROSION AND SOILING THROUGHOUT. VARIOUS OPENINGS BLOCKED WITH PLYWOOD
- STEEL WINDOWS: CRACKS AT GLAZING, MISSING WINDOW PARTS, MISSING SEALANT, INOPERABLE HARDWARE, CORROSION AND SOILING THROUGHOUT. VARIOUS OPENINGS BLOCKED WITH PLYWOOD

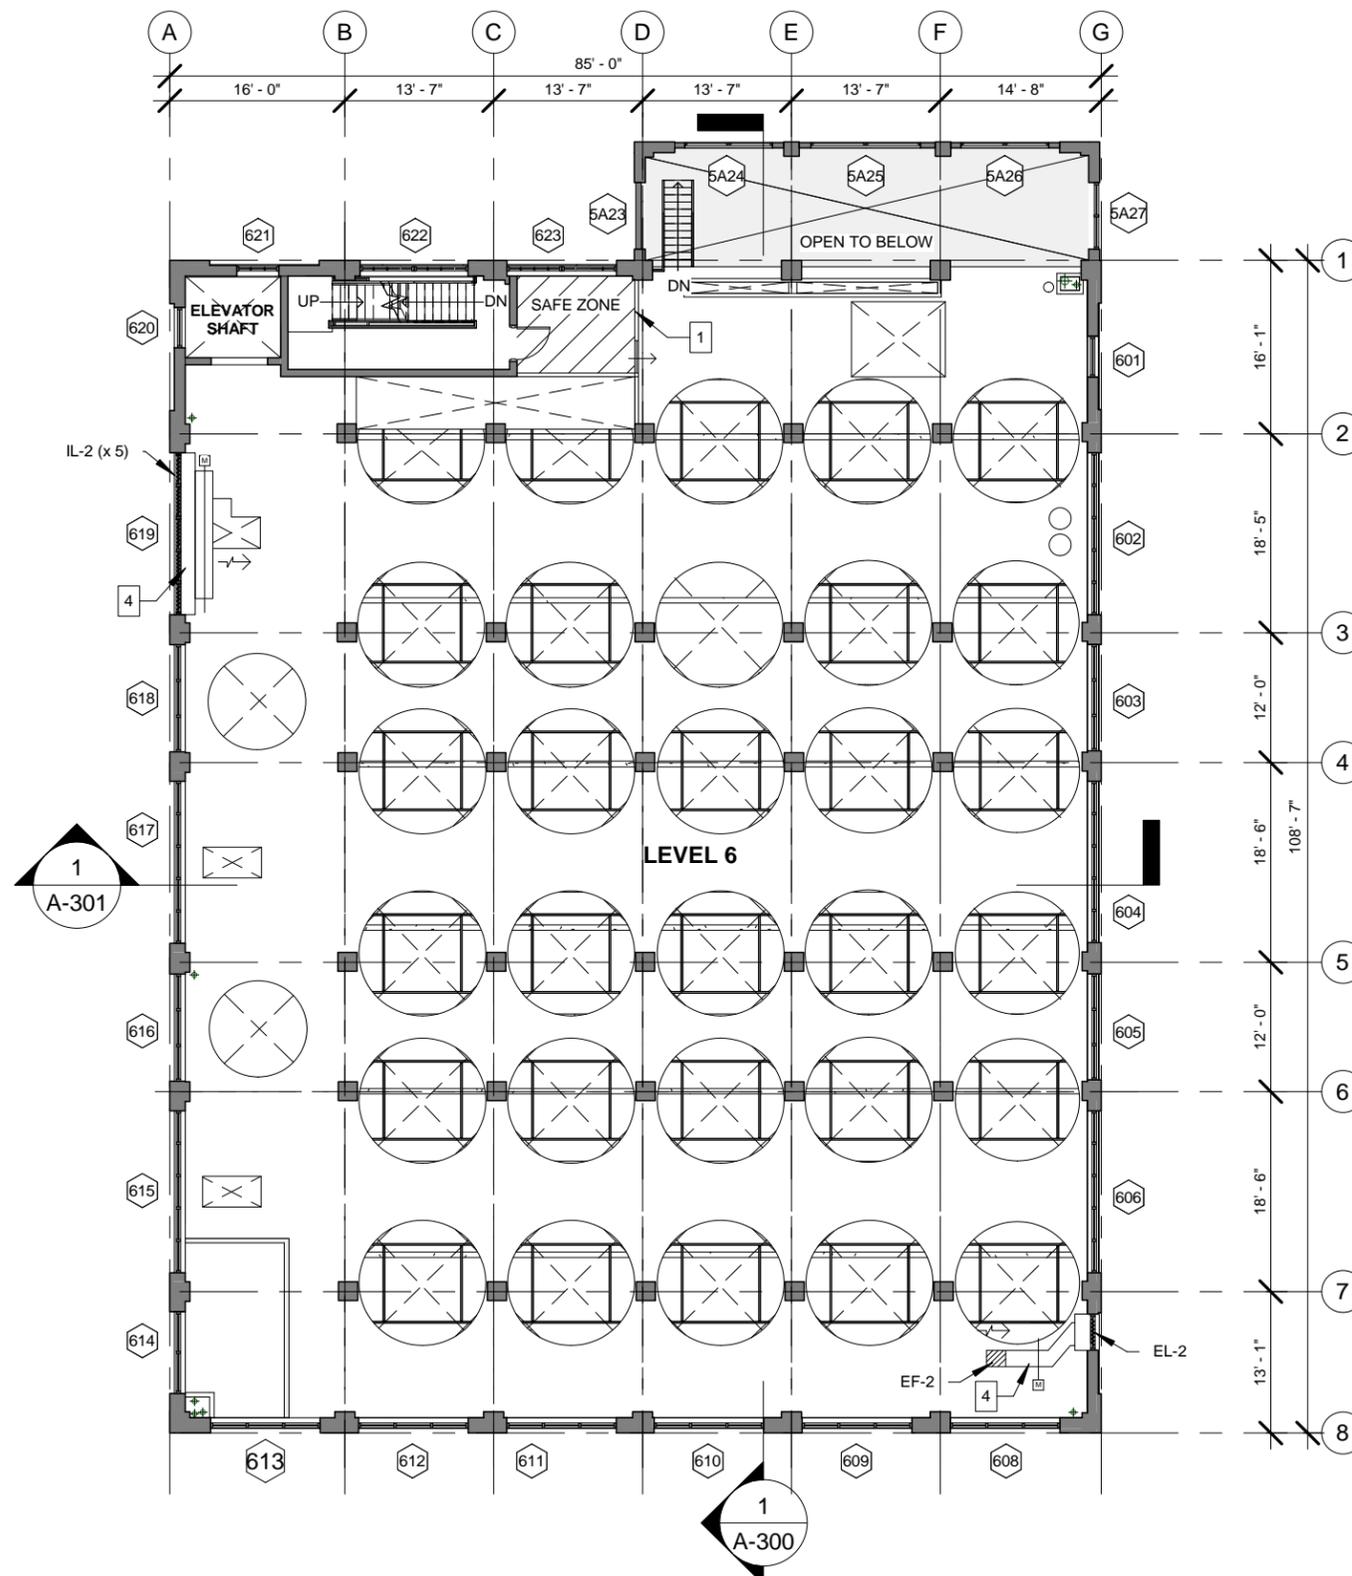
- VARIOUS LARGE OPENINGS AT CONCRETE SLAB
- EXPOSED AGGREGATE AND REBAR AT CONCRETE SLAB THROUGHOUT
- SILVER COATING AT MASONRY THROUGHOUT
- SPALLING, CRACKING AND SOILING AT UNDERSIDE OF CONCRETE SLAB ABOVE. WITH VISIBLE SIGNS OF CORROSION FROM EXPOSED REBAR
- EVIDENCE OF CORROSION AT STORM RISER PIPING AND VISIBLE LEAKS
- ALUMINUM WINDOWS: CRACKS AT GLAZING, MISSING WINDOW PARTS, MISSING SEALANT, INOPERABLE HARDWARE, CORROSION AND SOILING THROUGHOUT. VARIOUS OPENINGS BLOCKED WITH PLYWOOD. SIGNS OF SILVER COATING THROUGHOUT
- STEEL WINDOWS: CRACKS AT GLAZING, MISSING WINDOW PARTS, MISSING SEALANT, INOPERABLE HARDWARE, CORROSION AND SOILING THROUGHOUT. VARIOUS OPENINGS BLOCKED WITH PLYWOOD

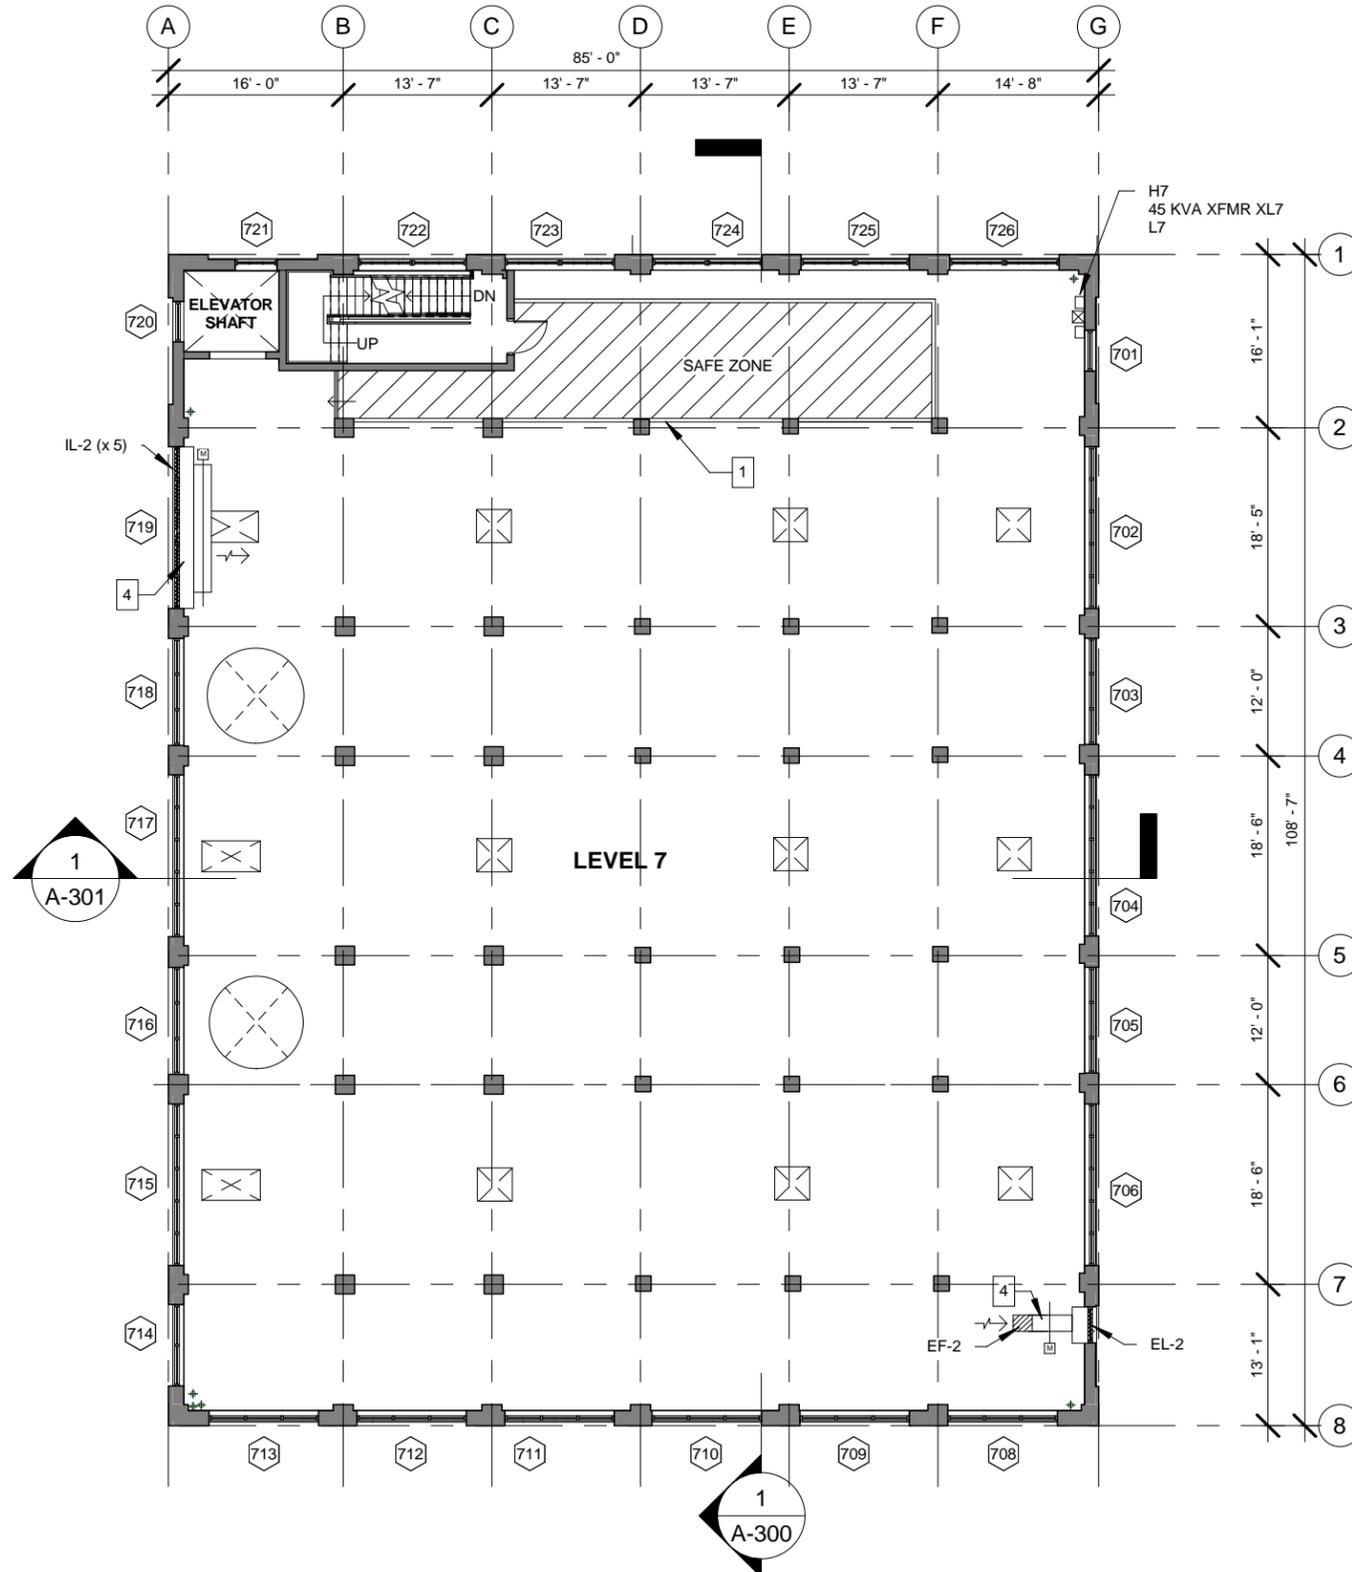
- VISIBLE SIGNS OF STAINING, PONDING, EXPOSED AGGREGATE AND CRACKS AT CONCRETE SLAB
- SPALLING, CRACKING AND SOILING AT UNDERSIDE OF CONCRETE SLAB ABOVE, WITH VISIBLE SIGNS OF CORROSION FROM EXPOSED REBAR
- STAINING AND SOILING AT MASONRY THROUGHOUT
- ADDITIONAL REINFORCEMENT AT LOWER AREA OF MASONRY COLUMNS APPEARS TO HAVE BEEN INSTALLED
- SOME MISSING MASONRY UNITS AT COLUMNS, EXPOSING STEEL BEAMS
- EVIDENCE OF CORROSION AT STORM RISER PIPING AND VISIBLE LEAKS
- ALUMINUM WINDOWS: CRACKS AT GLAZING, MISSING WINDOW PARTS, MISSING SEALANT, INOPERABLE HARDWARE, CORROSION AND SOILING THROUGHOUT. VARIOUS OPENINGS BLOCKED WITH PLYWOOD
- STEEL WINDOWS: CRACKS AT GLAZING, MISSING WINDOW PARTS, MISSING SEALANT, INOPERABLE HARDWARE, CORROSION AND SOILING THROUGHOUT. VARIOUS OPENINGS BLOCKED WITH PLYWOOD

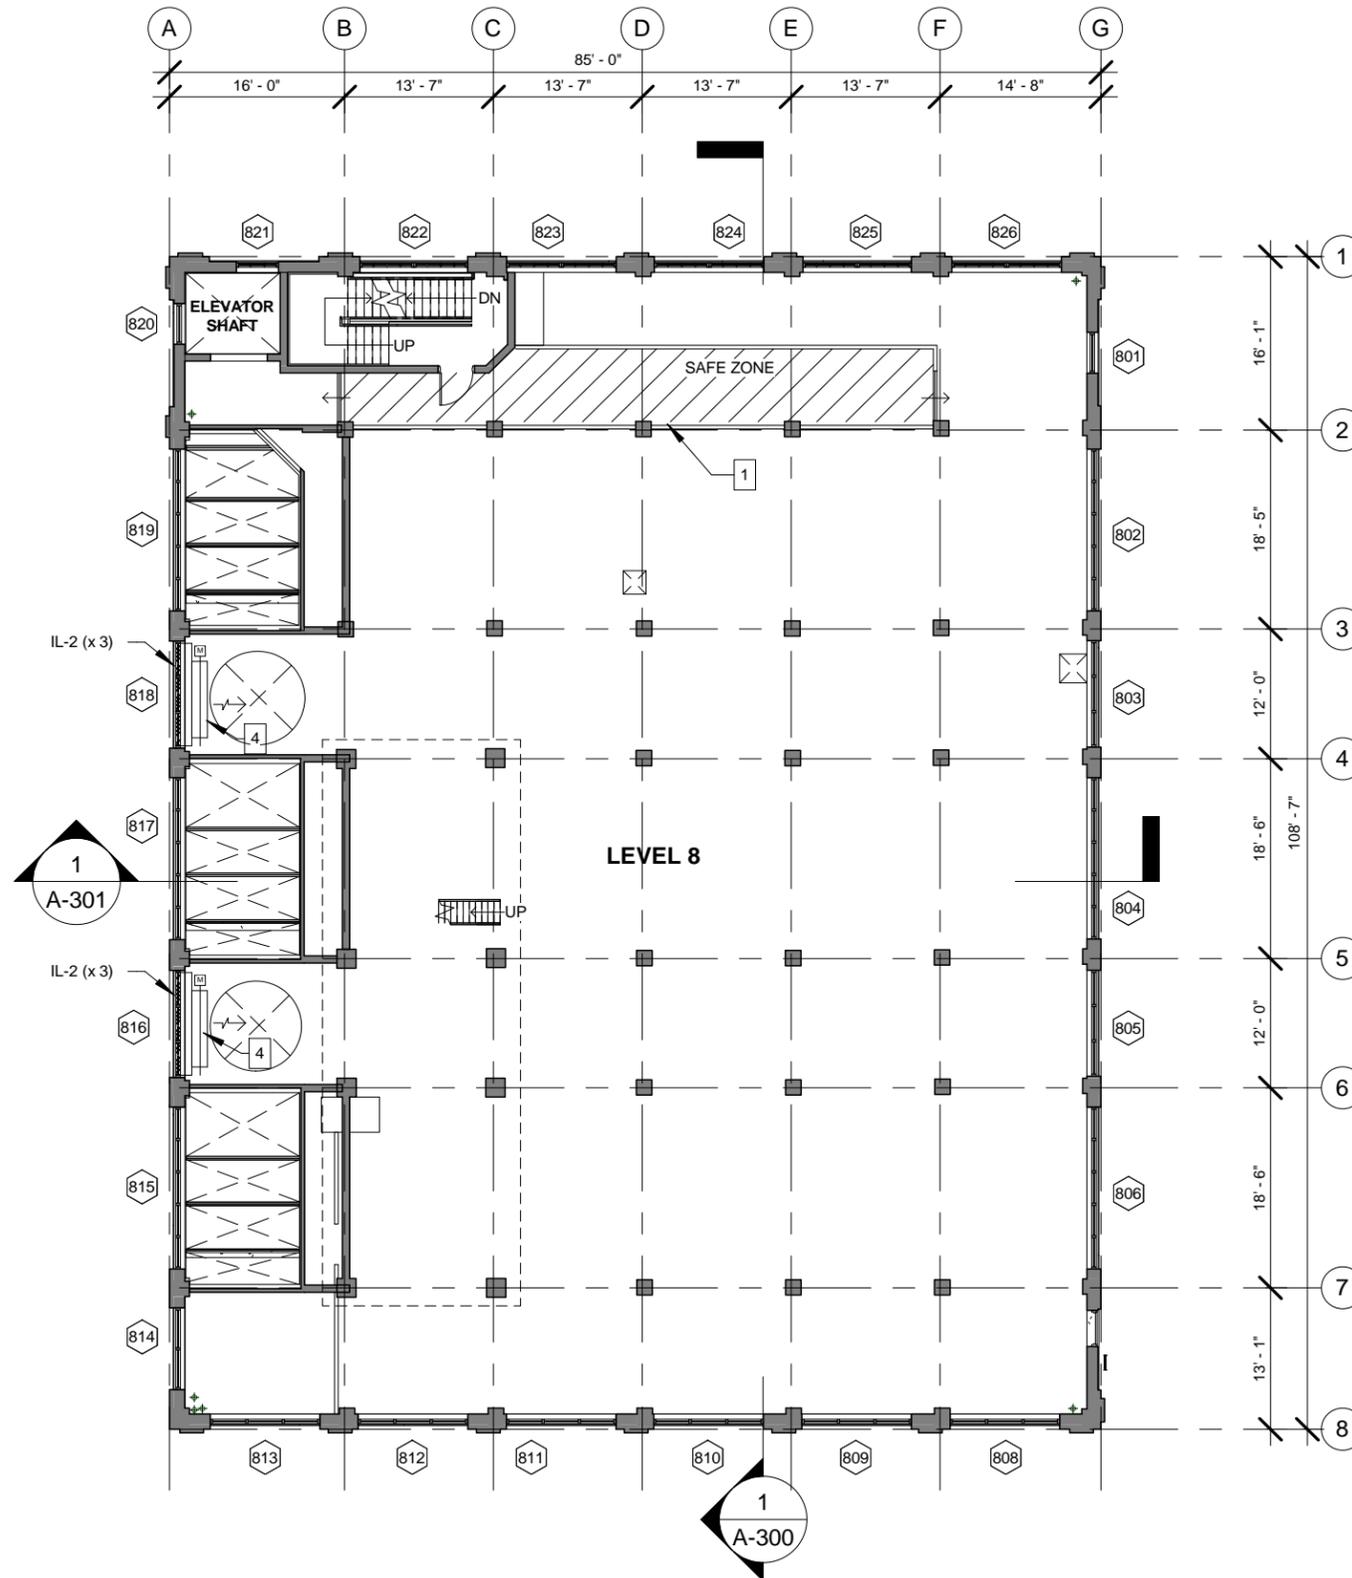
- EXPOSED AGGREGATE AT CONCRETE SLAB THROUGHOUT
- VISIBLE SIGNS OF PONDING AND STAINING AT CONCRETE SLAB
- MISCELLANEOUS CRACKS AND SPALLING AT CONCRETE ROOF DECK THROUGHOUT
- EVIDENCE OF WATER INFILTRATION AT CONCRETE THROUGHOUT
- EVIDENCE OF CORROSION AT STEEL BEAMS
- GRAFFITI AT MASONRY AND CONCRETE THROUGHOUT
- STAINING AND SOILING AT MASONRY THROUGHOUT
- EVIDENCE OF CORROSION AT STORM RISER PIPING AND VISIBLE LEAKS THROUGHOUT. VARIOUS OPENINGS BLOCKED WITH PLYWOOD
- ALUMINUM WINDOWS: CRACKS AT GLAZING, MISSING WINDOW PARTS, MISSING SEALANT, INOPERABLE HARDWARE. CORROSION AND SOILING THROUGHOUT.
- STEEL WINDOWS: CRACKS AT GLAZING, MISSING WINDOW PARTS, MISSING SEALANT, INOPERABLE HARDWARE, CORROSION AND SOILING THROUGHOUT. VARIOUS OPENINGS BLOCKED WITH PLYWOOD
