IMPERIAL SUGAR COMPANY CHAR FILTER HOUSE CONDITIONS ASSESSMENT

FINAL SUBMISSION TO
CITY OF SUGAR LAND ECONOMIC DEVELOPMENT

30 SEPTEMBER, 2020

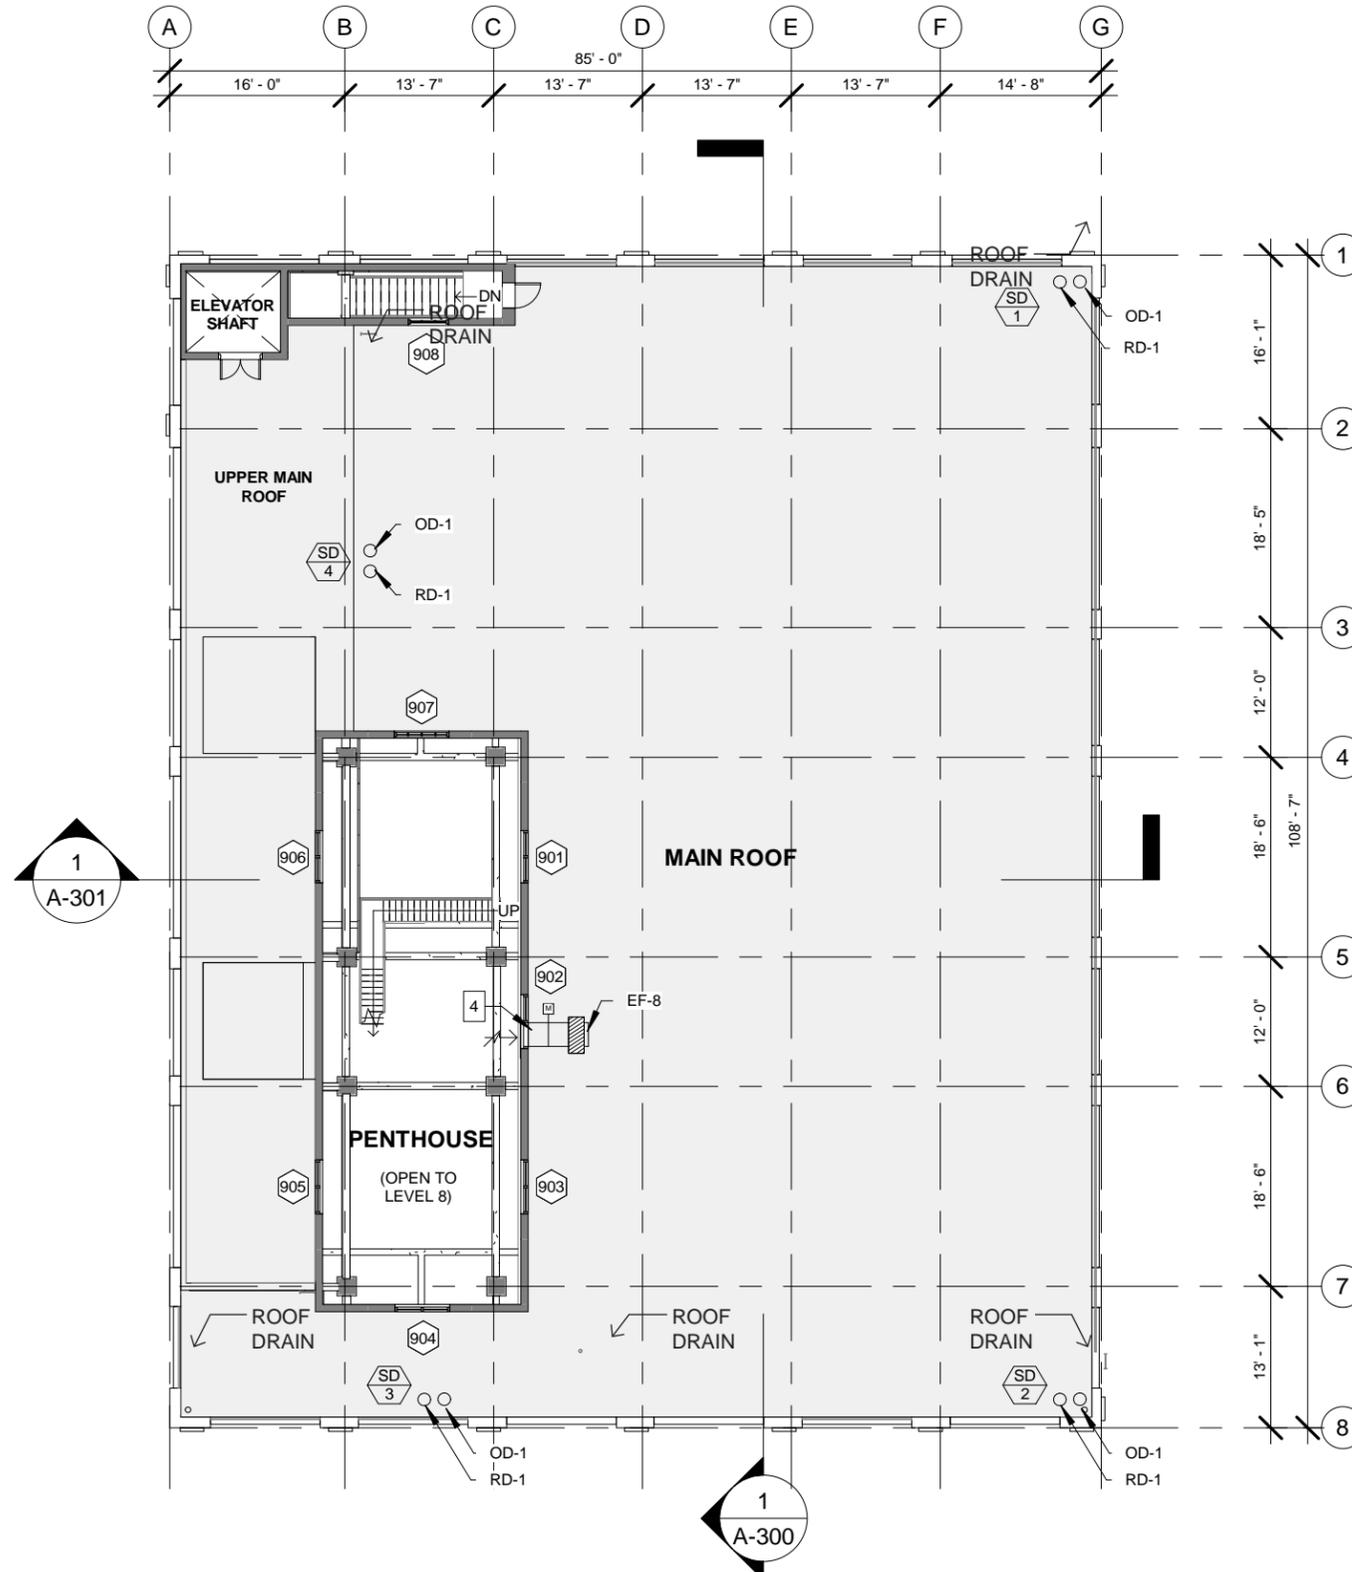
- MISCELLANEOUS CRACKS AND SPALLING AT CONCRETE ROOF DECK THROUGHOUT AT PENTHOUSE
- EVIDENCE OF CORROSION AT STEEL BEAMS AT PENTHOUSE
- STAINING AND SOILING AT MASONRY THROUGHOUT
- MISCELLANEOUS CRACKS AT MASONRY NEAR LINTELS AT PENTHOUSE
- INAPPROPRIATE MORTAR INFILL AT MASONRY CRACKS AT PENTHOUSE
- EVIDENCE OF CORROSION AT METAL RAILING THROUGHOUT
- ROOF OPENINGS TO THE OUTSIDE, WITH VISIBLE LEAKS
- EVIDENCE OF CORROSION AND CLOGGING AT ROOF DRAINS AND VISIBLE LEAKS
- NO SECONDARY DRAINAGE FOUND
- NUMEROUS PATCH REPAIRS AT ROOF
- FLASHING IN POOR CONDITION OR MISSING
- ROOF METAL COPING AND SCUPPERS IN POOR CONDITION
- ALUMINUM WINDOWS: CRACKS AT GLAZING, MISSING WINDOW PARTS, MISSING SEALANT, INOPERABLE HARDWARE, CORROSION AND SOILING THROUGHOUT.
- STEEL WINDOWS: CRACKS AT GLAZING, MISSING WINDOW PARTS, MISSING SEALANT, INOPERABLE HARDWARE, CORROSION AND SOILING THROUGHOUT.

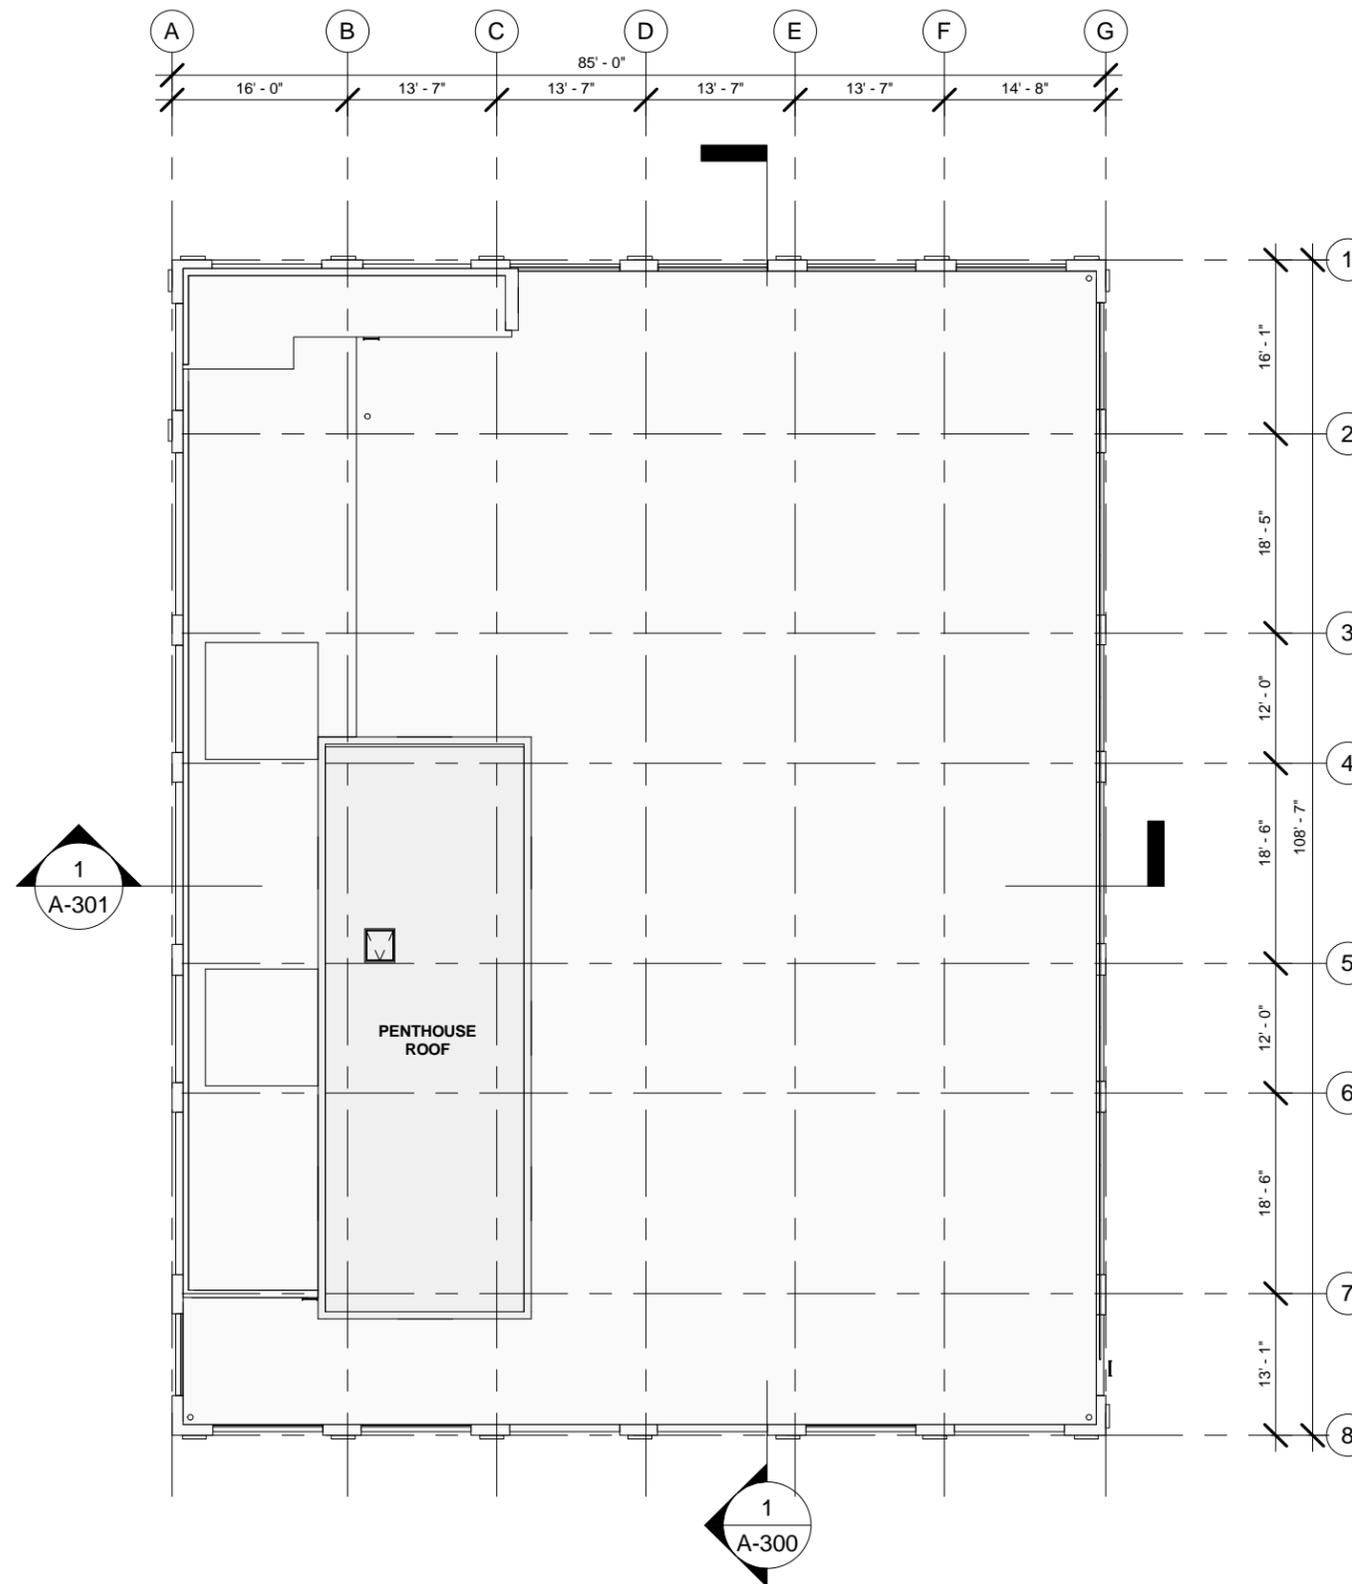
- THIS AREA WAS NOT ACCESSIBLE DUE TO SAFETY CONCERNS
- MISSING ROOF HATCH AND VARIOUS ROOF OPENINGS TO THE OUTSIDE, WITH VISIBLE LEAKS
- REFER TO GENERAL NOTES ON A-109

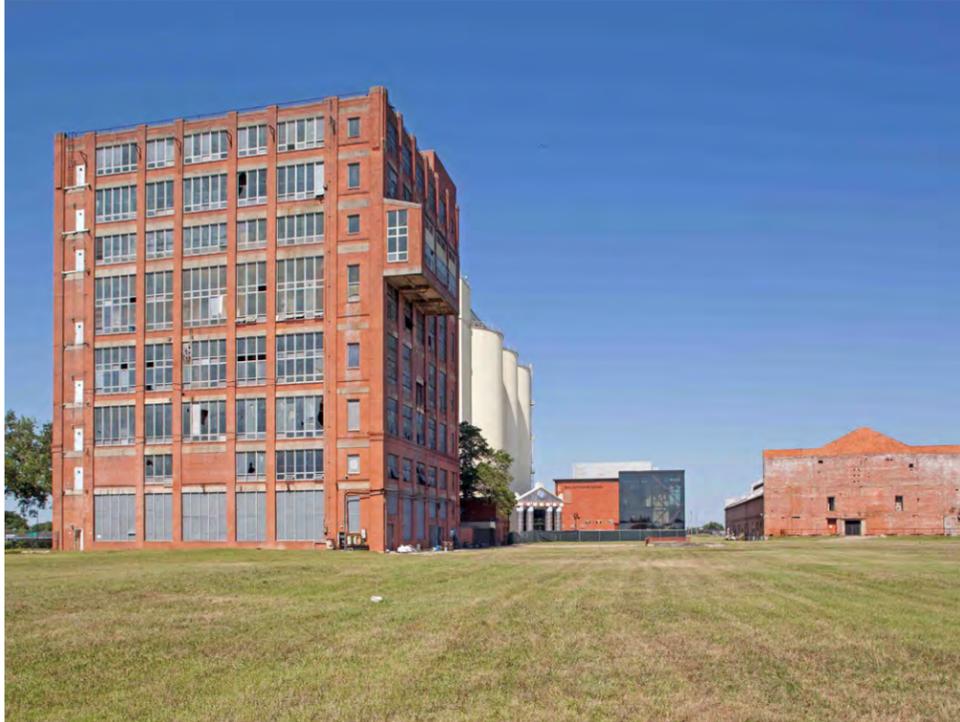
SITE SURROUNDINGS, MINIMAL POSITIVE DRAINAGE

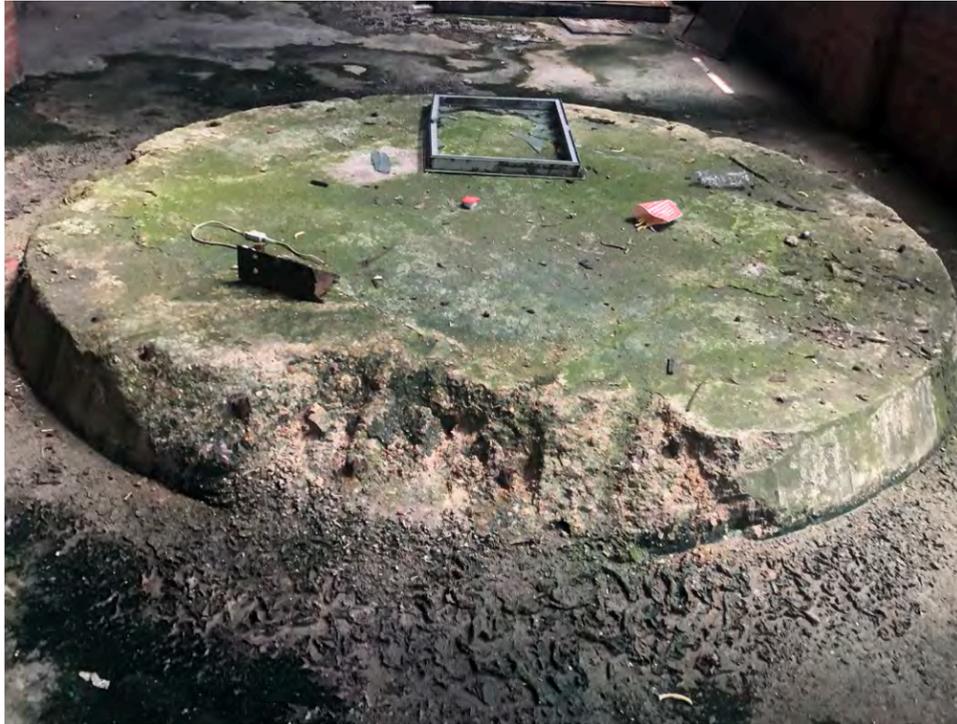
SOILING AT CONCRETE

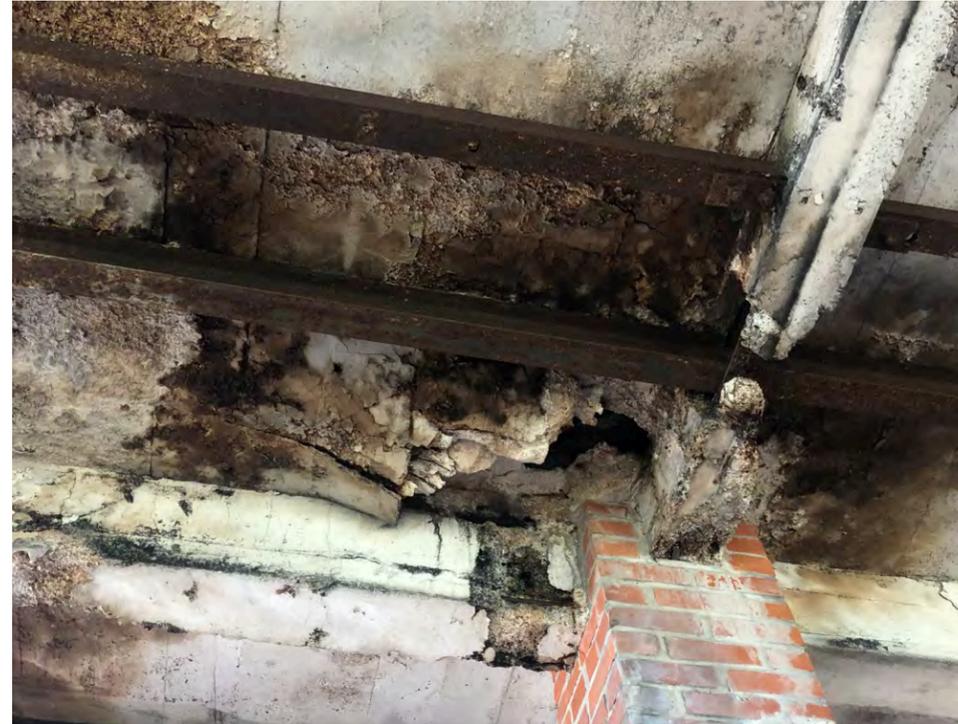
DETERIORATING ROOF DECK & FIRE PROOFING TAKEN FROM LEVEL 8

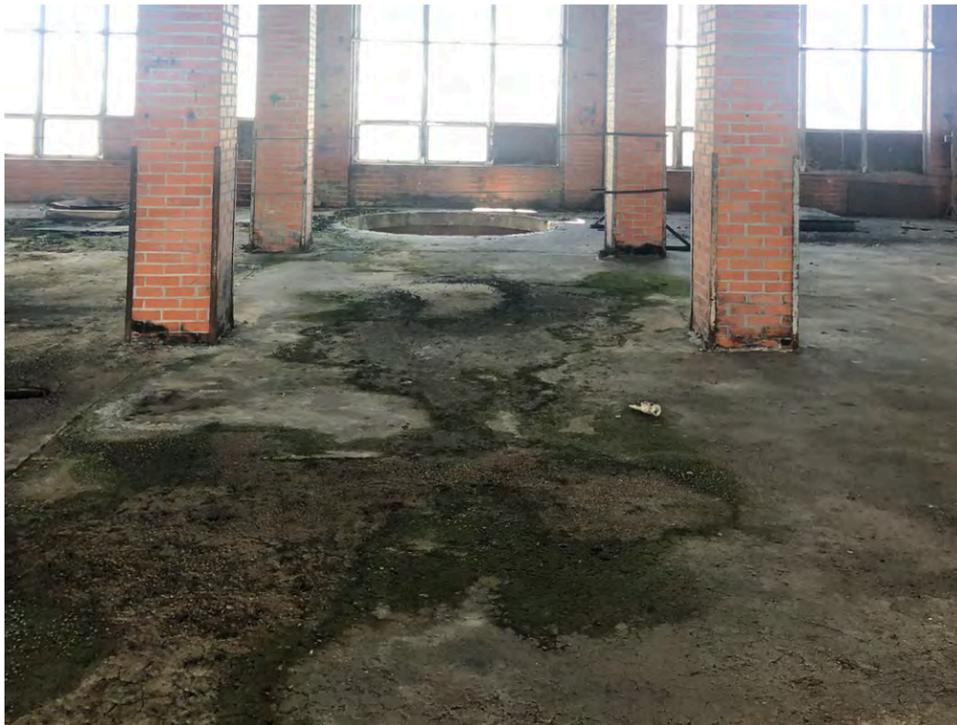
CONCRETE DETERIORATION AT LEVEL 7 SLAB

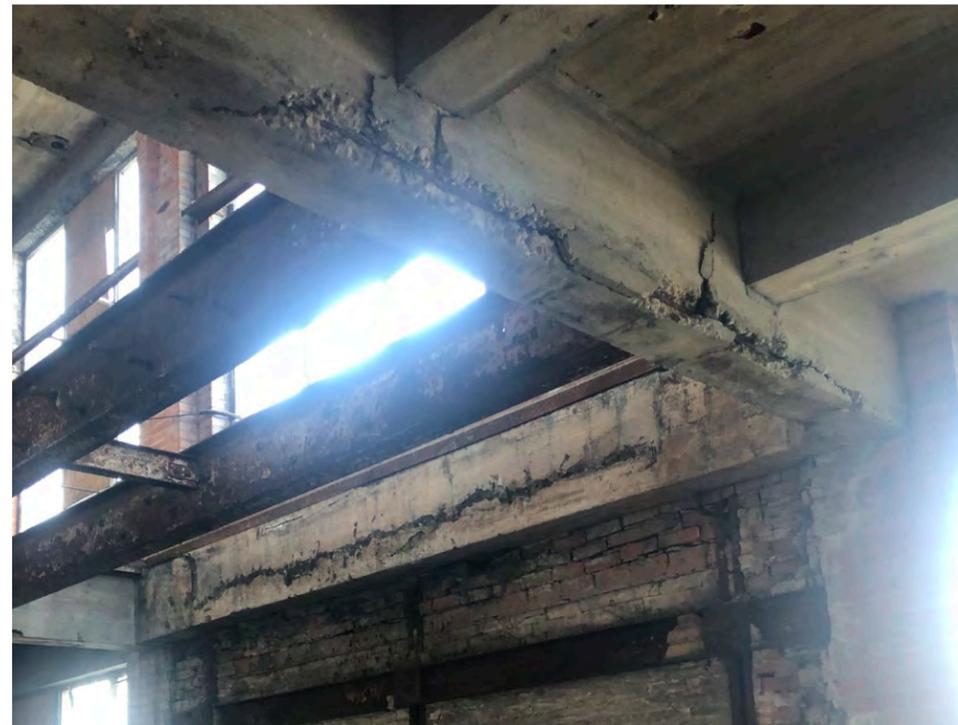
CONCRETE BREAKING AWAY FROM REBAR AT BEAMS

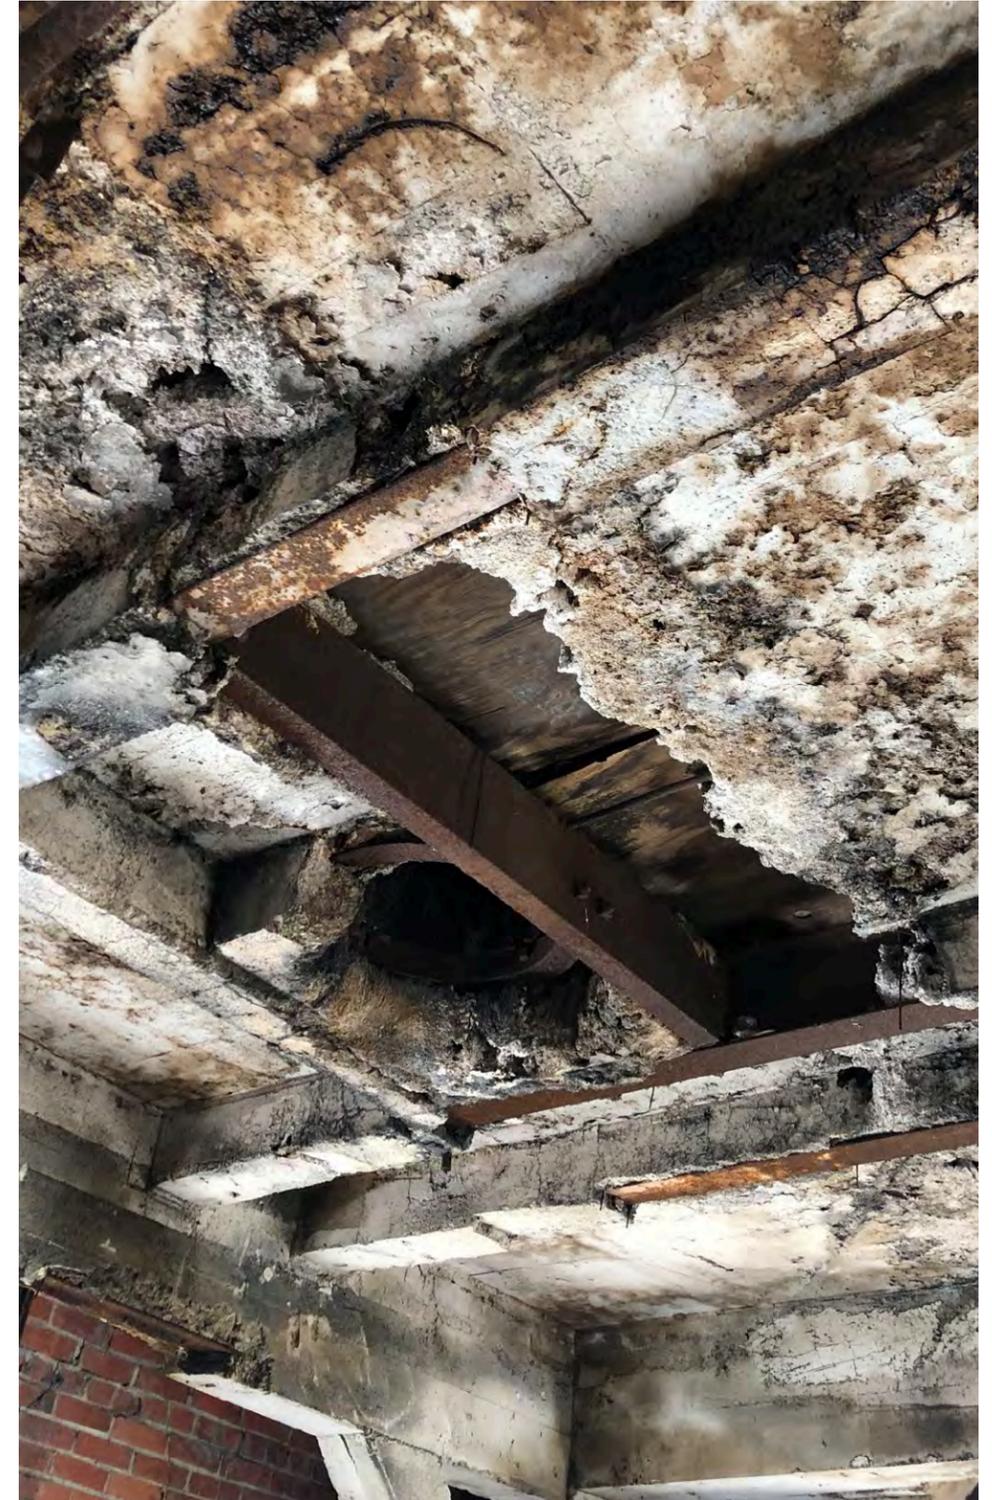
DETERIORATING ROOF DECK & FIREPROOFING TAKEN AT PENTHOUSE

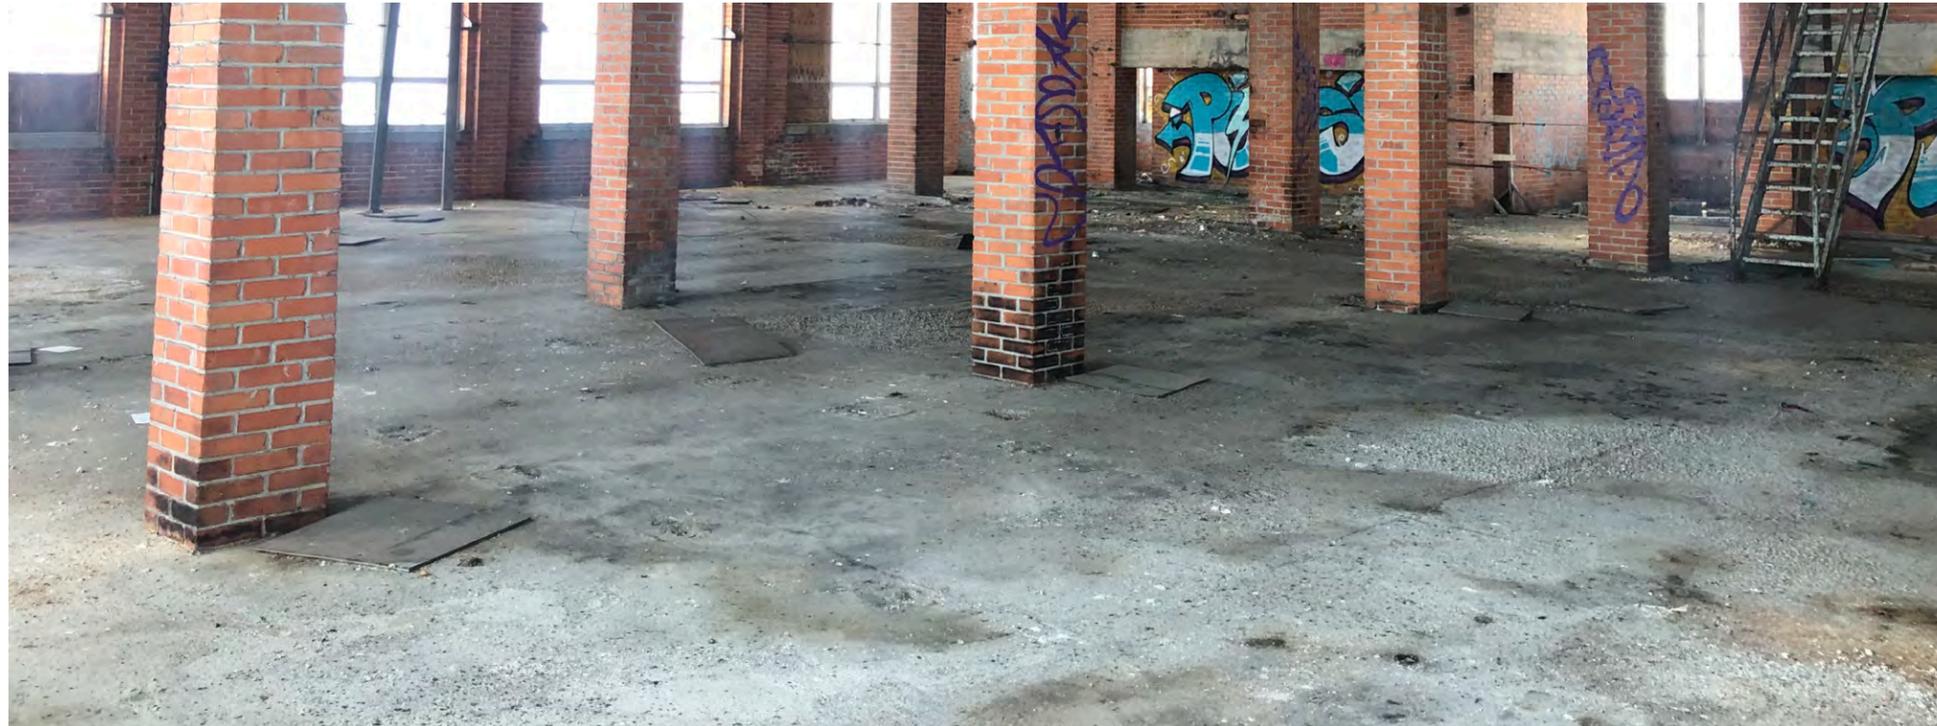
CONCRETE SLAB STAINING AT LEVEL 8

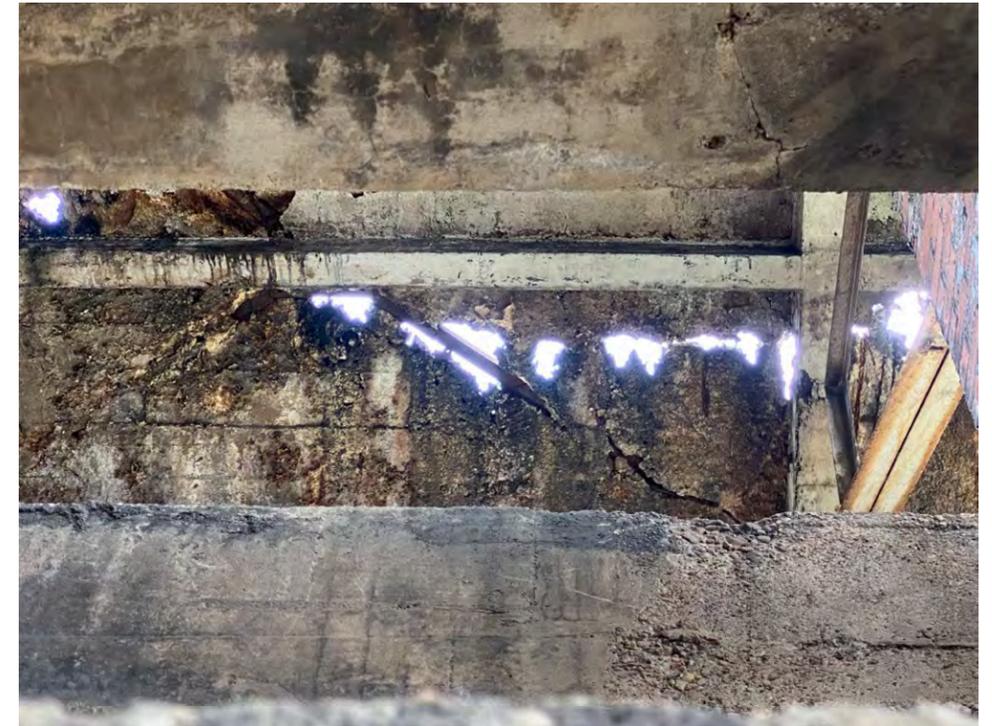
DETERIORATING ROOF DECK AT SADDLEBAG

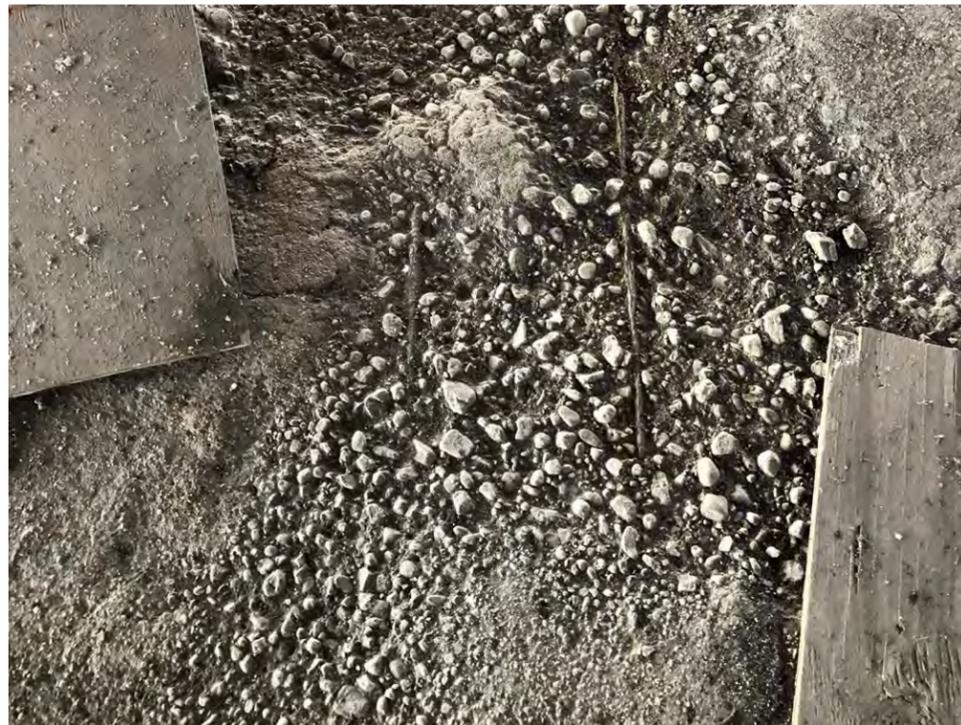
DETERIORATED SLABS EXPOSING REBAR AT LEVEL 8

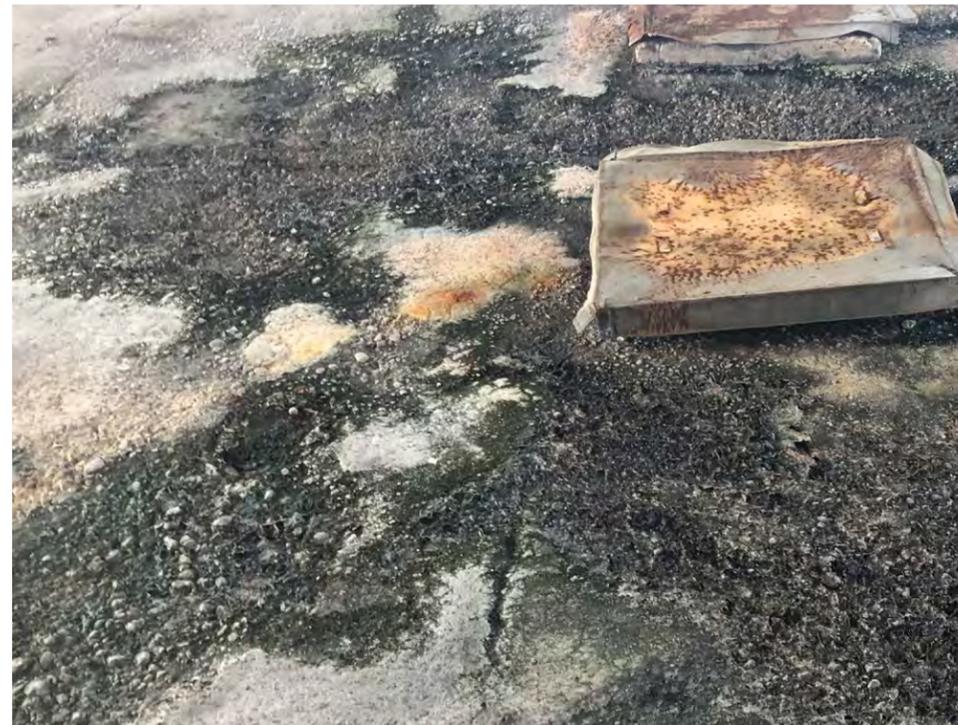
DETERIORATED SLABS EXPOSING AGGREGATE AT LEVEL 5

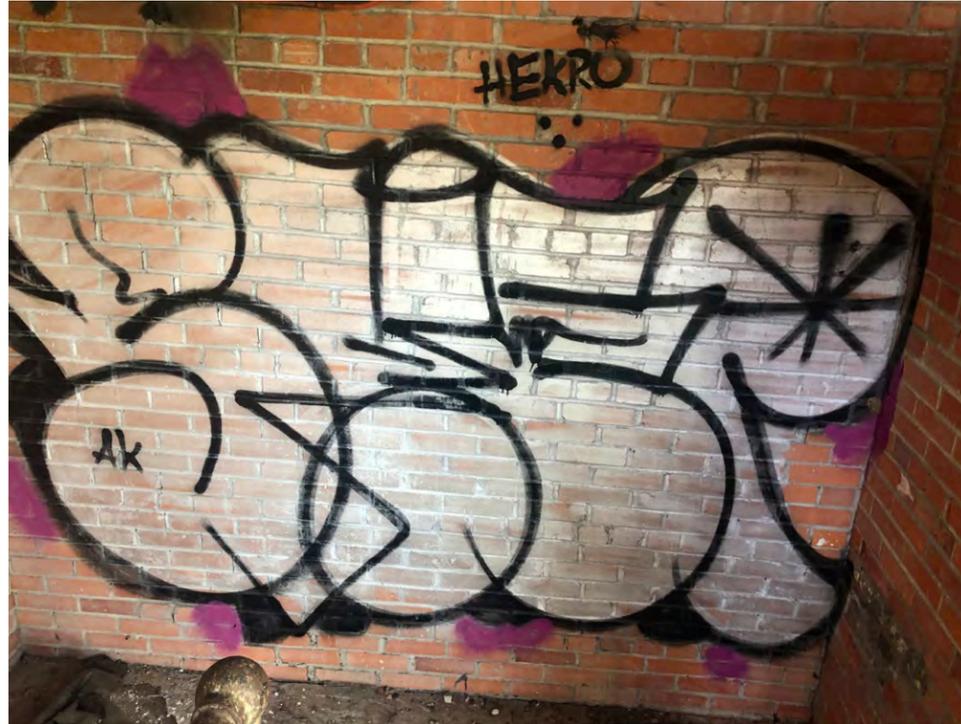
GRAFFITI AT STAIRWELL

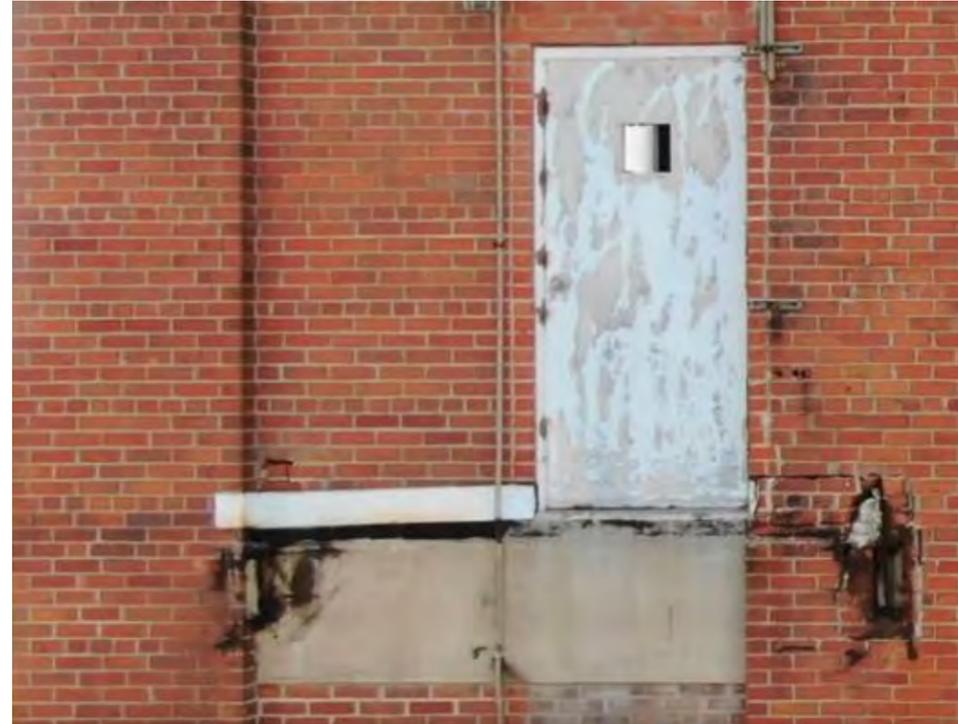
PREVIOUS STEEL SUPPORTS AT E FACADE DETERIORATING THE BRICK

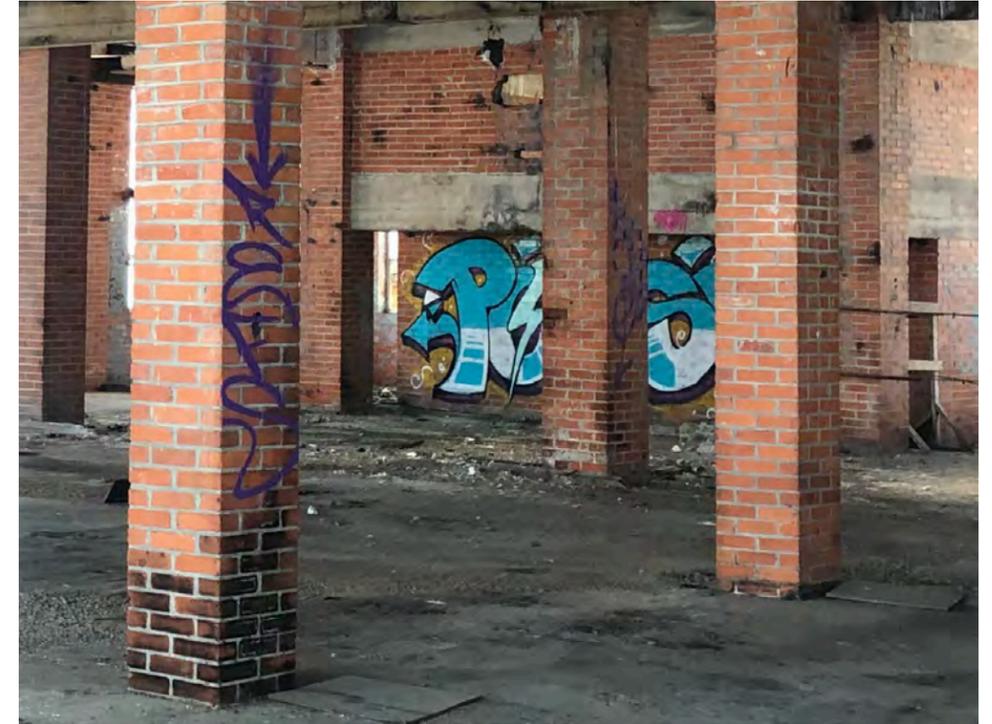
GRAFFITI AT SEVERAL LOCATIONS ON INTERIOR BRICK

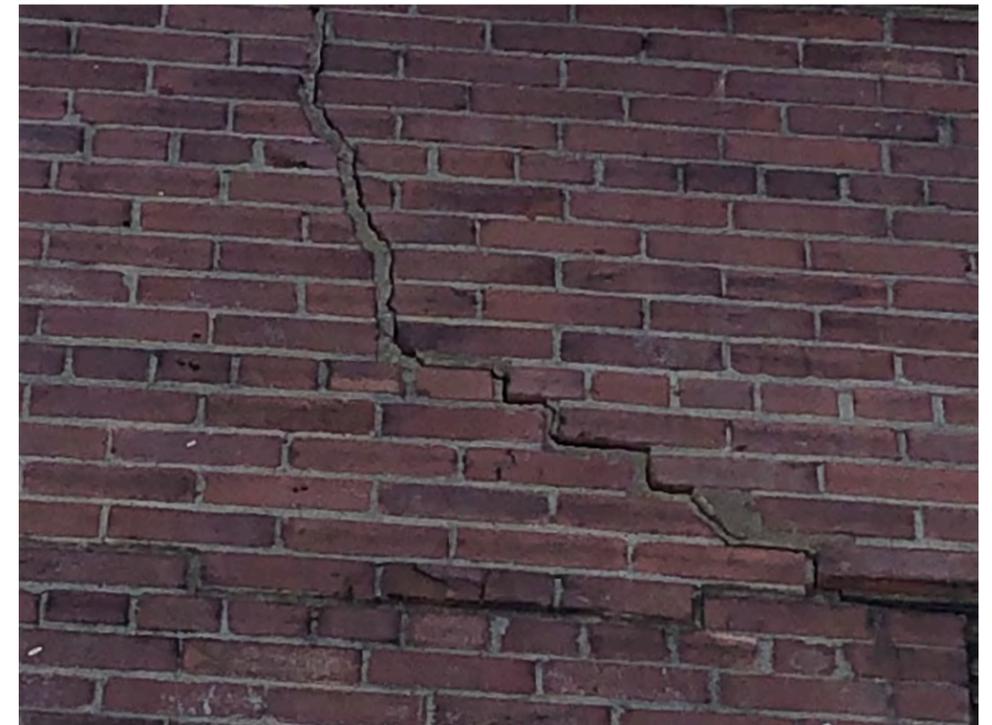
CRACK AT PENTHOUSE WINDOW OPENING

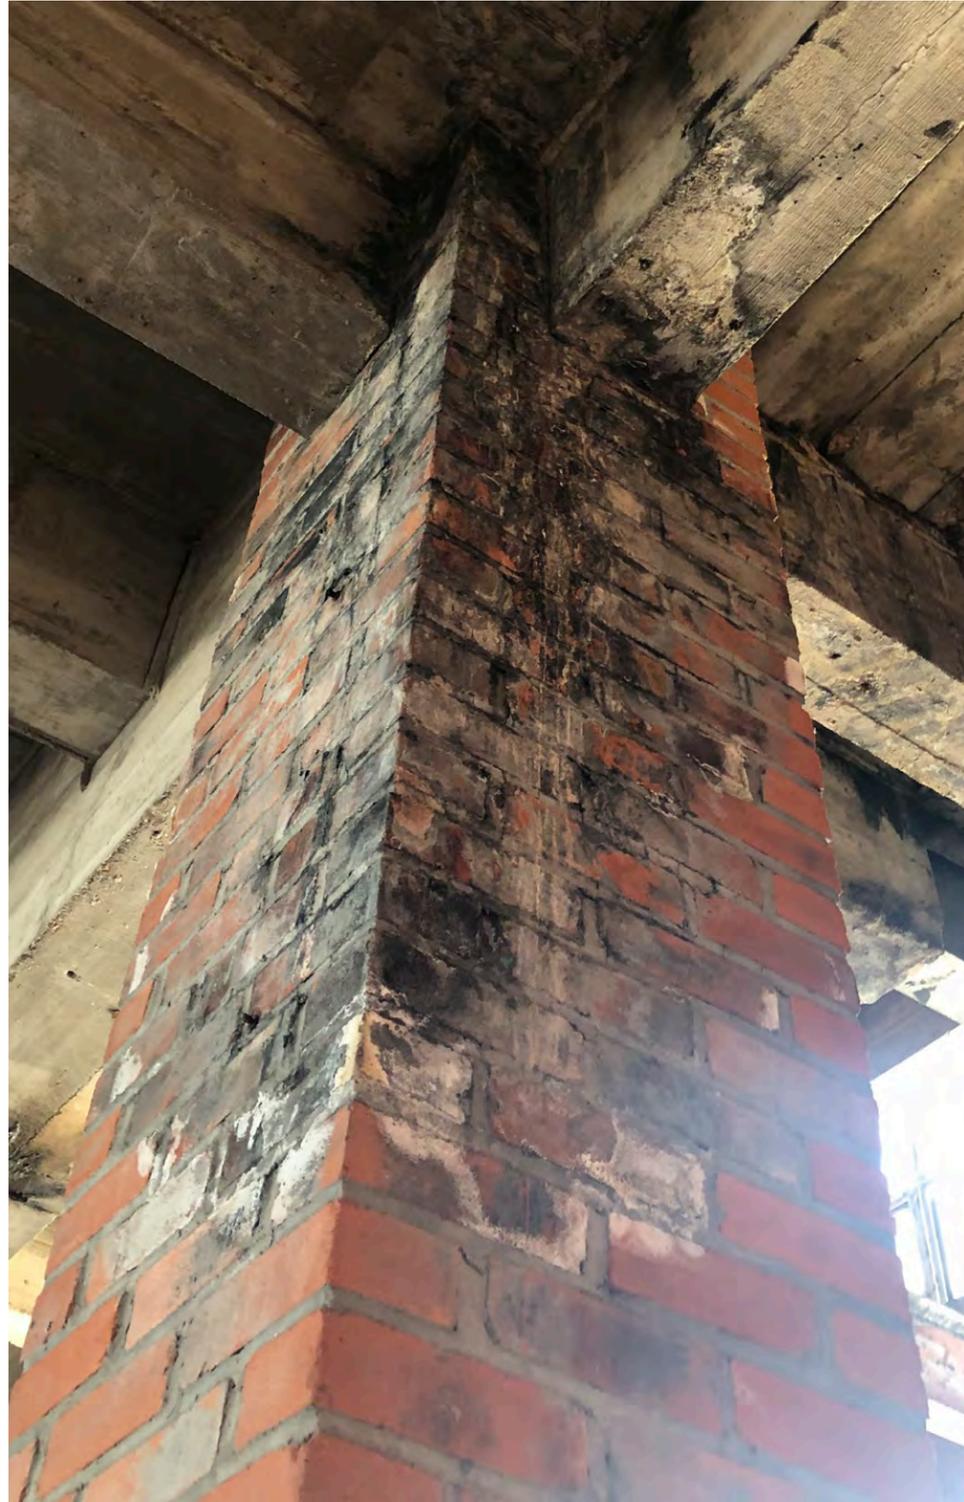
INTERIOR BRICK CONDITION AT LEVEL 7 IN NEED OF CLEANING

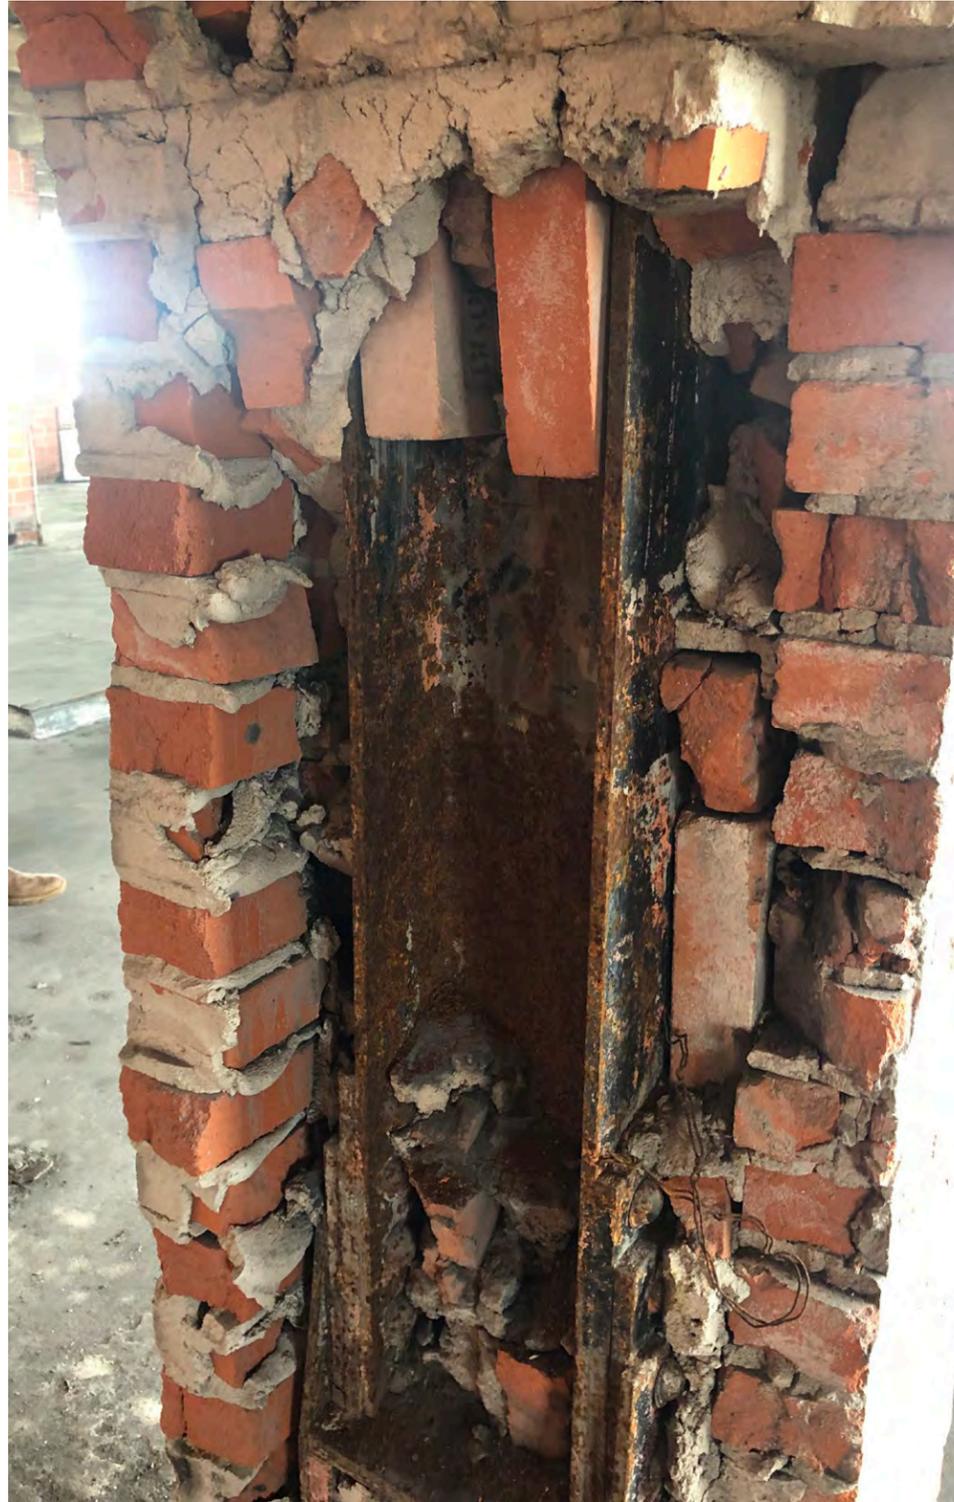
INTERIOR BRICK CONDITION AT LEVEL 7 IN NEED OF REPAIR

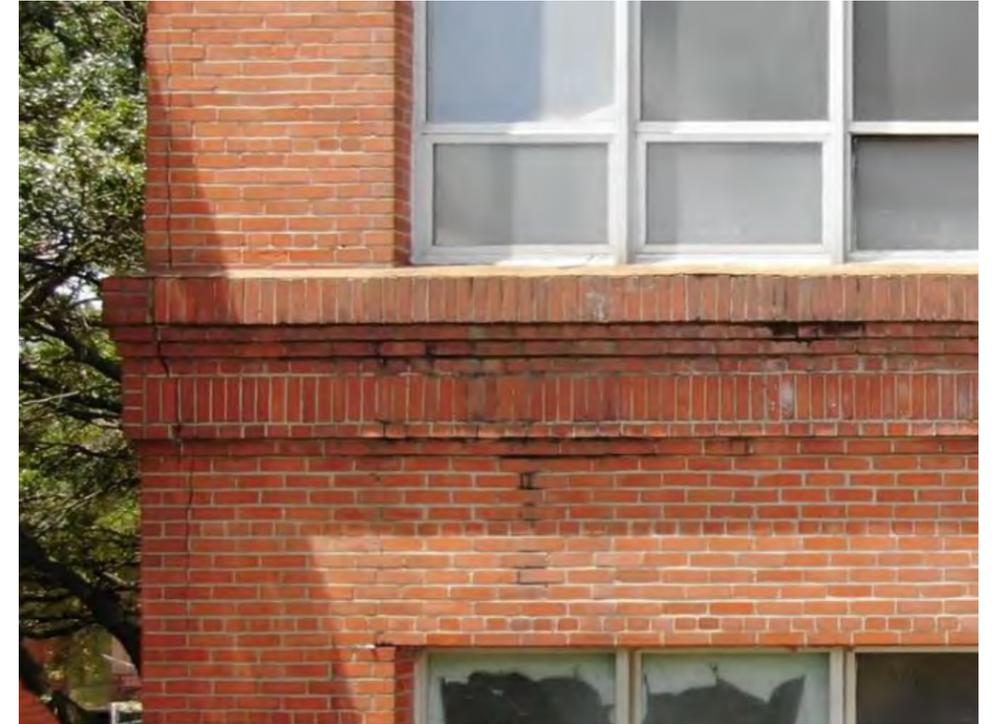
EXISTING BRICK CRACK ON SOUTH CORNER

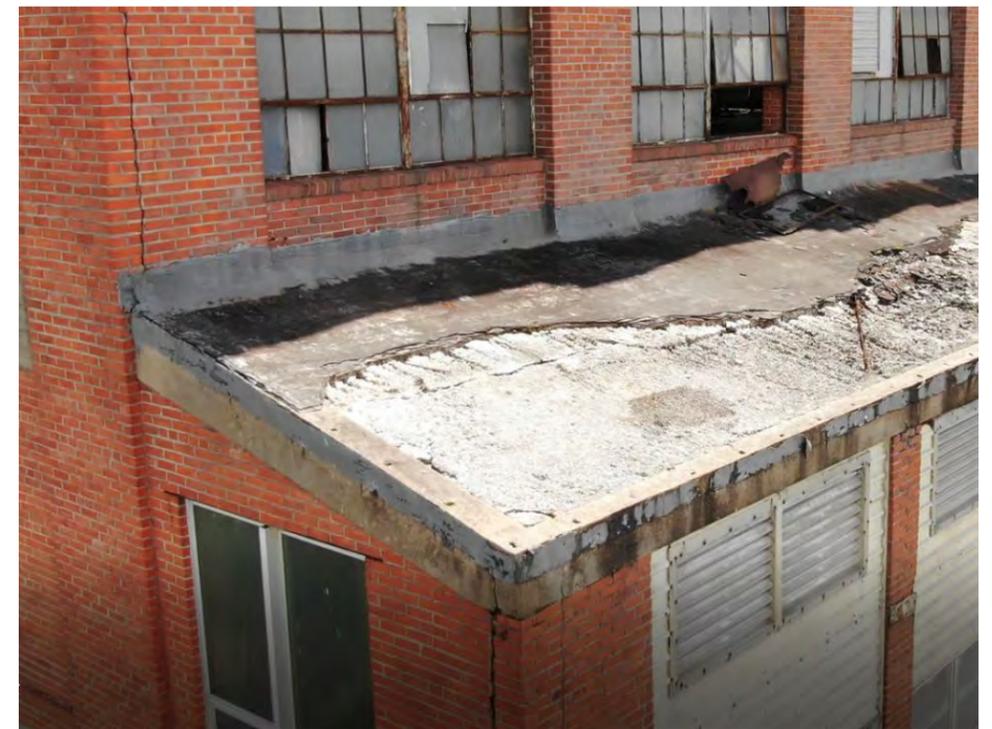
LARGE CRACK AT BRICK AT NE CORNER OF SADDLEBAG & N CORNER OF MAIN BUILDING

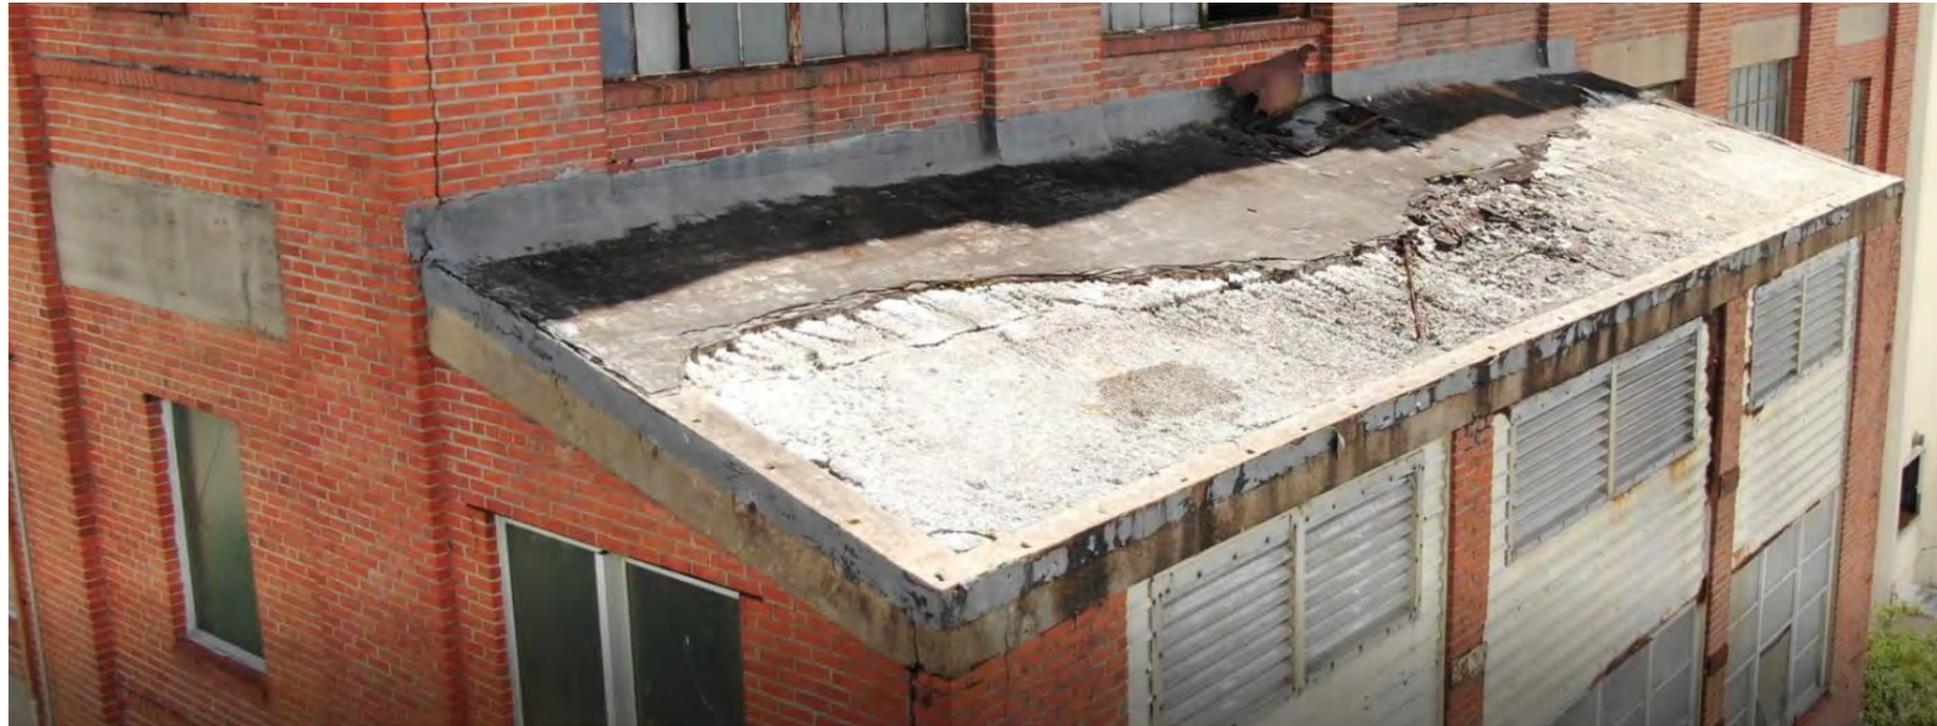
SADDLEBAG ROOF DETERIORATED

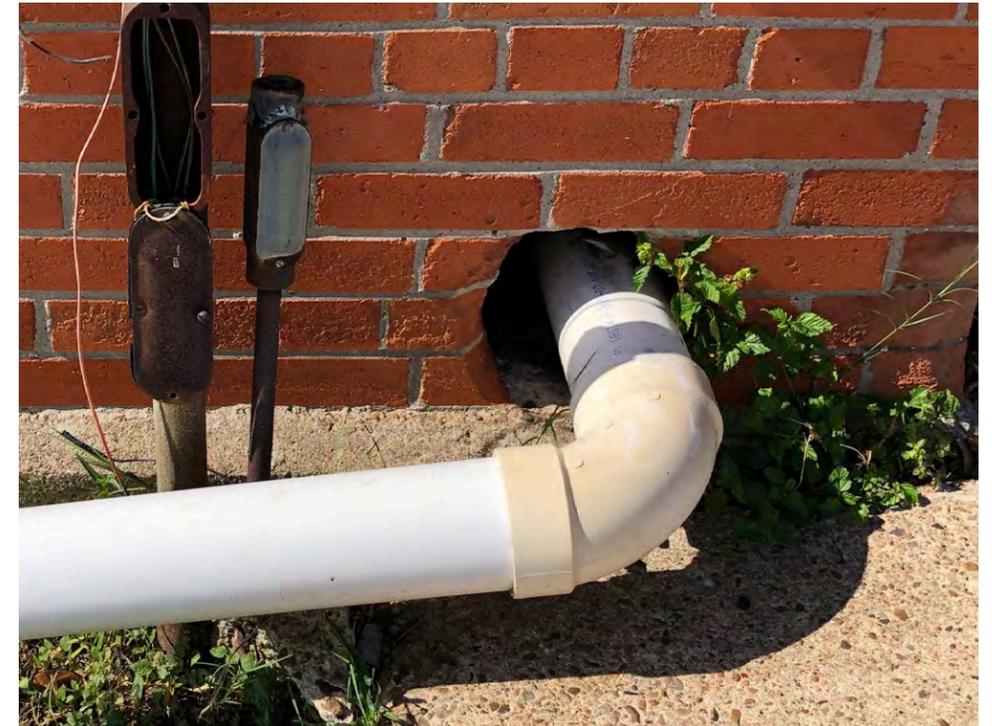
MISSING SEALANTS AT OPENING

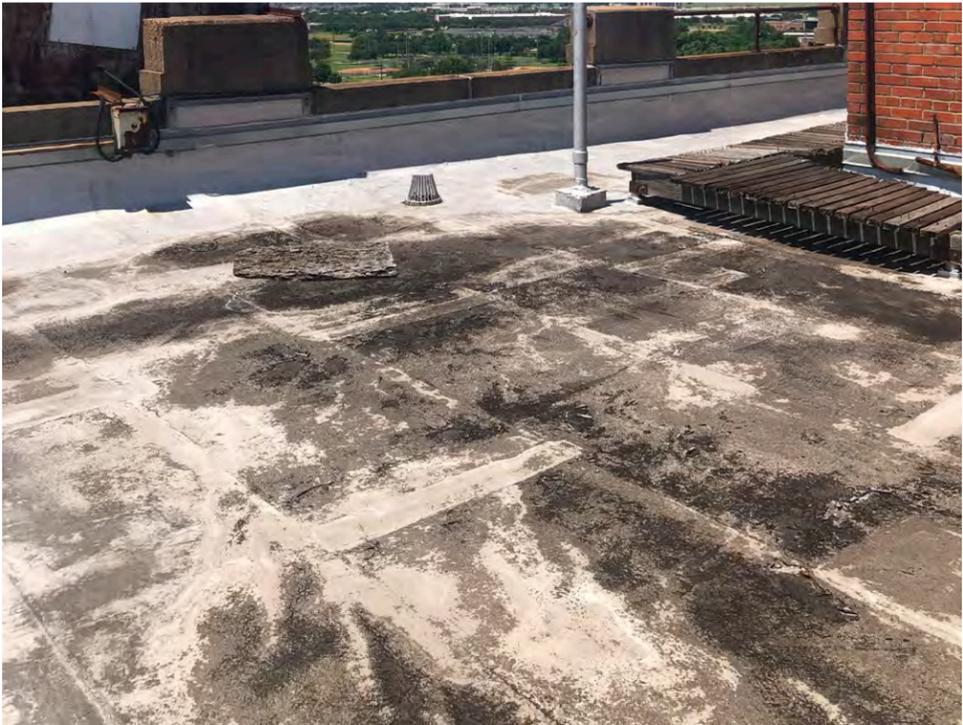
EXISTING MAIN ROOF WITH MINIMUM SLOPE AND SHOWING SIGNS OF DETERIORATION
