IMPERIAL SUGAR COMPANY CHAR FILTER HOUSE CONDITIONS ASSESSMENT

FINAL SUBMISSION TO
CITY OF SUGAR LAND ECONOMIC DEVELOPMENT

30 SEPTEMBER, 2020

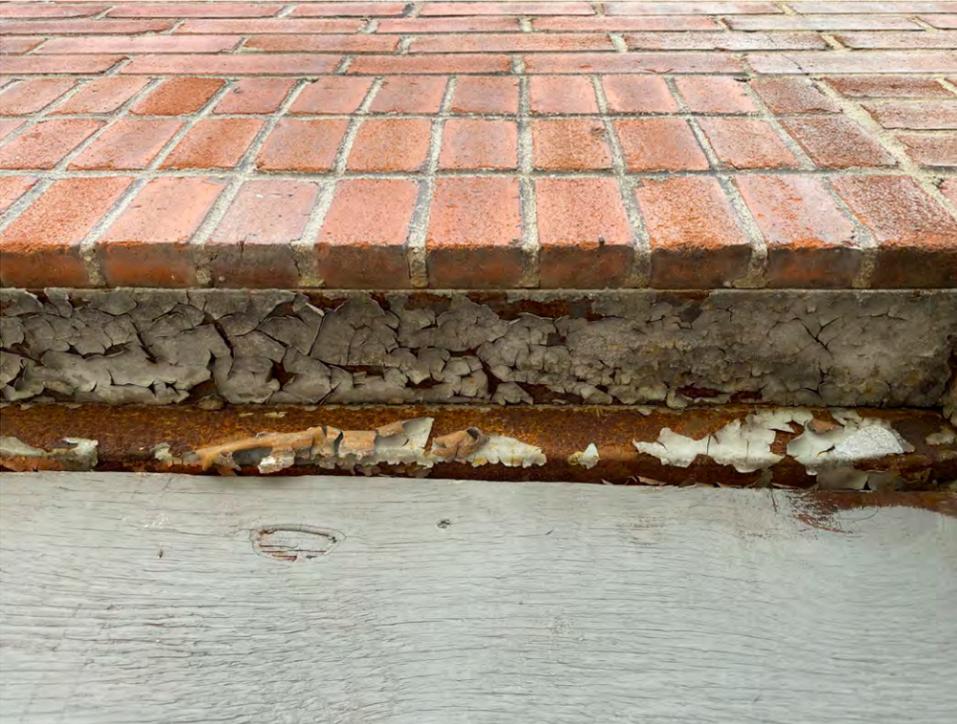
COATING PEELING AT LINTEL, TYPICAL CONDITION

Mothballing scope of work also include painting of steel lintels at selective locations throughout.

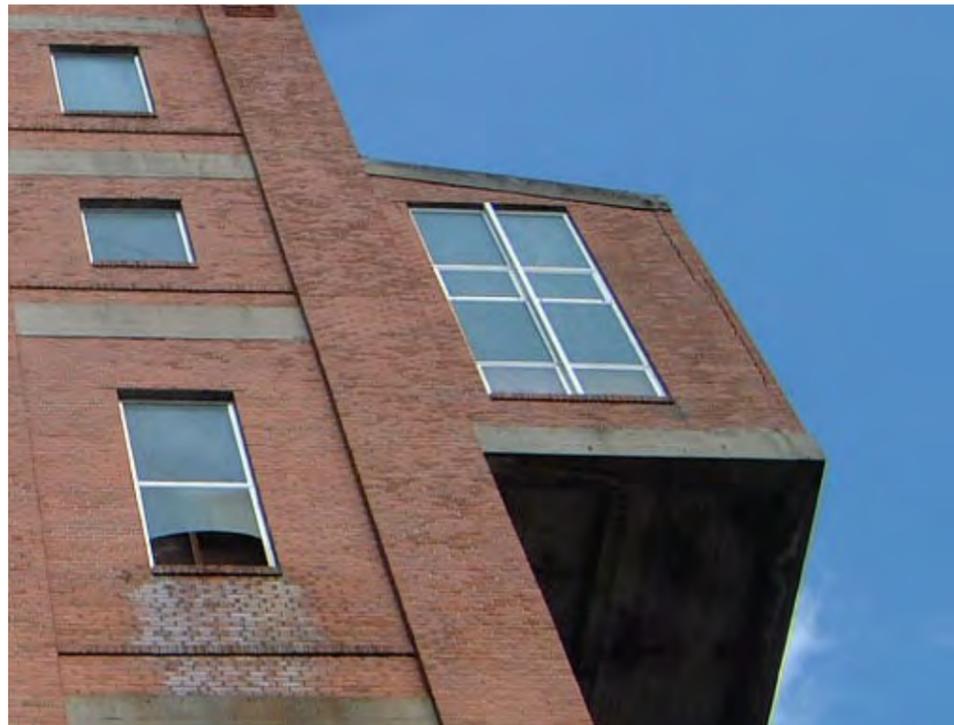
PHOTO FROM 2006 - CRACK AT BUILDING CORNER NEAR SADDLEBAG

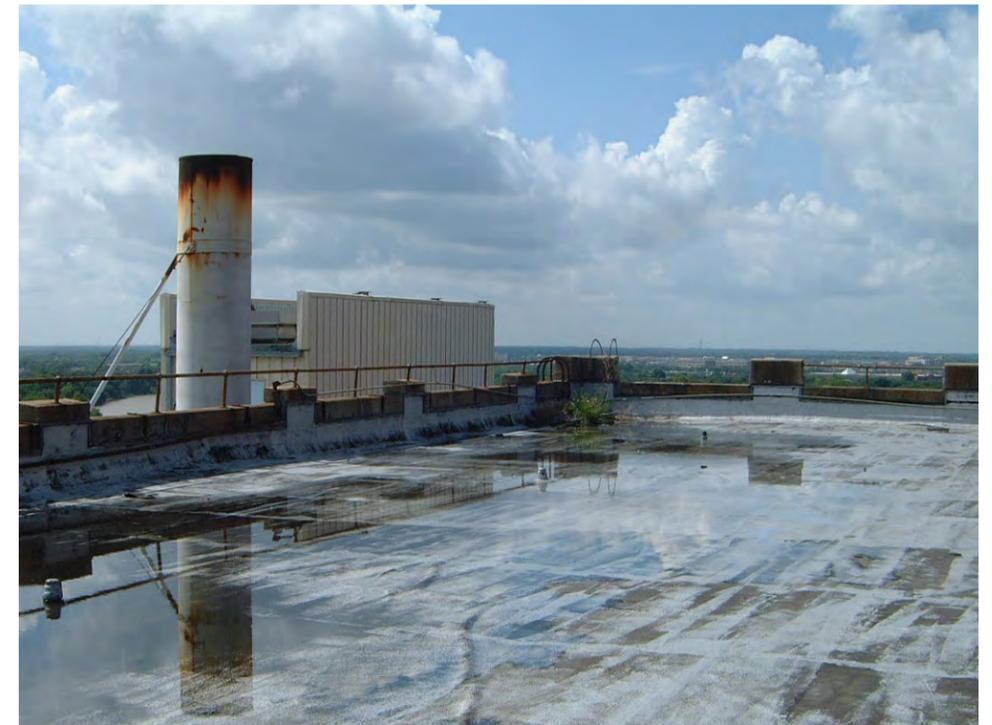
PHOTO FROM 2006 - ROOF WITH WATER PONDING

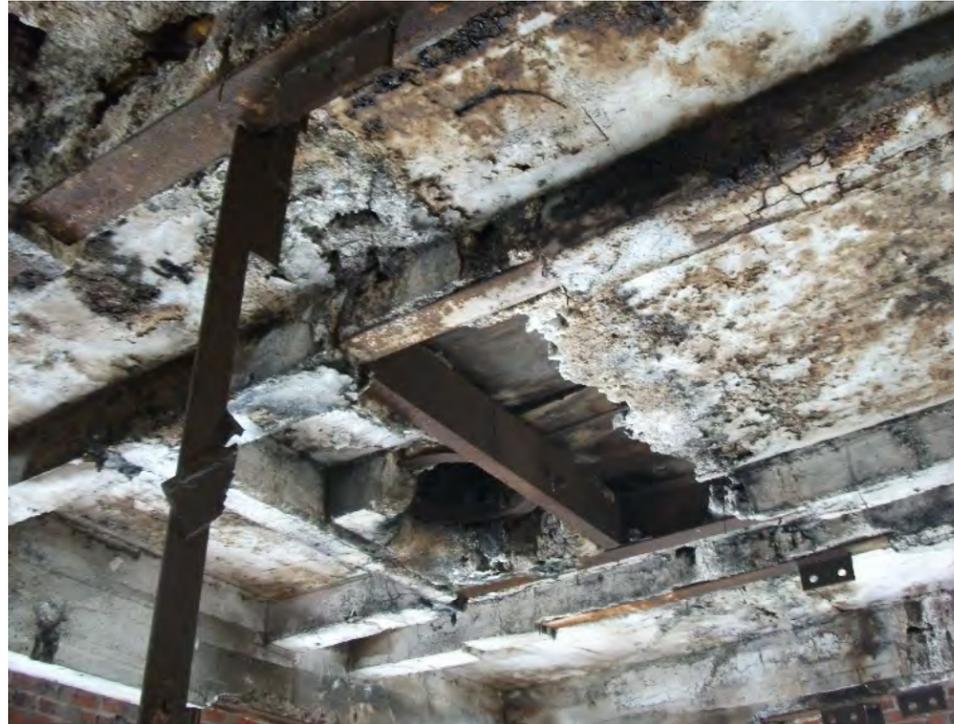
PHOTO 2.01 SEVERE DETERIORATION OF PENTHOUSE ROOF

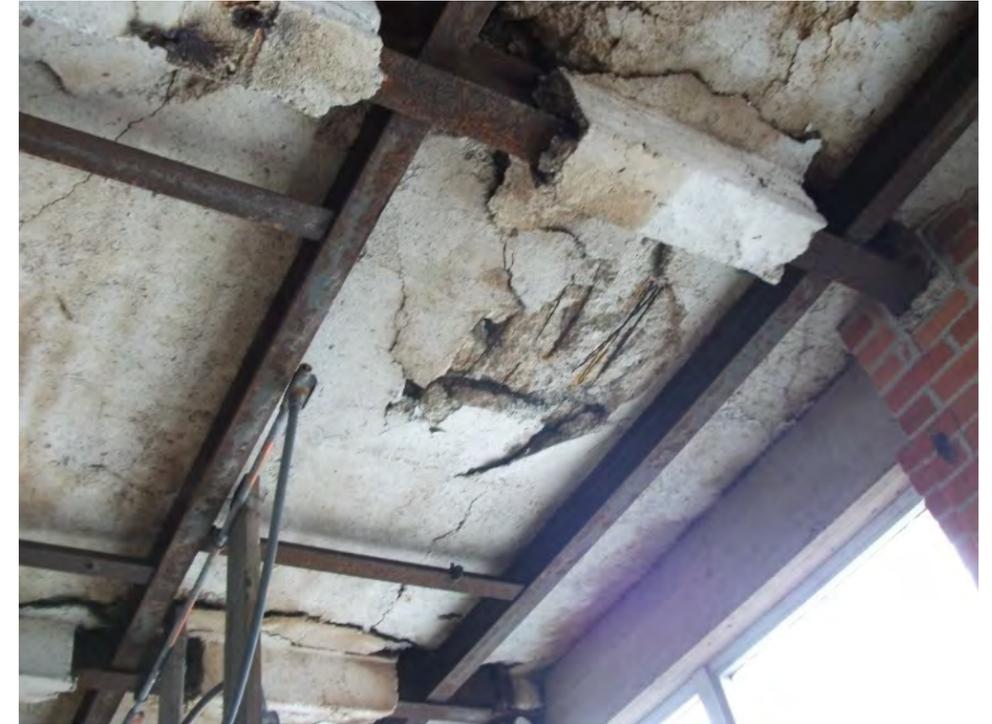
PHOTO 3.01 SPALLING AT UNDERSIDE OF CONCRETE ROOF DECK

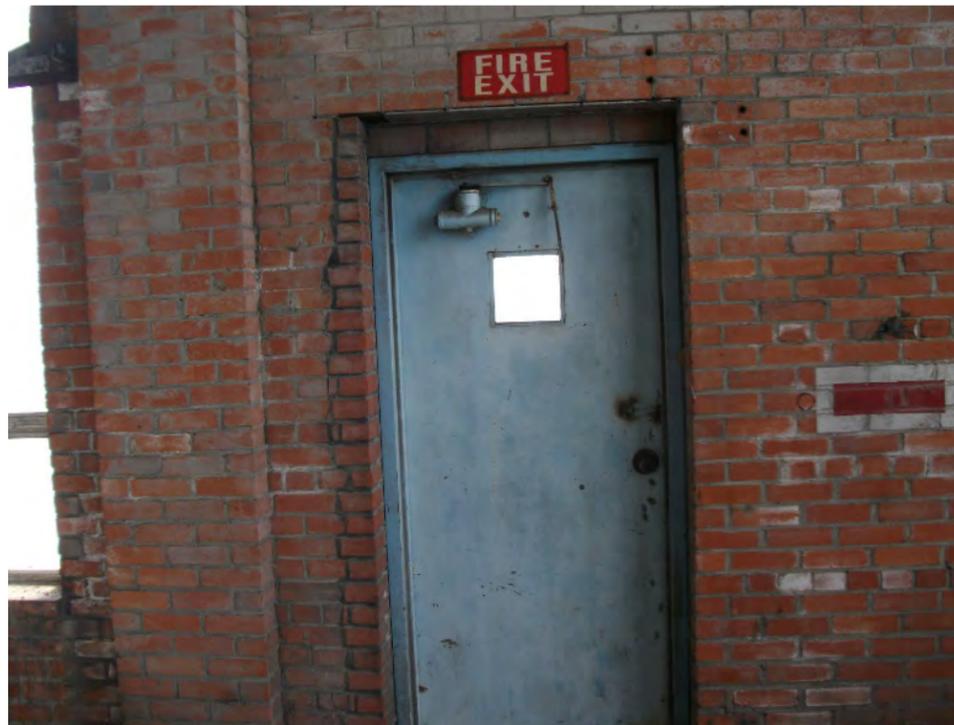
PHOTO 4.01 UNSAFE FIRE EXIT

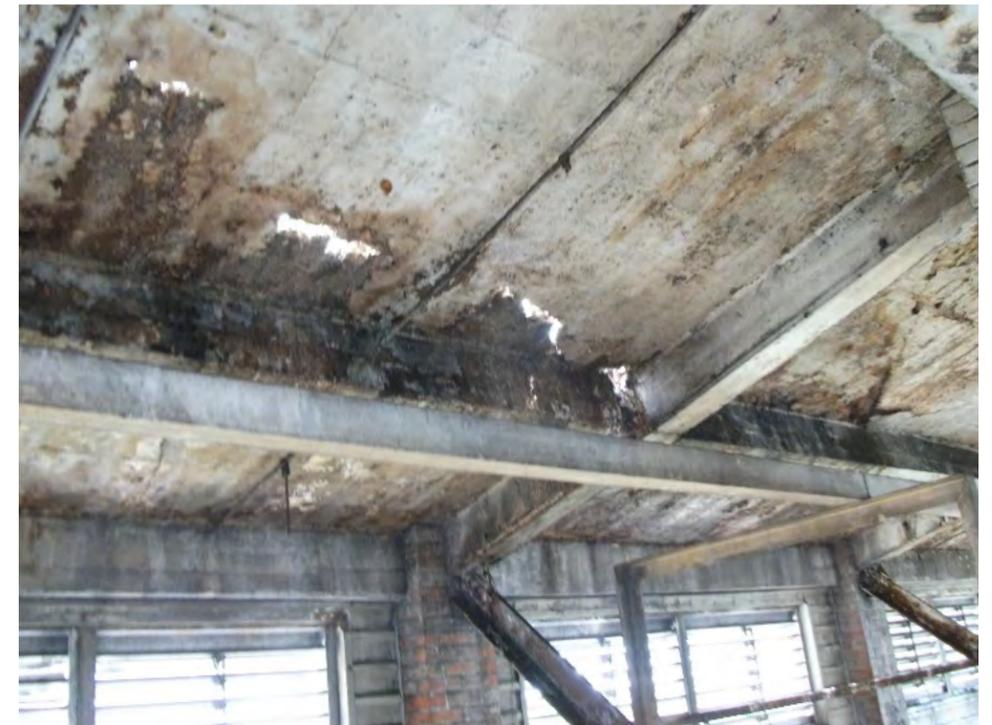
PHOTO 5.01 DAMAGED ROOF OF CANTILEVER STRUCTURE

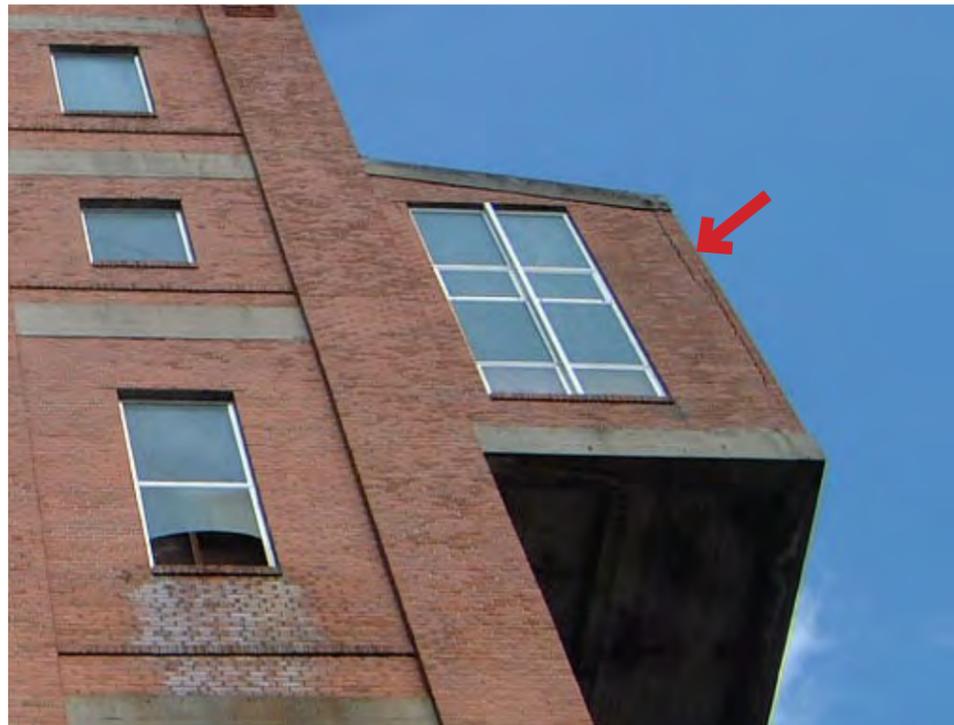
From the images presented in both reports, it appears that the worst of the cracks, located at the Saddlebag North-east corner, have maintained their severity in the past 14 years. At this point, we can conclude from the most recent structural report, that there is no present structural concern regarding the Saddlebag that justifies its removal. However, it is recommended that the area be monitored and that further structural analysis be performed prior to the commencement of any future rehabilitation work and building occupancy.

PHOTO FROM 2006 - CRACK AT BUILDING CORNER NEAR SADDLEBAG

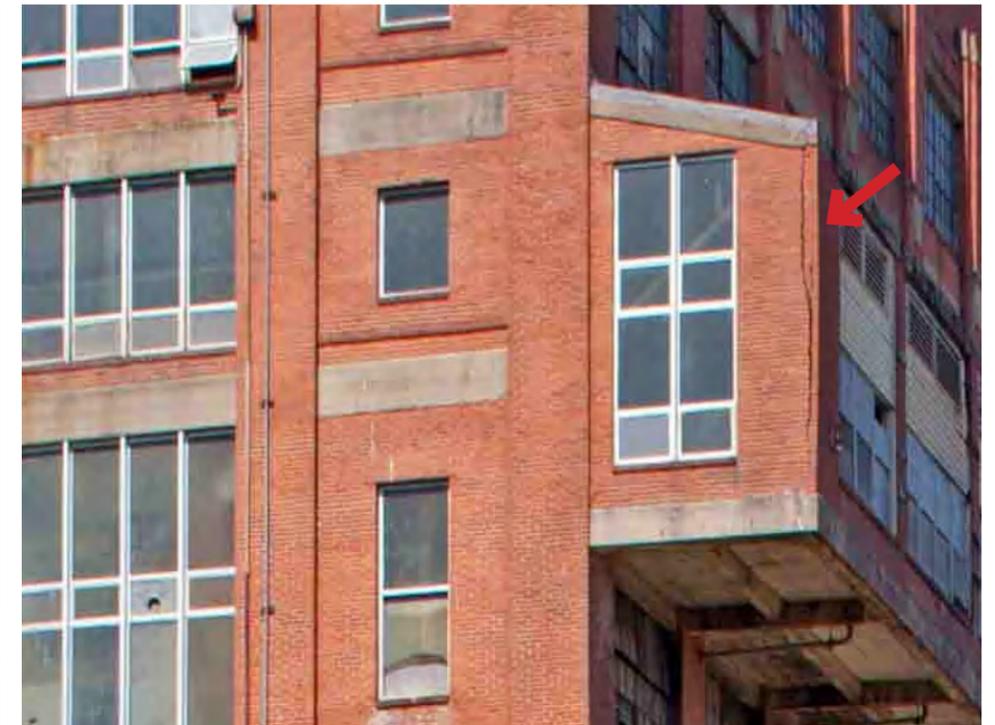
PHOTO FROM 2020 - CRACK AT BUILDING CORNER ON CANTILEVER
