IMPERIAL SUGAR COMPANY CHAR FILTER HOUSE CONDITIONS ASSESSMENT

FINAL SUBMISSION TO
CITY OF SUGAR LAND ECONOMIC DEVELOPMENT

30 SEPTEMBER, 2020

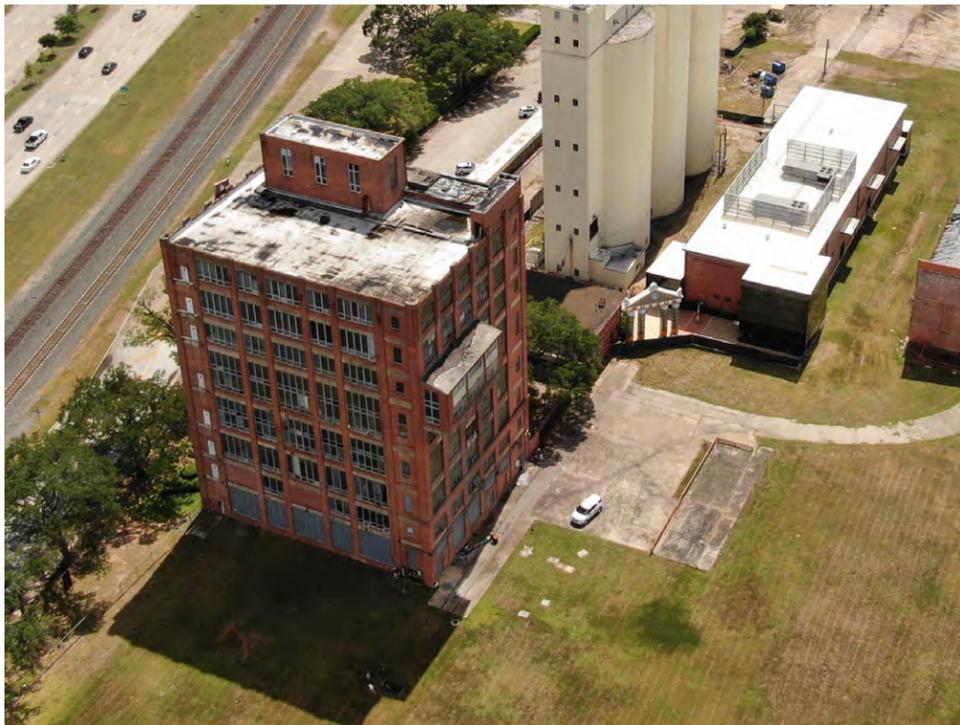
SITE SURROUNDINGS & GROUND COVERING AT NORTH AND EAST

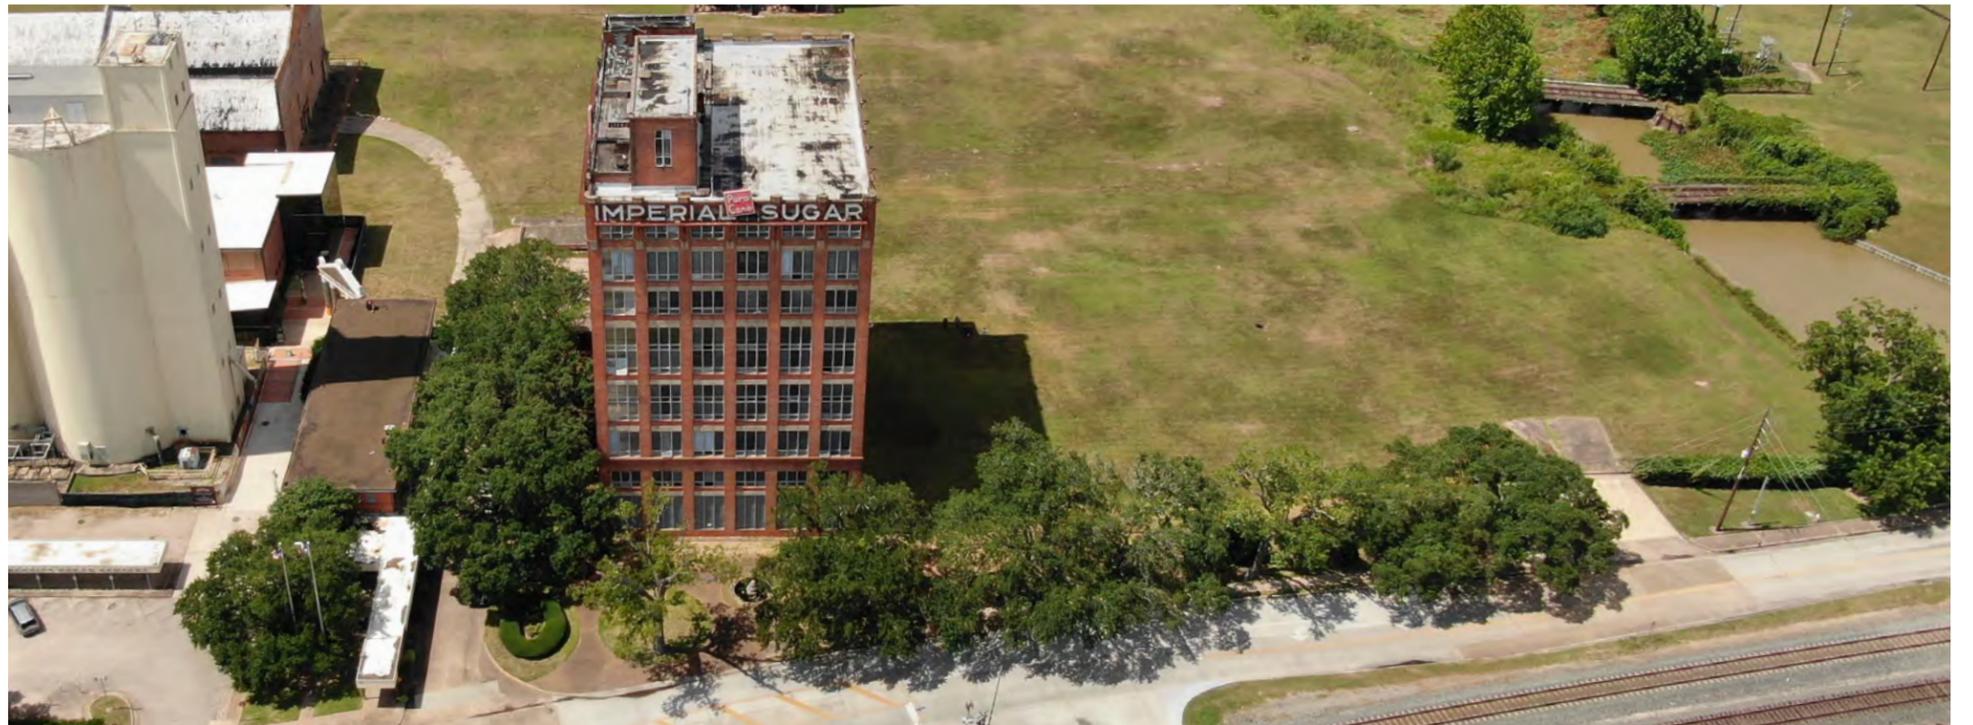
SITE VEGETATION AT SOUTH AND WEST

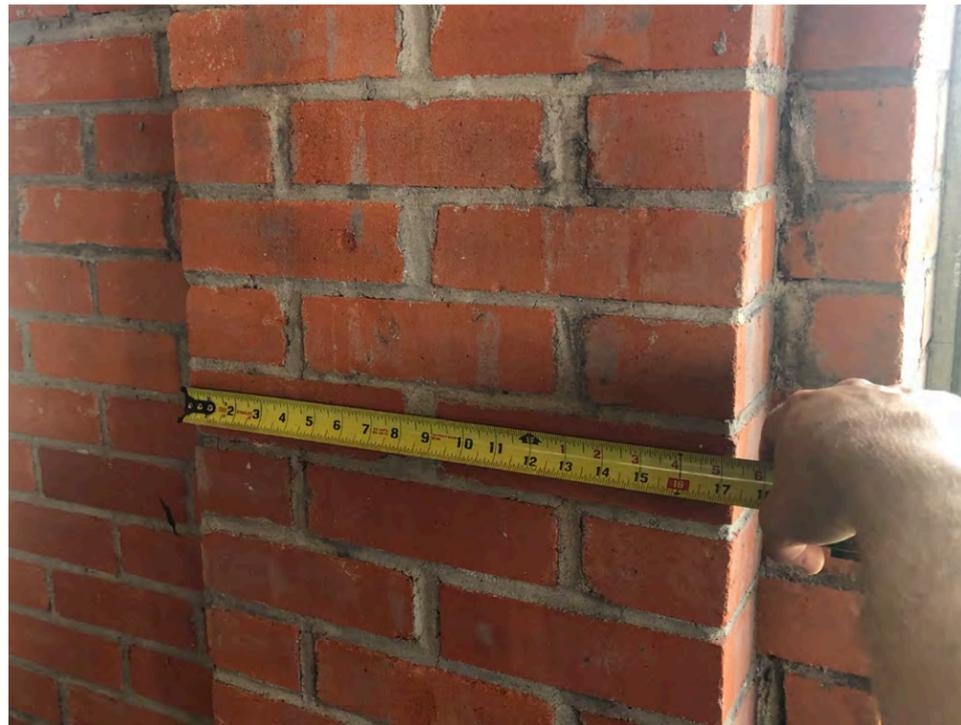
TYPICAL INTERIOR BRICK SIZES

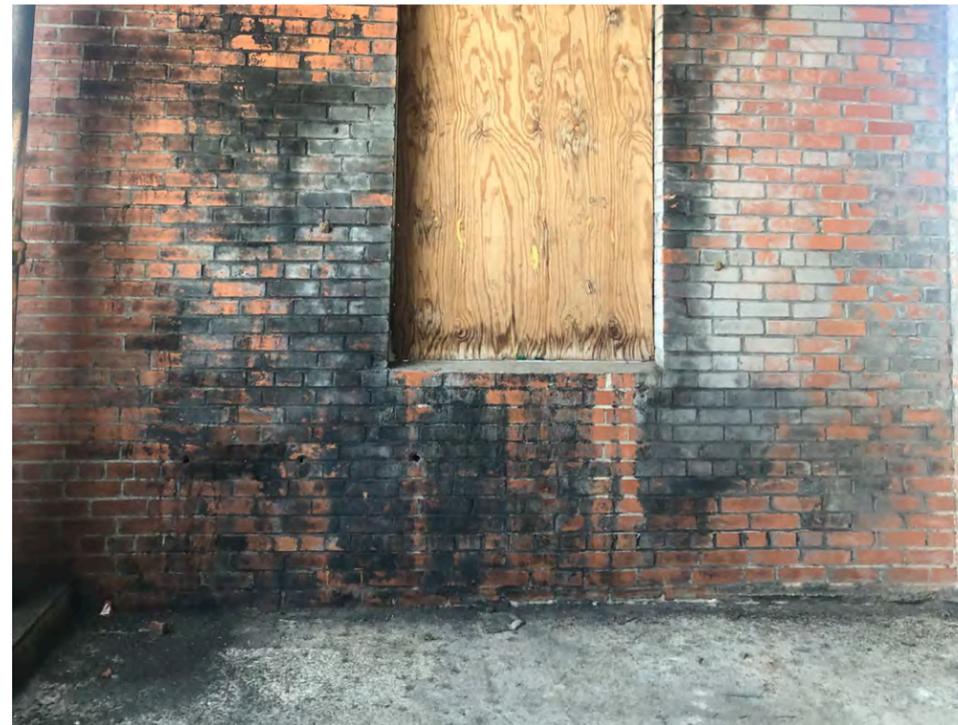
INTERIOR BRICK CONDITION

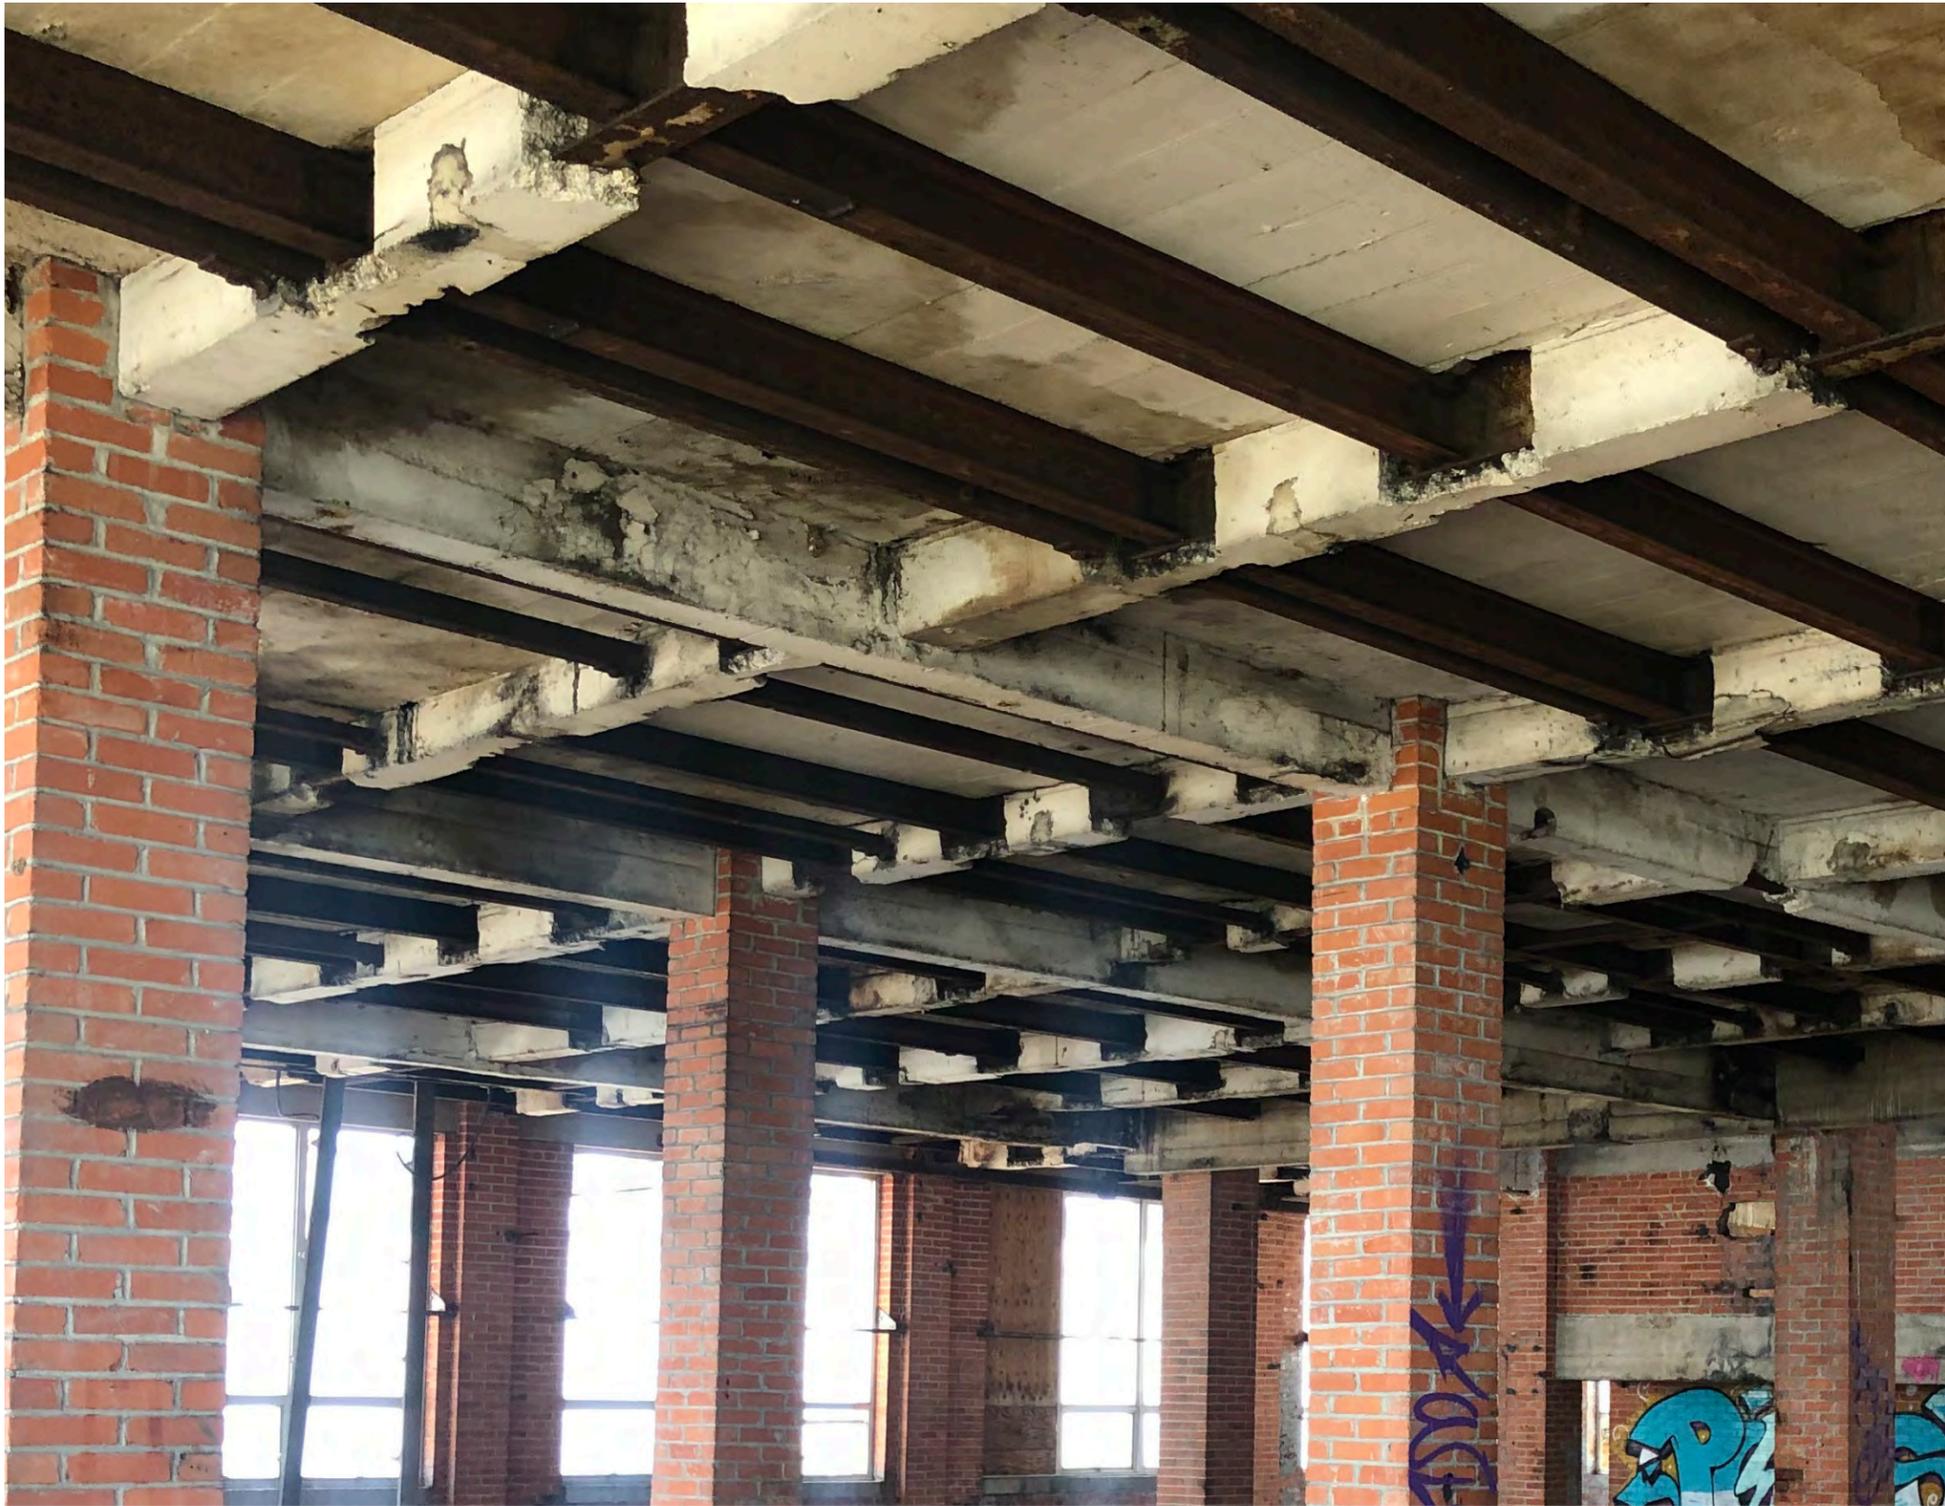
STEEL BEAMS AT ROOF DECK

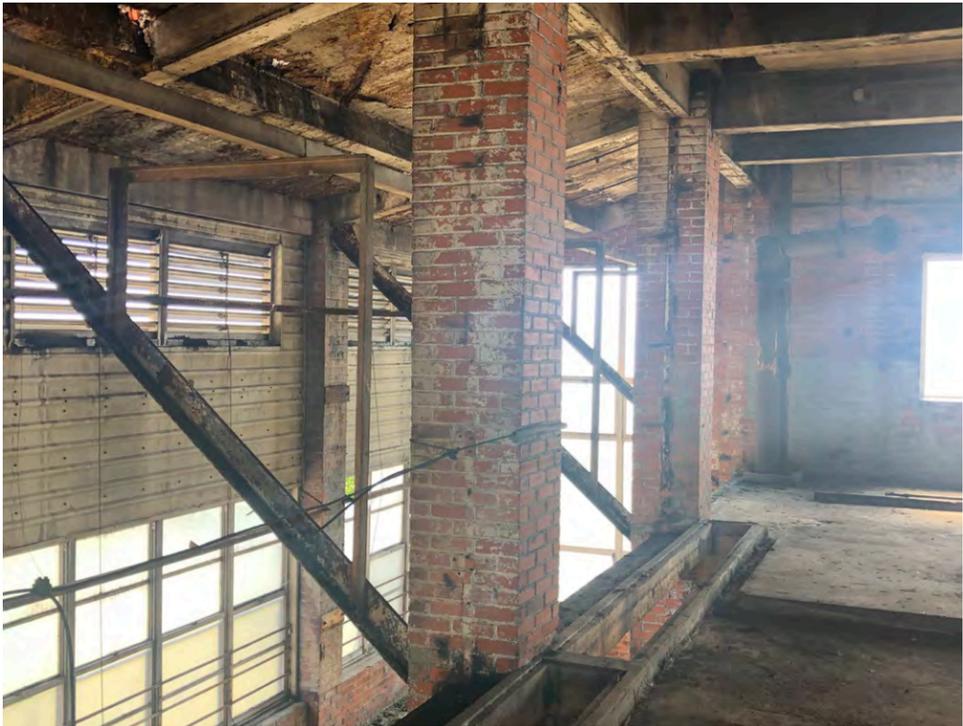
STEEL BEAMS AT SADDLEBAG

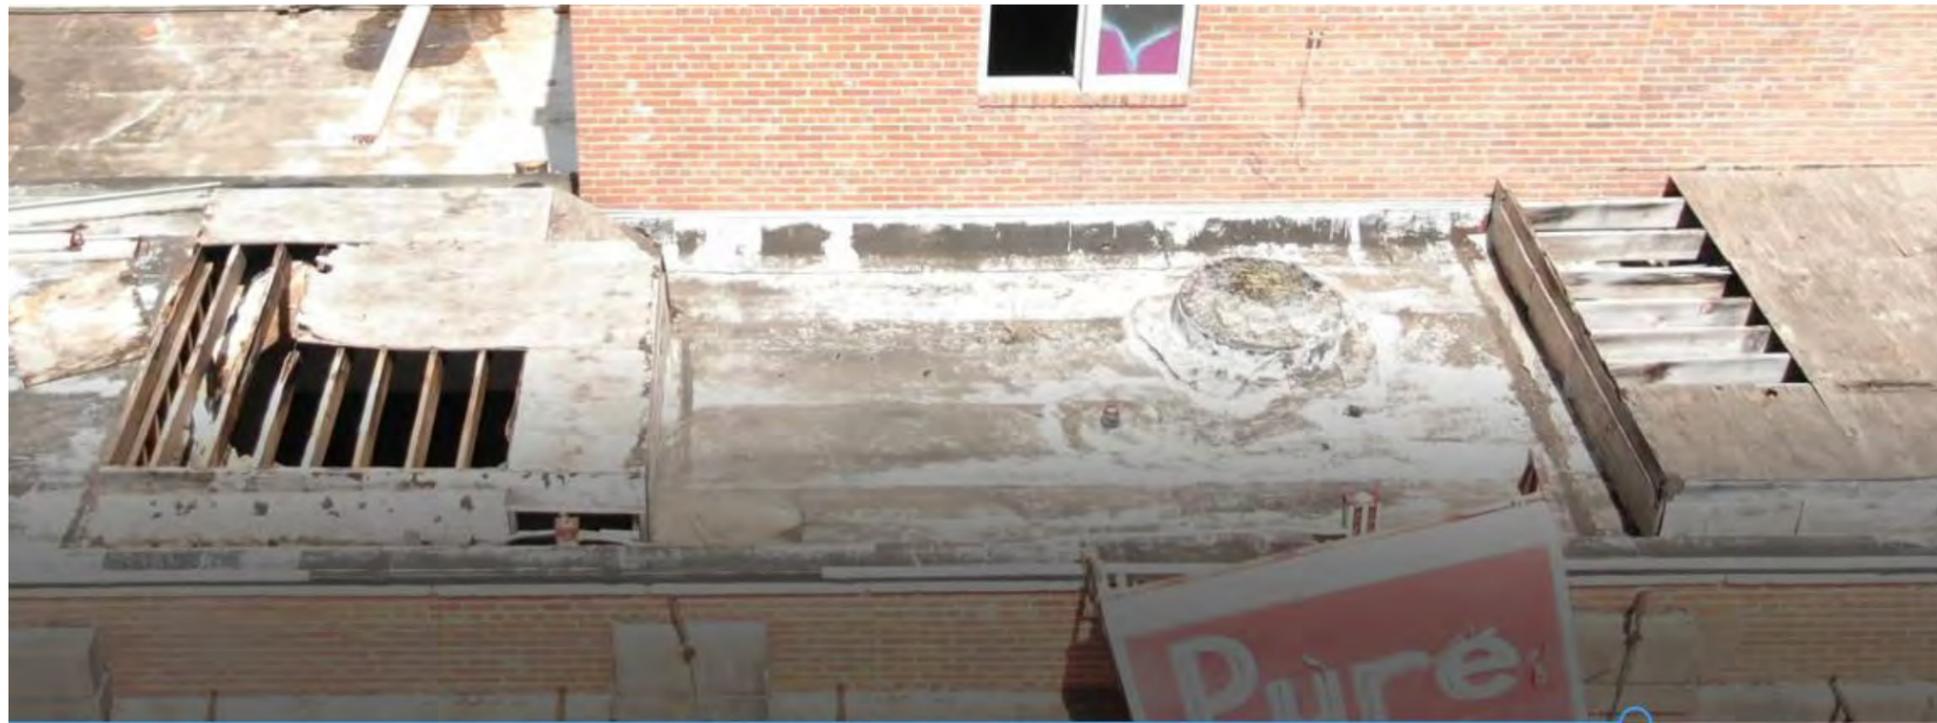
EXPOSED ROOF CONDITION AT UPPER MAIN ROOF

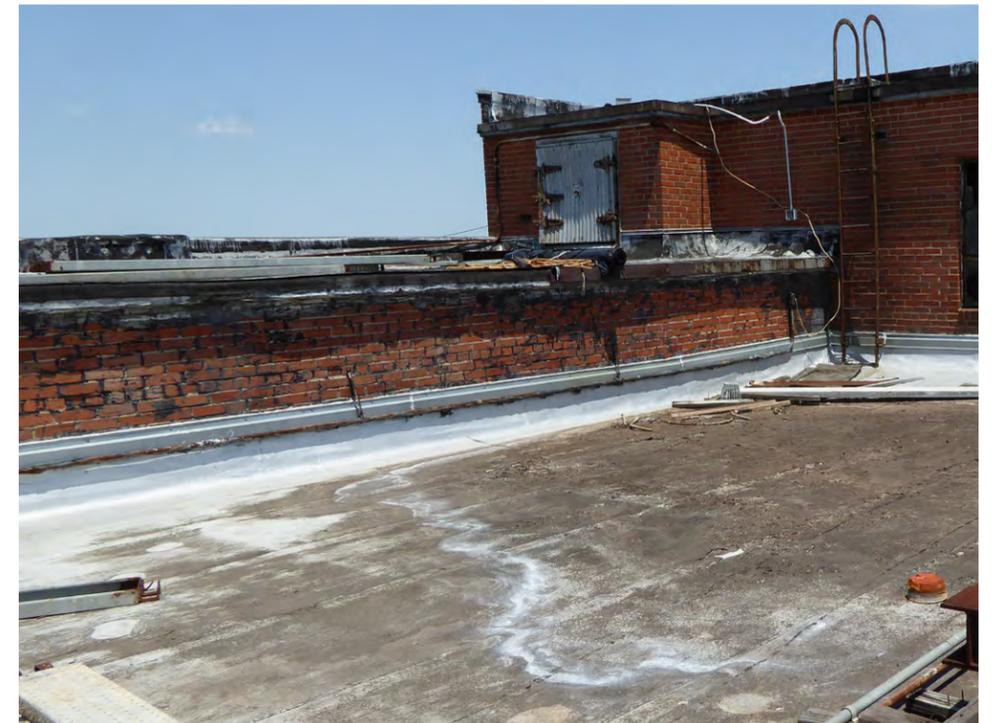
ROOF EDGE CONDITION AT UPPER MAIN ROOF

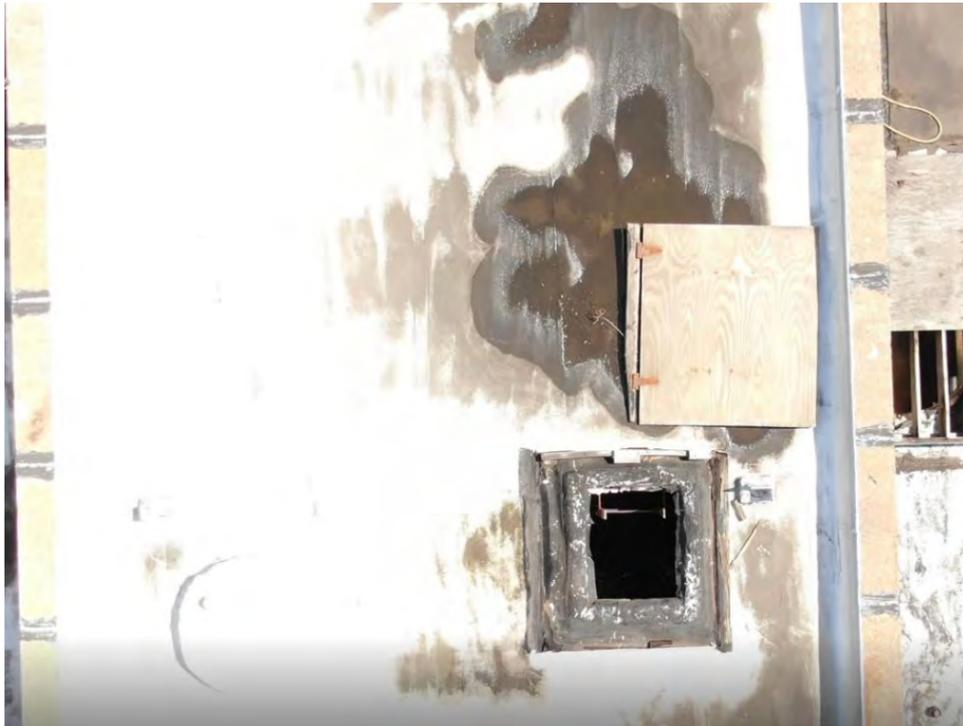
PENTHOUSE ROOF HATCH

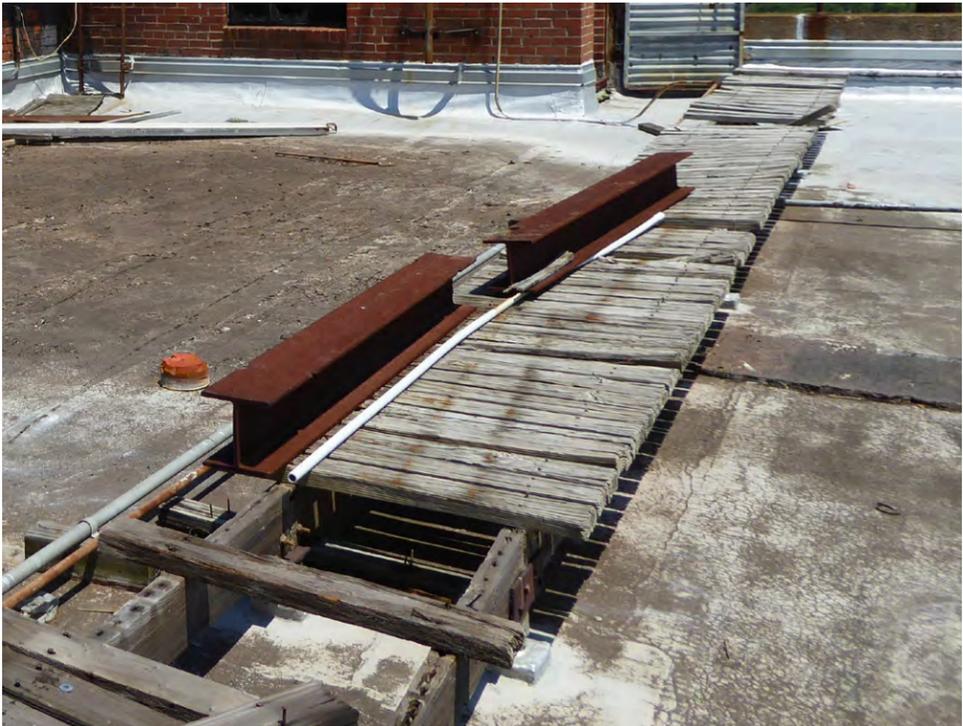
EXISTING CATWALK AT MAIN ROOF

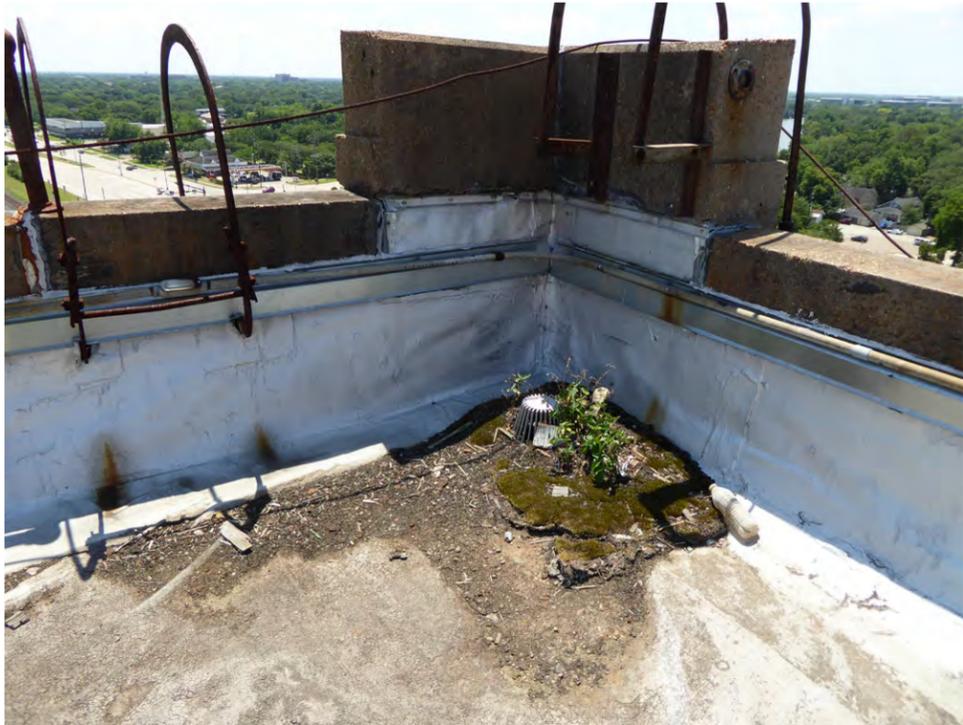
EXISTING ROOF PARAPET CONDITION

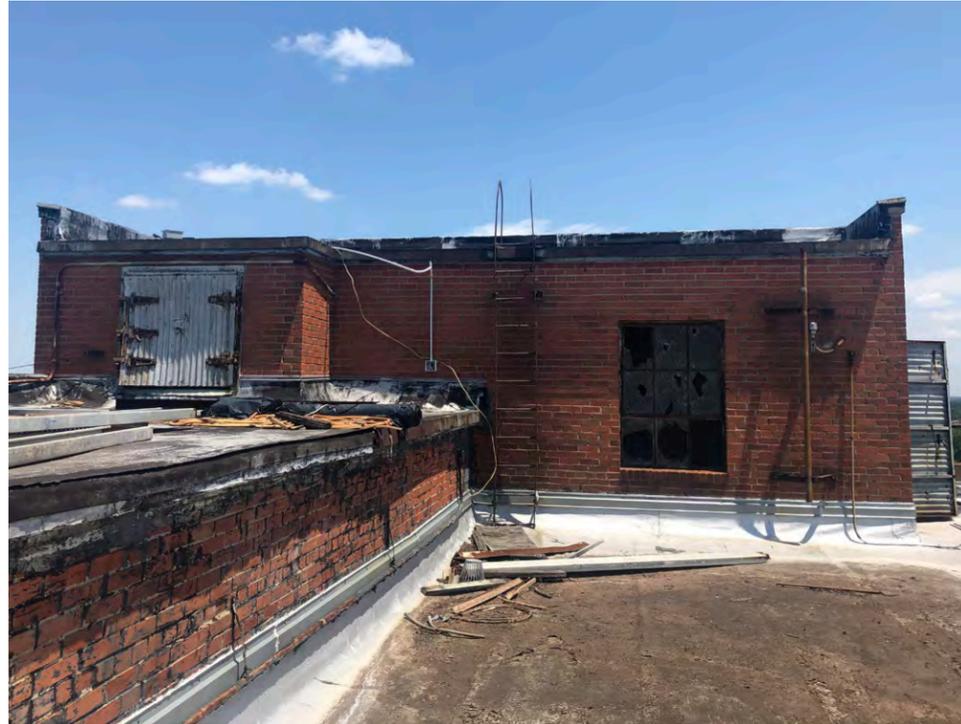
STAIRWELL STEEL WINDOW AND ACCESS DOORS TO ELEVATOR SHAFT

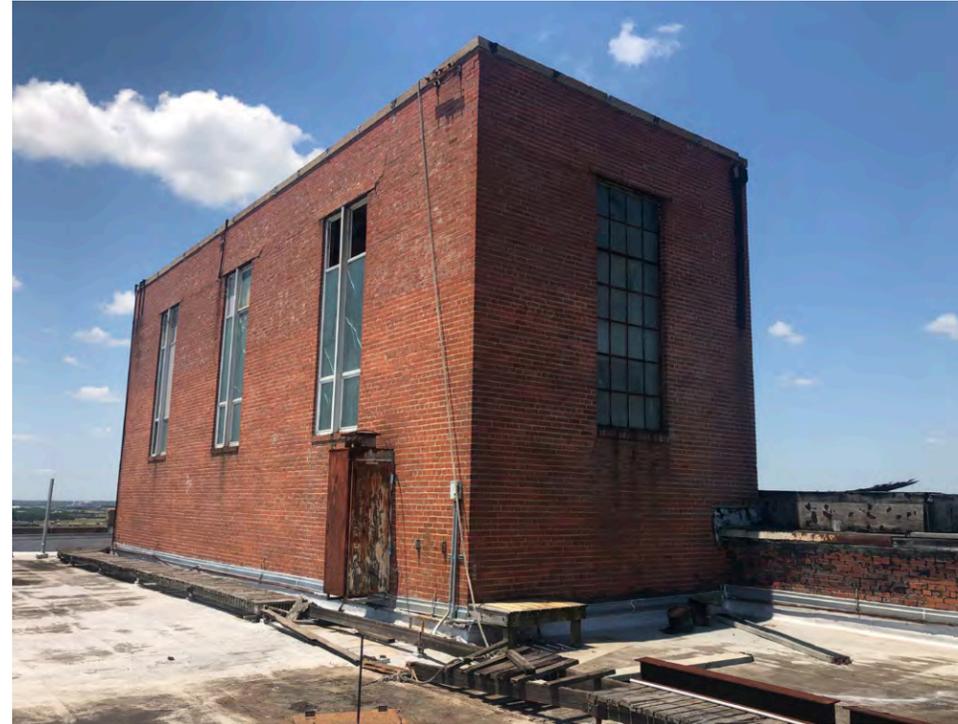
The east, south and west facade windows have all been replaced with aluminum windows. Several of these are damaged with corroded frames and broken glass panels. The windows at the north and west sides of the Saddlebag have been modified to integrate metal louvers. Some window sashes are loose throughout and inoperable hardware is observed throughout. There are Aluminum Window Replacement sketches dated 1973 by Greacen II & Houston & Rogers located at the Houston Metropolitan Research Center.

PENTHOUSE ALUMINUM WINDOWS AT EAST/WEST/SOUTH. STEEL WINDOWS AT NORTH

The aluminum windows throughout the building are newer and the majority of them are in fair condition with an estimated 20% requiring selective repairs or replacement to ensure they are protected from both wind and moisture damage. A new aluminum window is recommended to be installed at the previous bridge opening. It is also recommended that air and water leak testing be performed at all steel and aluminum windows.

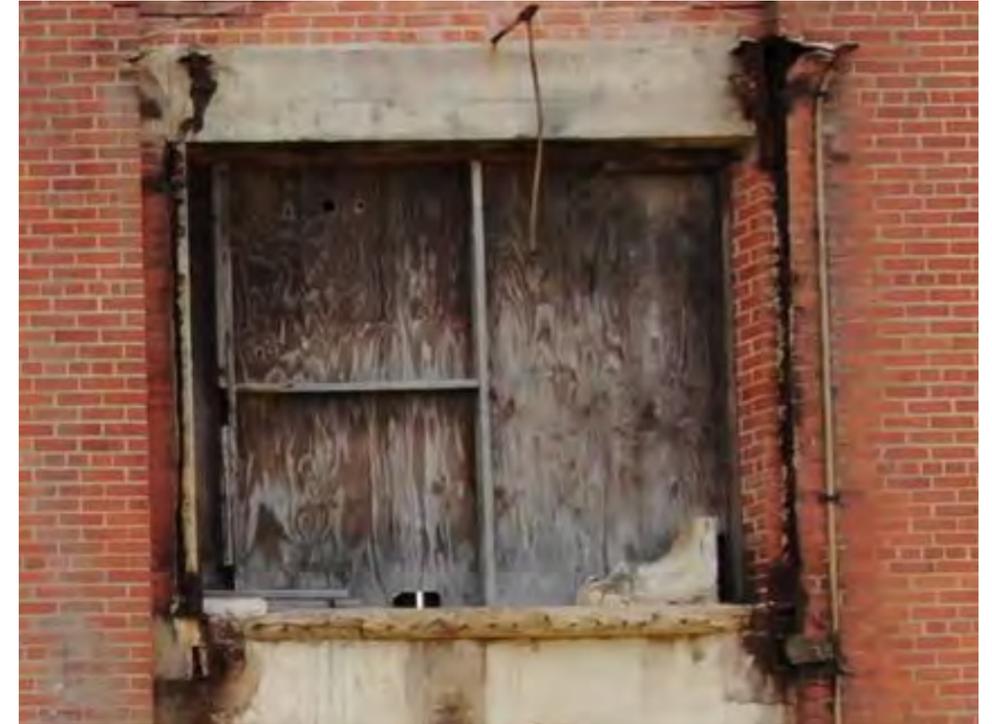
Plywood boarding has been installed over broken windows throughout the building. In addition, a previous connection to a bridge at the Fourth floor has also been boarded with plywood.

BOARDED OPENING WHERE PREVIOUS BRIDGE EXISTED

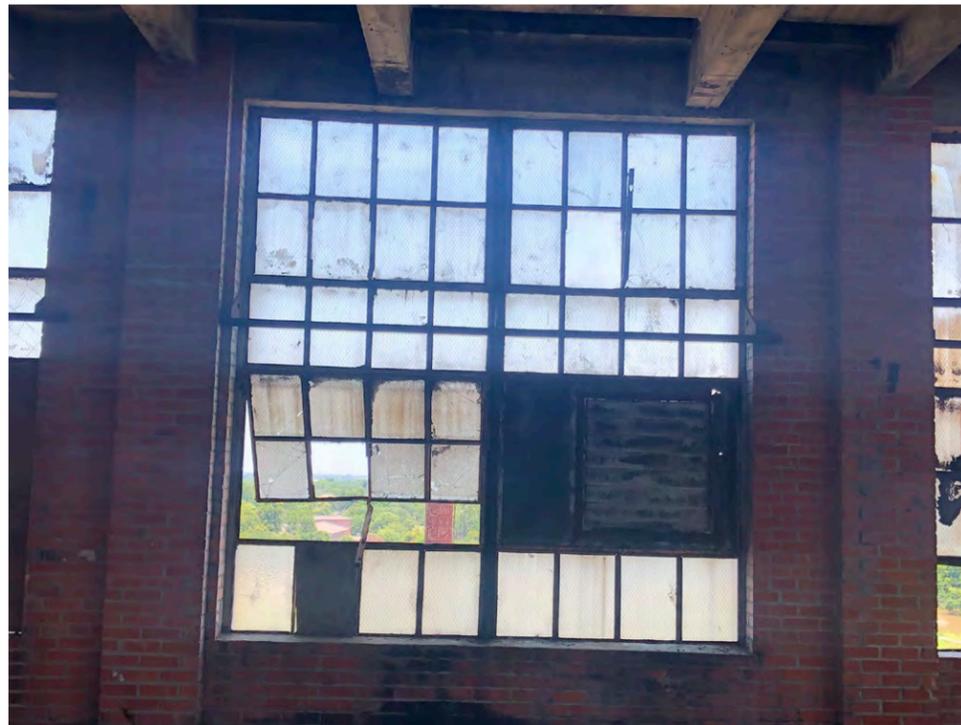
STEEL WINDOW WITH LOUVER MODIFICATION ON LEVEL 7

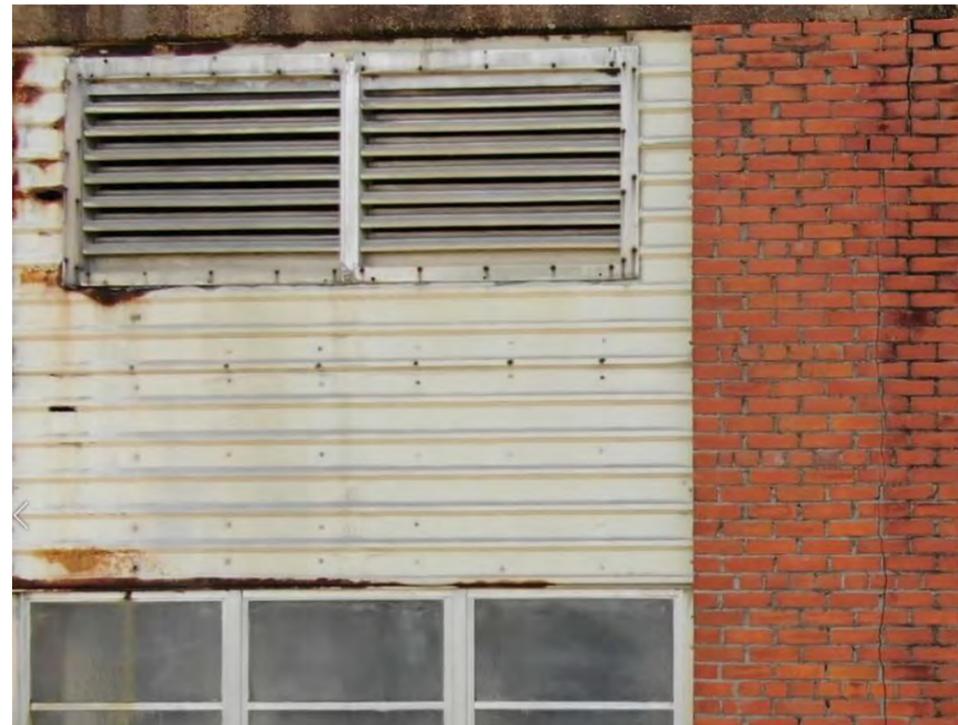
METAL PANELS AND LOUVERS AT SADDLEBAG WINDOWS

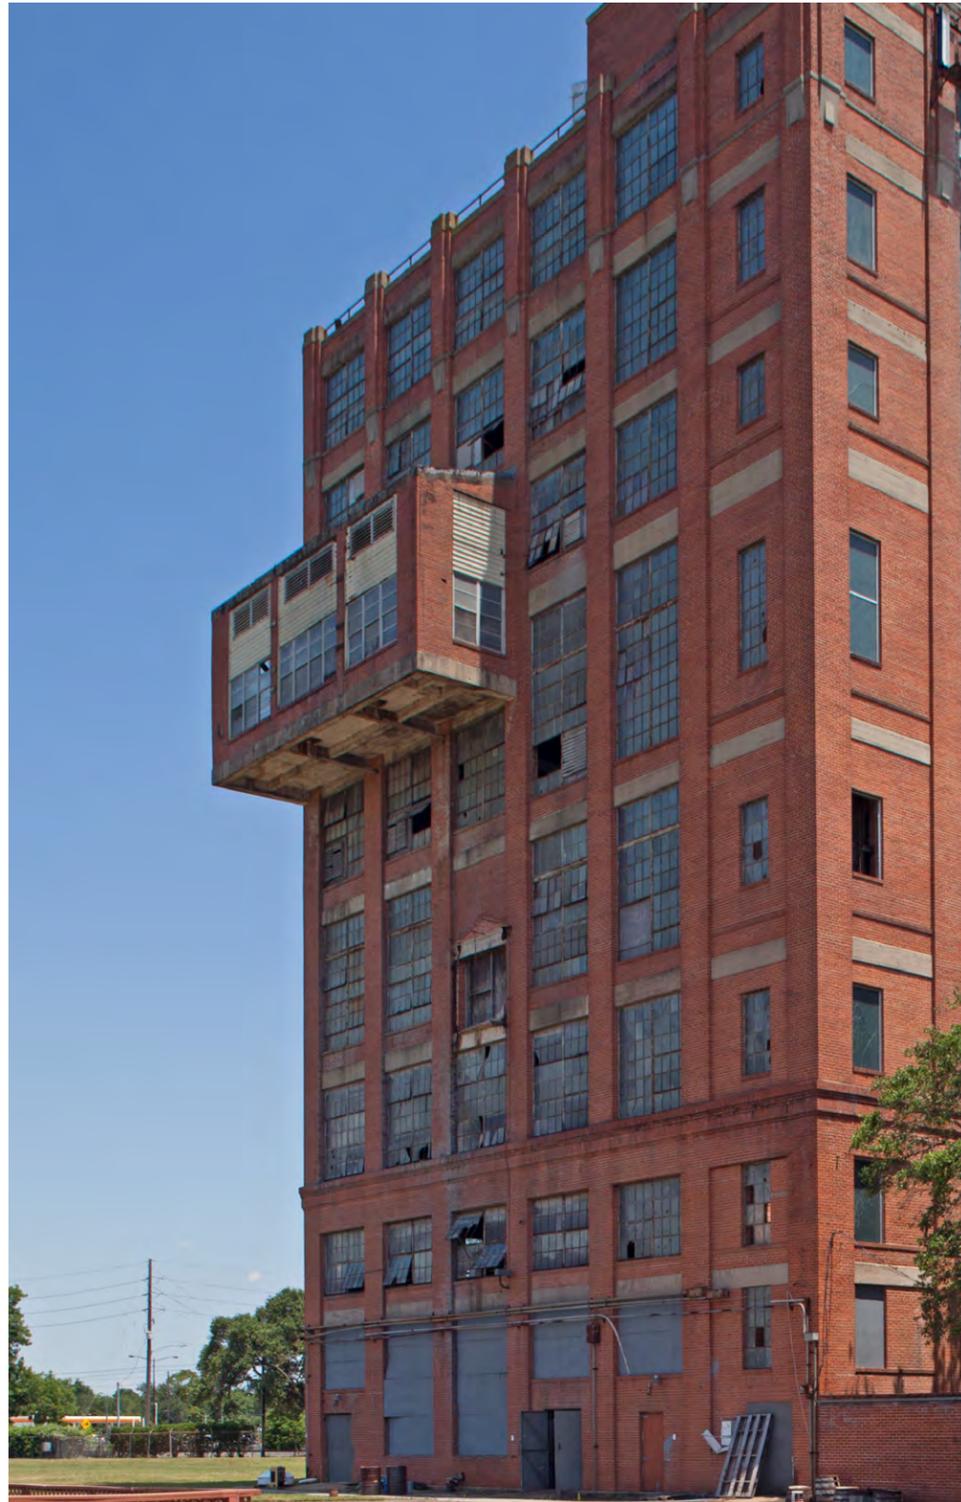
The original steel windows were manufactured by Fenestra of Detroit (Refer to Appendix H for details) and are still present at the north building facade and south side of the Penthouse only. Several of these windows have steel frames that are broken or corroded, with broken glass, soiled or missing glass panels. Some of the windows are also missing portions of the steel frames. Glazing at steel windows is single pane with patterned wire glass. Some window sashes are loose throughout and inoperable hardware is observed throughout.

NORTH FACADE WINDOWS ARE ORIGINAL HISTORIC STEEL AND GLASS

Considering the age of the building, the Imperial Sugar Company Char Filter House has a large area of glazing-to-masonry ratio. Since windows make up a large portion of the facades, it is important that they are adequately sealed to protect the interior of the building for mothballing purposes. Thus, it is recommended that all steel windows at the north facade of the building are replaced to match original detailing, in order to ensure adequate weatherproofing protection from both wind and moisture damage.

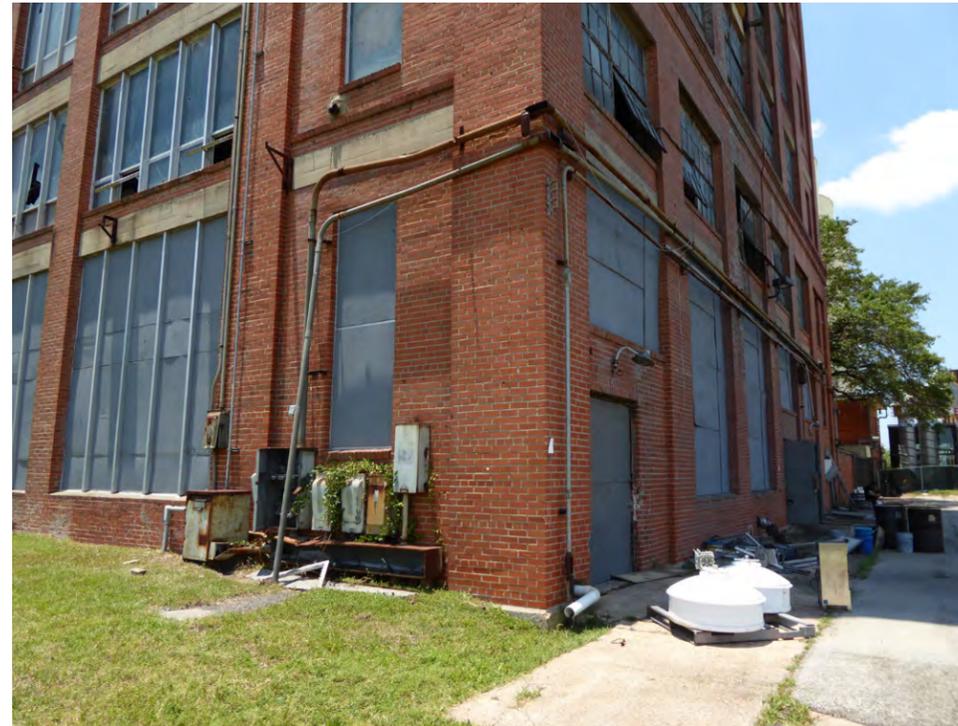
There are four door openings at the ground level on the north elevation. One opening has temporary double door panels and the other three are boarded shut with plywood. No original frames remain. The metal frame and door at the East facade is in poor condition. At the upper levels on the east facade, there are existing doors that previously led to an exterior egress stair. These openings are a safety concern as they open directly to a large vertical drop. At the roof level, there is one access door from the main staircase that is also in poor condition.

BOARDED-UP WINDOW AND DOOR OPENINGS AT GROUND LEVEL

Installation of a new set of double doors at the North facade is recommended to serve as the main entry to the building. A new single door is recommended at the East facade to serve as secondary means of egress. A new interior hollow metal single door is recommended to be installed at the stairwell entry at the First Floor. All exterior proposed doors should be reviewed by the Texas Historical Commission.

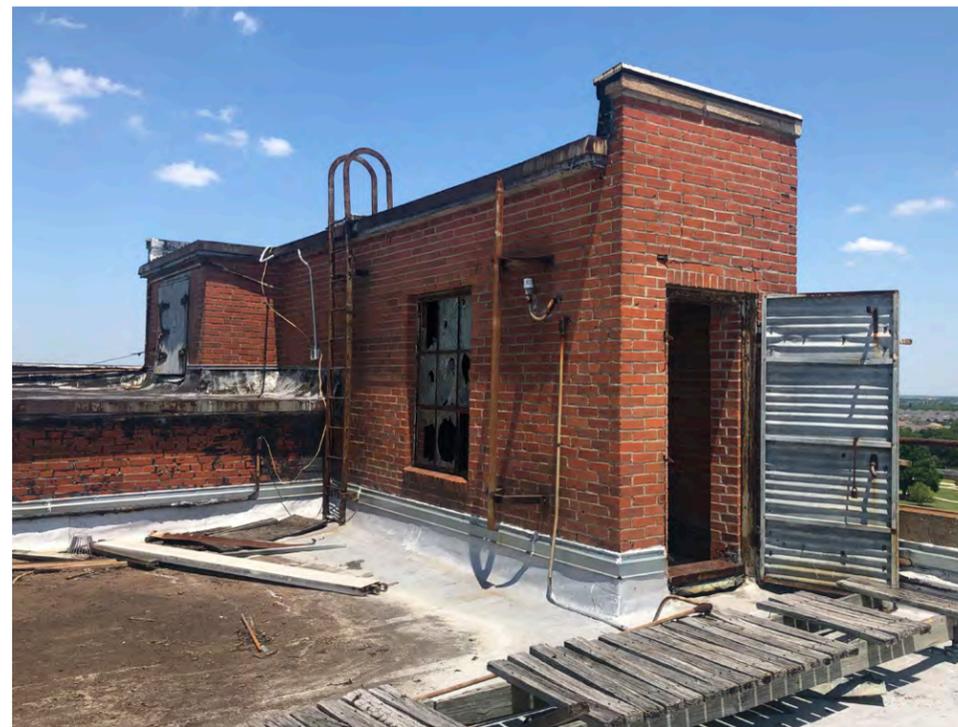
EXISTING ROOF ACCESS DOOR FROM STAIRWELL

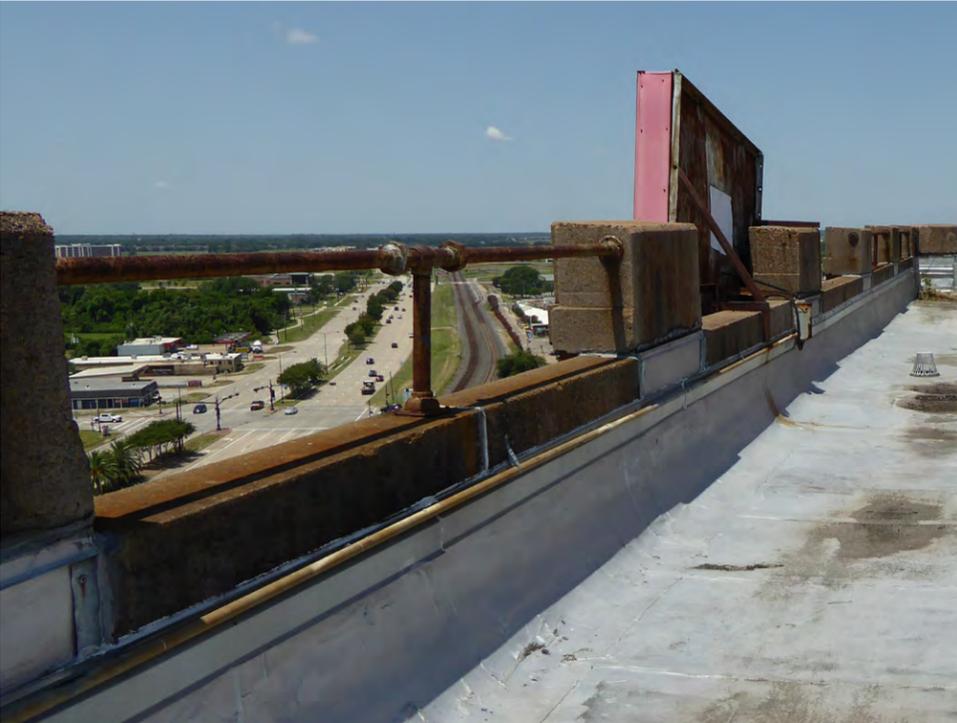
Existing finishes are minimal throughout as it is an industrial building with predominately exposed structure. The exposed steel beams and lintels currently do not have any coatings for erosion control or fireproofing. The steel railings at the main roof parapet are corroded and protection should be addressed.

STEEL RAILING AT ROOF

Mothballing recommendations for the building finishes include coatings and paintings at all exposed steel locations throughout the building. High-performance coatings should be used.

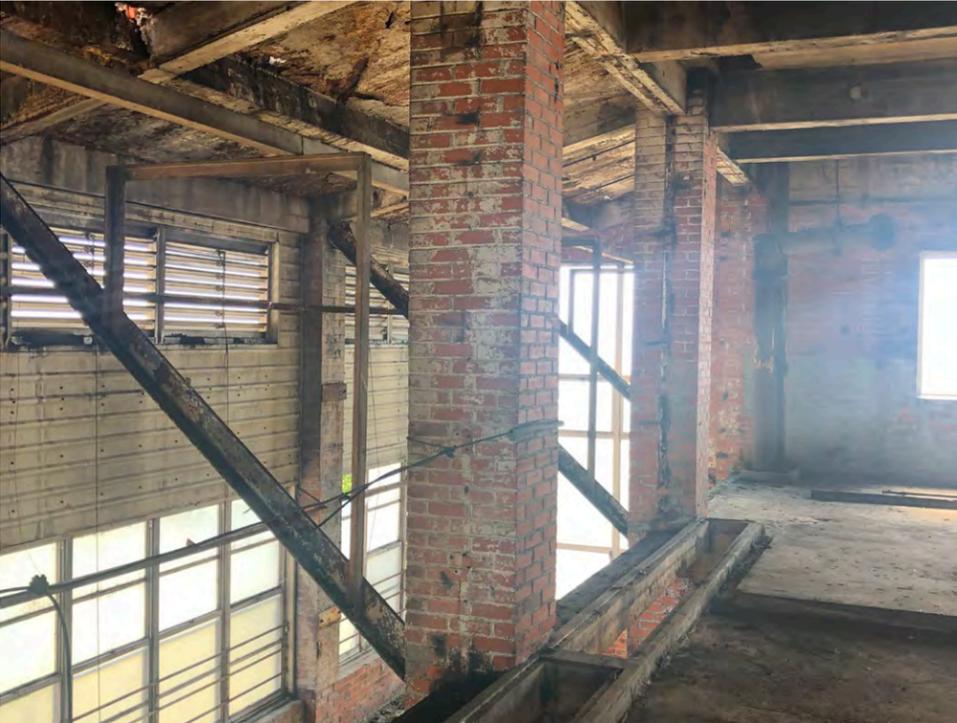
STEEL BEAMS AT SADDLEBAG

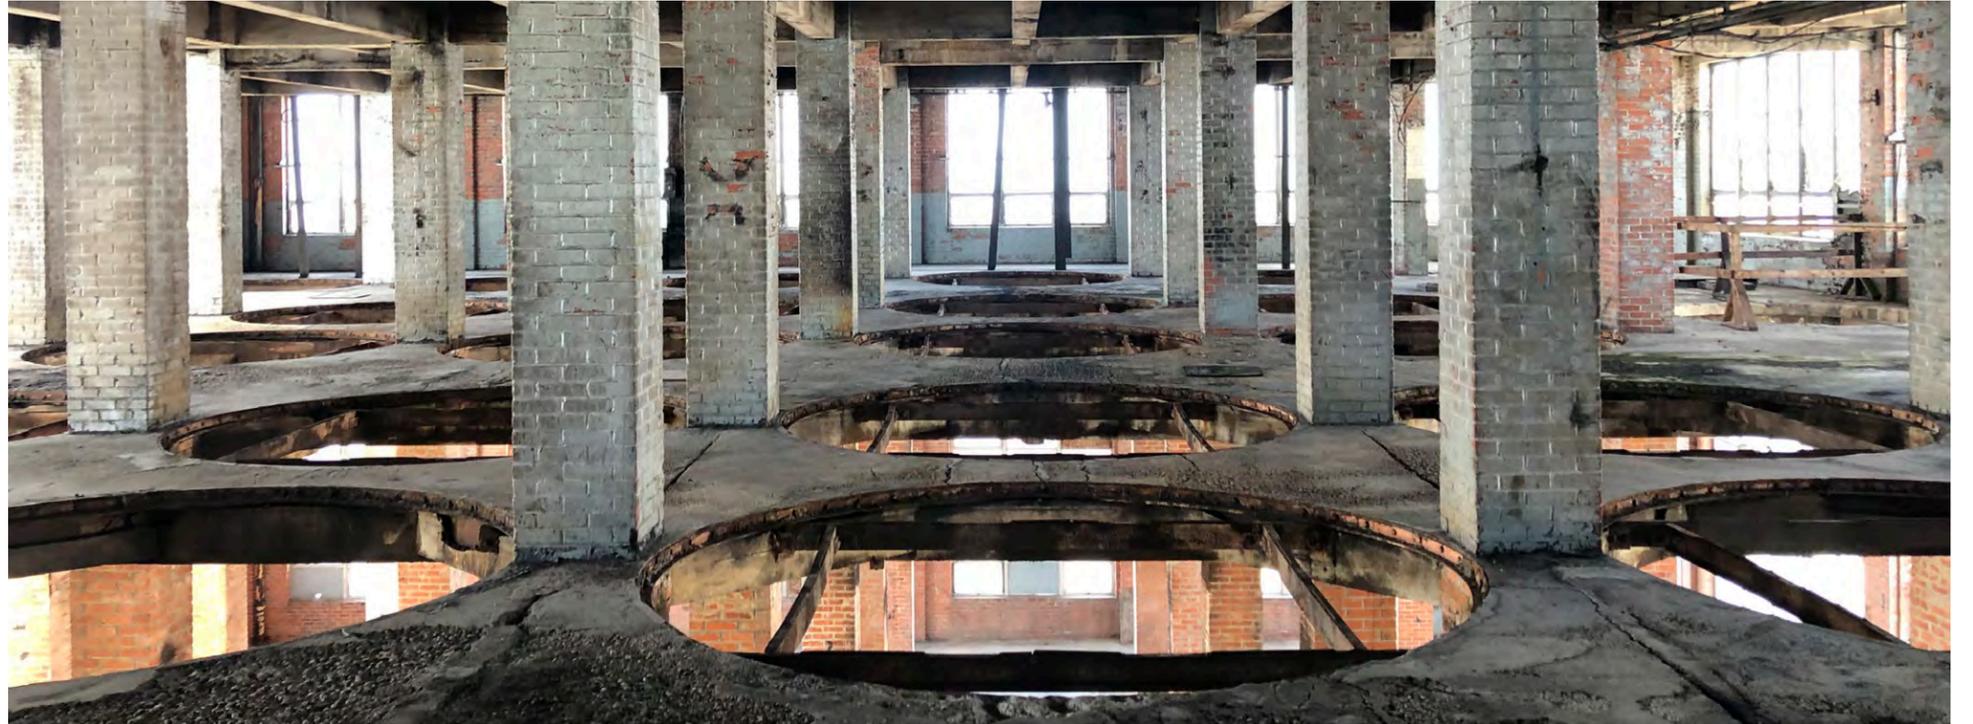
Exit signs and fire protection devices are missing throughout. There is no lightning protection present at the building. Various areas are missing protective barricades and currently present falling hazards.

FLOOR OPENINGS AT LEVEL 6

Recommendations include installing life safety equipment, including exit signs, fire extinguishers, cabinets and accessories, and protective barricades to minimize access throughout the floors due to various slab openings throughout the building.

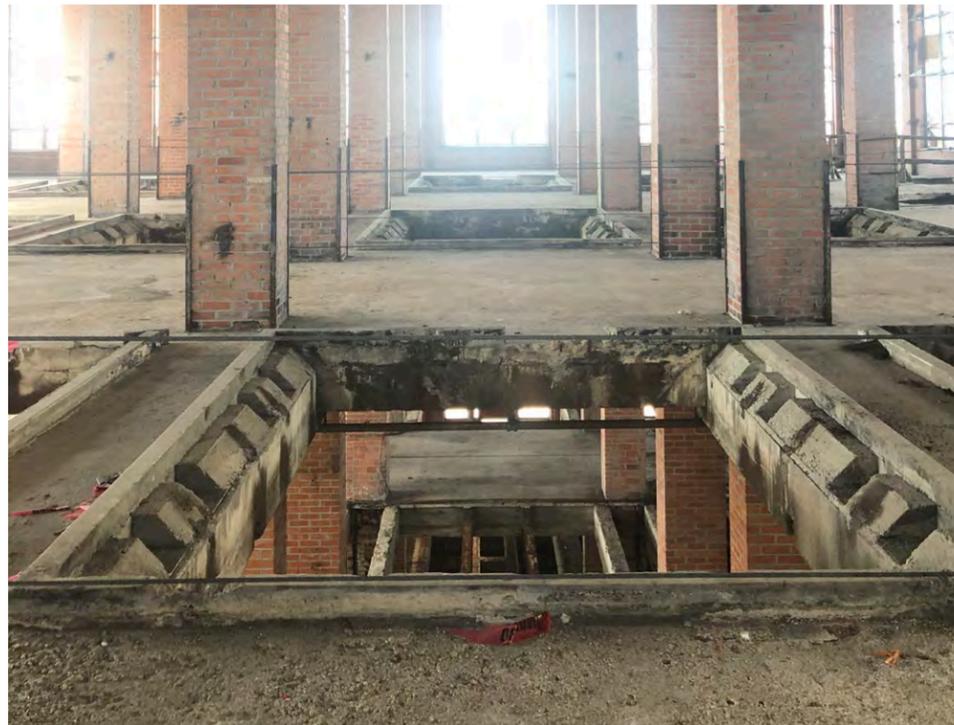
FLOOR OPENINGS AT LEVEL 4
