IMPERIAL SUGAR COMPANY CHAR FILTER HOUSE CONDITIONS ASSESSMENT

FINAL SUBMISSION TO
CITY OF SUGAR LAND ECONOMIC DEVELOPMENT

30 SEPTEMBER, 2020

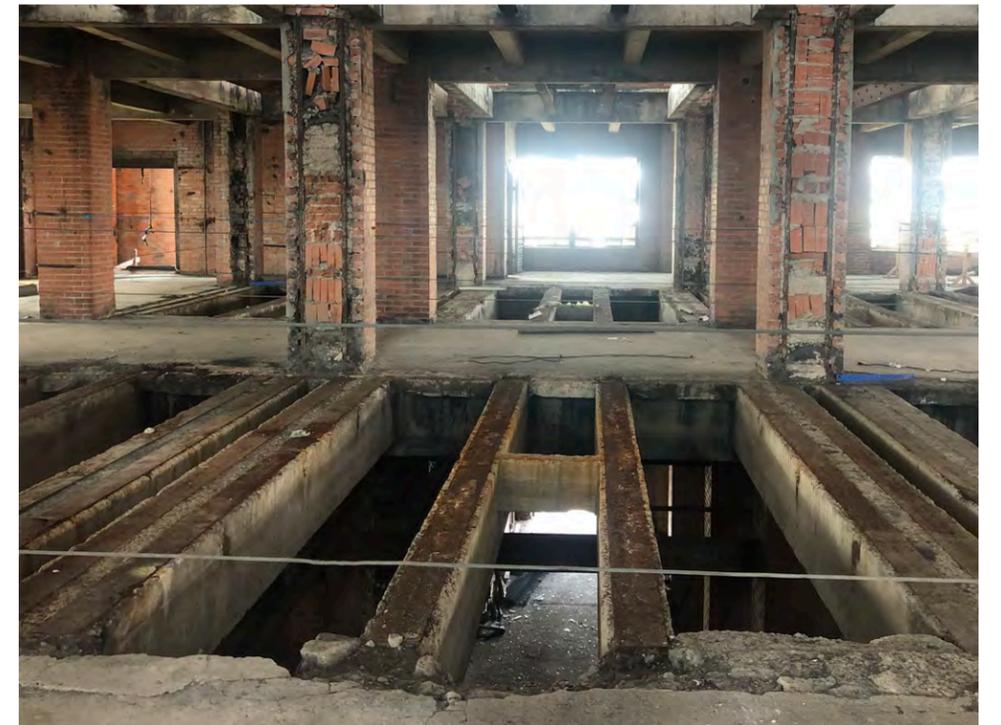
Exit signs and fire protection devices are missing throughout. There is no lightning protection present at the building. Various areas are missing protective barricades and currently present falling hazards.

FLOOR OPENINGS AT LEVEL 2

Recommendations include installing life safety equipment, including exit signs, fire extinguishers, cabinets and accessories, and protective barricades to minimize access throughout the floors due to various slab openings throughout the building.

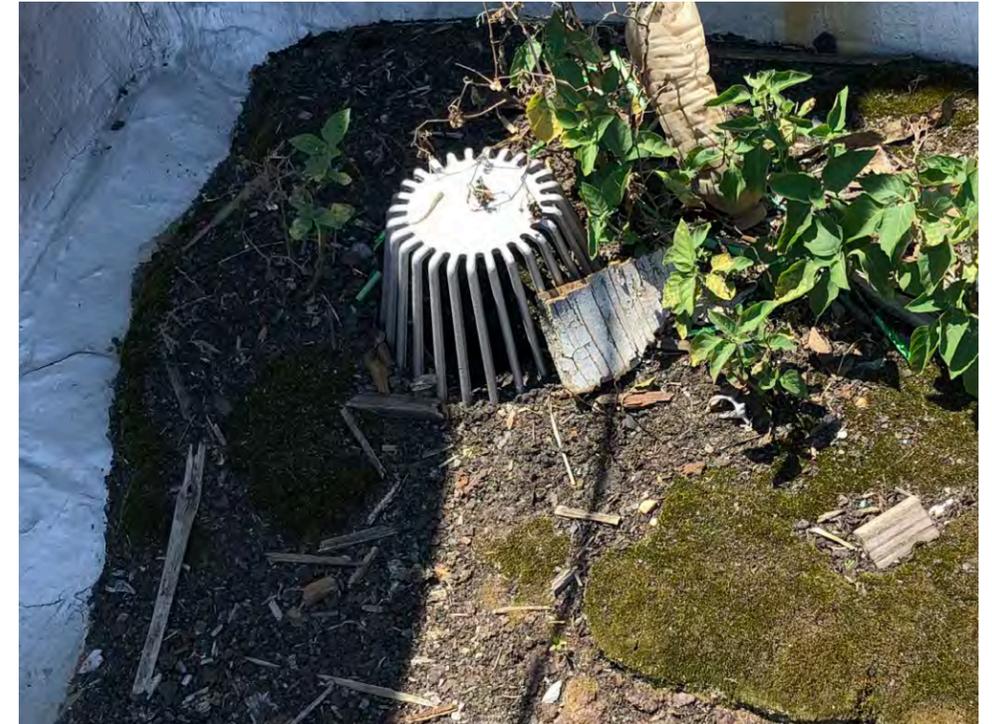
Existing plumbing systems have been removed or abandoned such that they are no longer in a functional state. The storm drains observed appeared to be blocked and are creating standing water on the roof, while at the same time, the piping in the building has deteriorated to the point of being visibly cracked and broken. In addition to concerns with existing condition, the existing roof drains appear to be undersized based on current code requirements and there was no method for overflow protection (secondary drains, scuppers, or similar). No active domestic water lines were observed and floor drains in the Saddlebag area appeared to be blocked (or missing). Any domestic water piping and waste and vent piping that has not already been removed is not expected to be in good enough condition to reuse. The fire sprinkler lines also had visible breaks and appear to be shut off outside the building. Existing valve and control hardware does not appear to be functional or repairable without complete replacement.

EXISTING DRAINS AT MAIN ROOF

It is recommended to replace the existing roof drainage system with new drains and risers sized to current code requirements. This should also include secondary/overflow drainage per current code requirements. Most existing storm risers in the building are in very poor shape (effectively non-functional). Replacing with something that meets current code is recommended in strongest possible terms over just replacing like-for-like with what was installed originally.

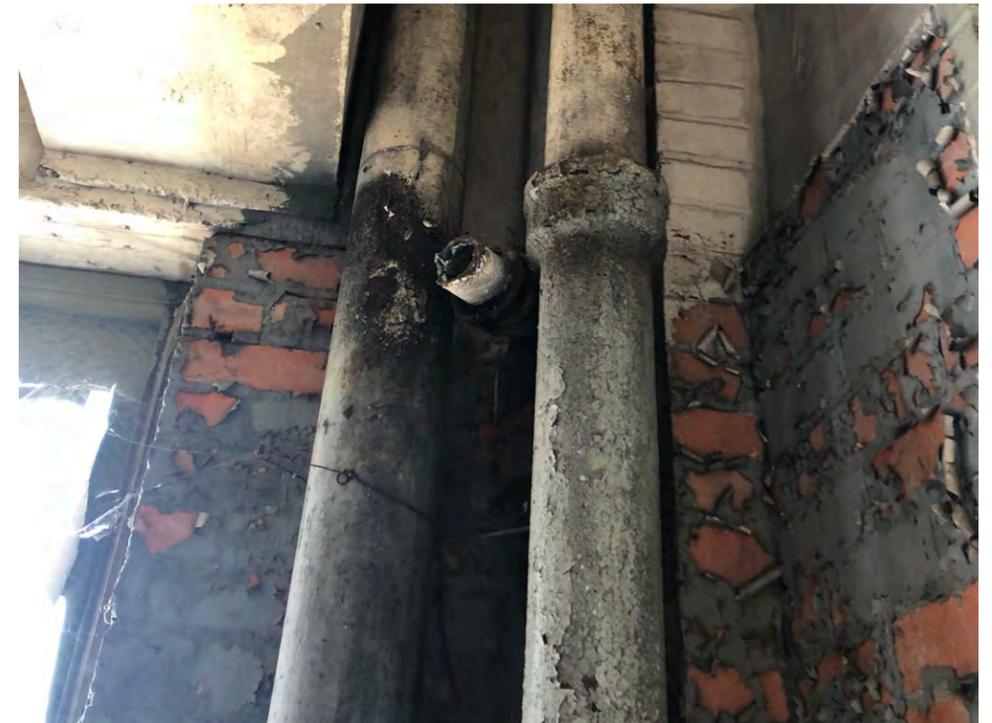
INTERIOR ROOF DRAINS, TYPICAL CONDITION THROUGHOUT

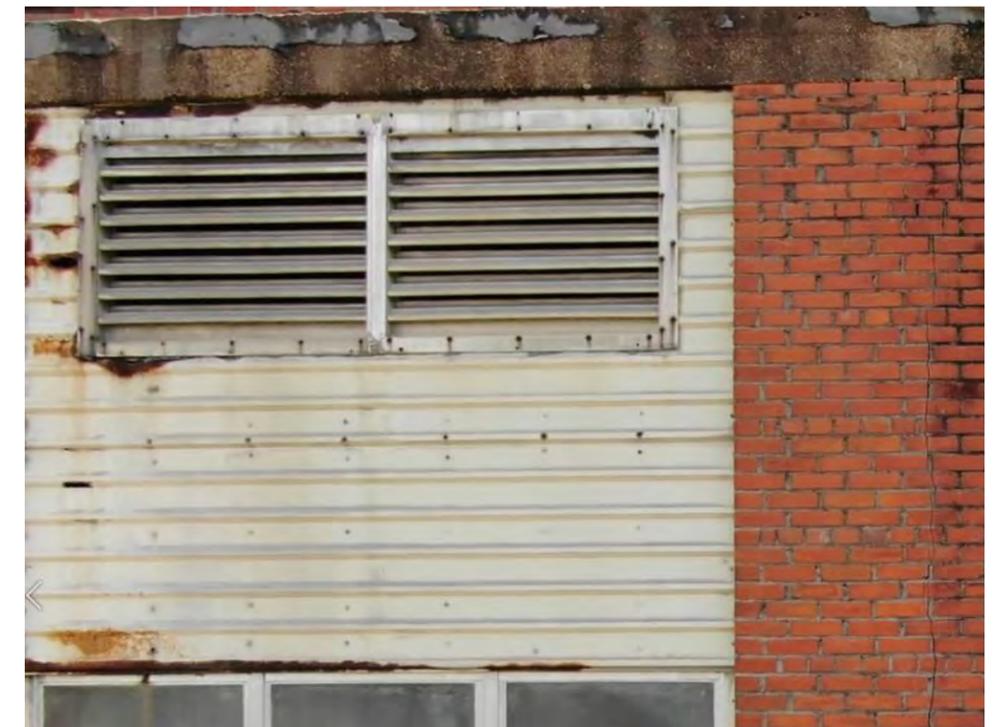
Existing mechanical systems have been removed. The few remaining accessories observed such as louvers and vent openings are not expected to meet current wind load requirements (for rain and debris per current IBC). Existing mechanical openings are doing more damage than good as a source of water penetration.

EXISTING LOUVERS AT SADDLEBAG

Park Service guidance for mothballing the building recommends a mechanical ventilation system which provides 4 air changes per hour (ACH). Fans and louvers alone should be sufficient to achieve this baseline for the assumed space and ambient conditions parameters. The interior masonry and concrete surfaces are expected to tolerate the relatively uncommon scenarios where condensation can still be expected to occur. It is recommended to implement basic relay-based temperature controls to control fans based on ambient and indoor temperature to prevent them from running when outside temperatures are higher than indoor temperatures (for example cool mornings). A winter change-over can be included to run in winter only when outdoor conditions are warmer than indoors. However, active freeze protection is not expected to be required. Intermittent monitoring is recommended for this system so that temperature set points can be adjusted if needed.

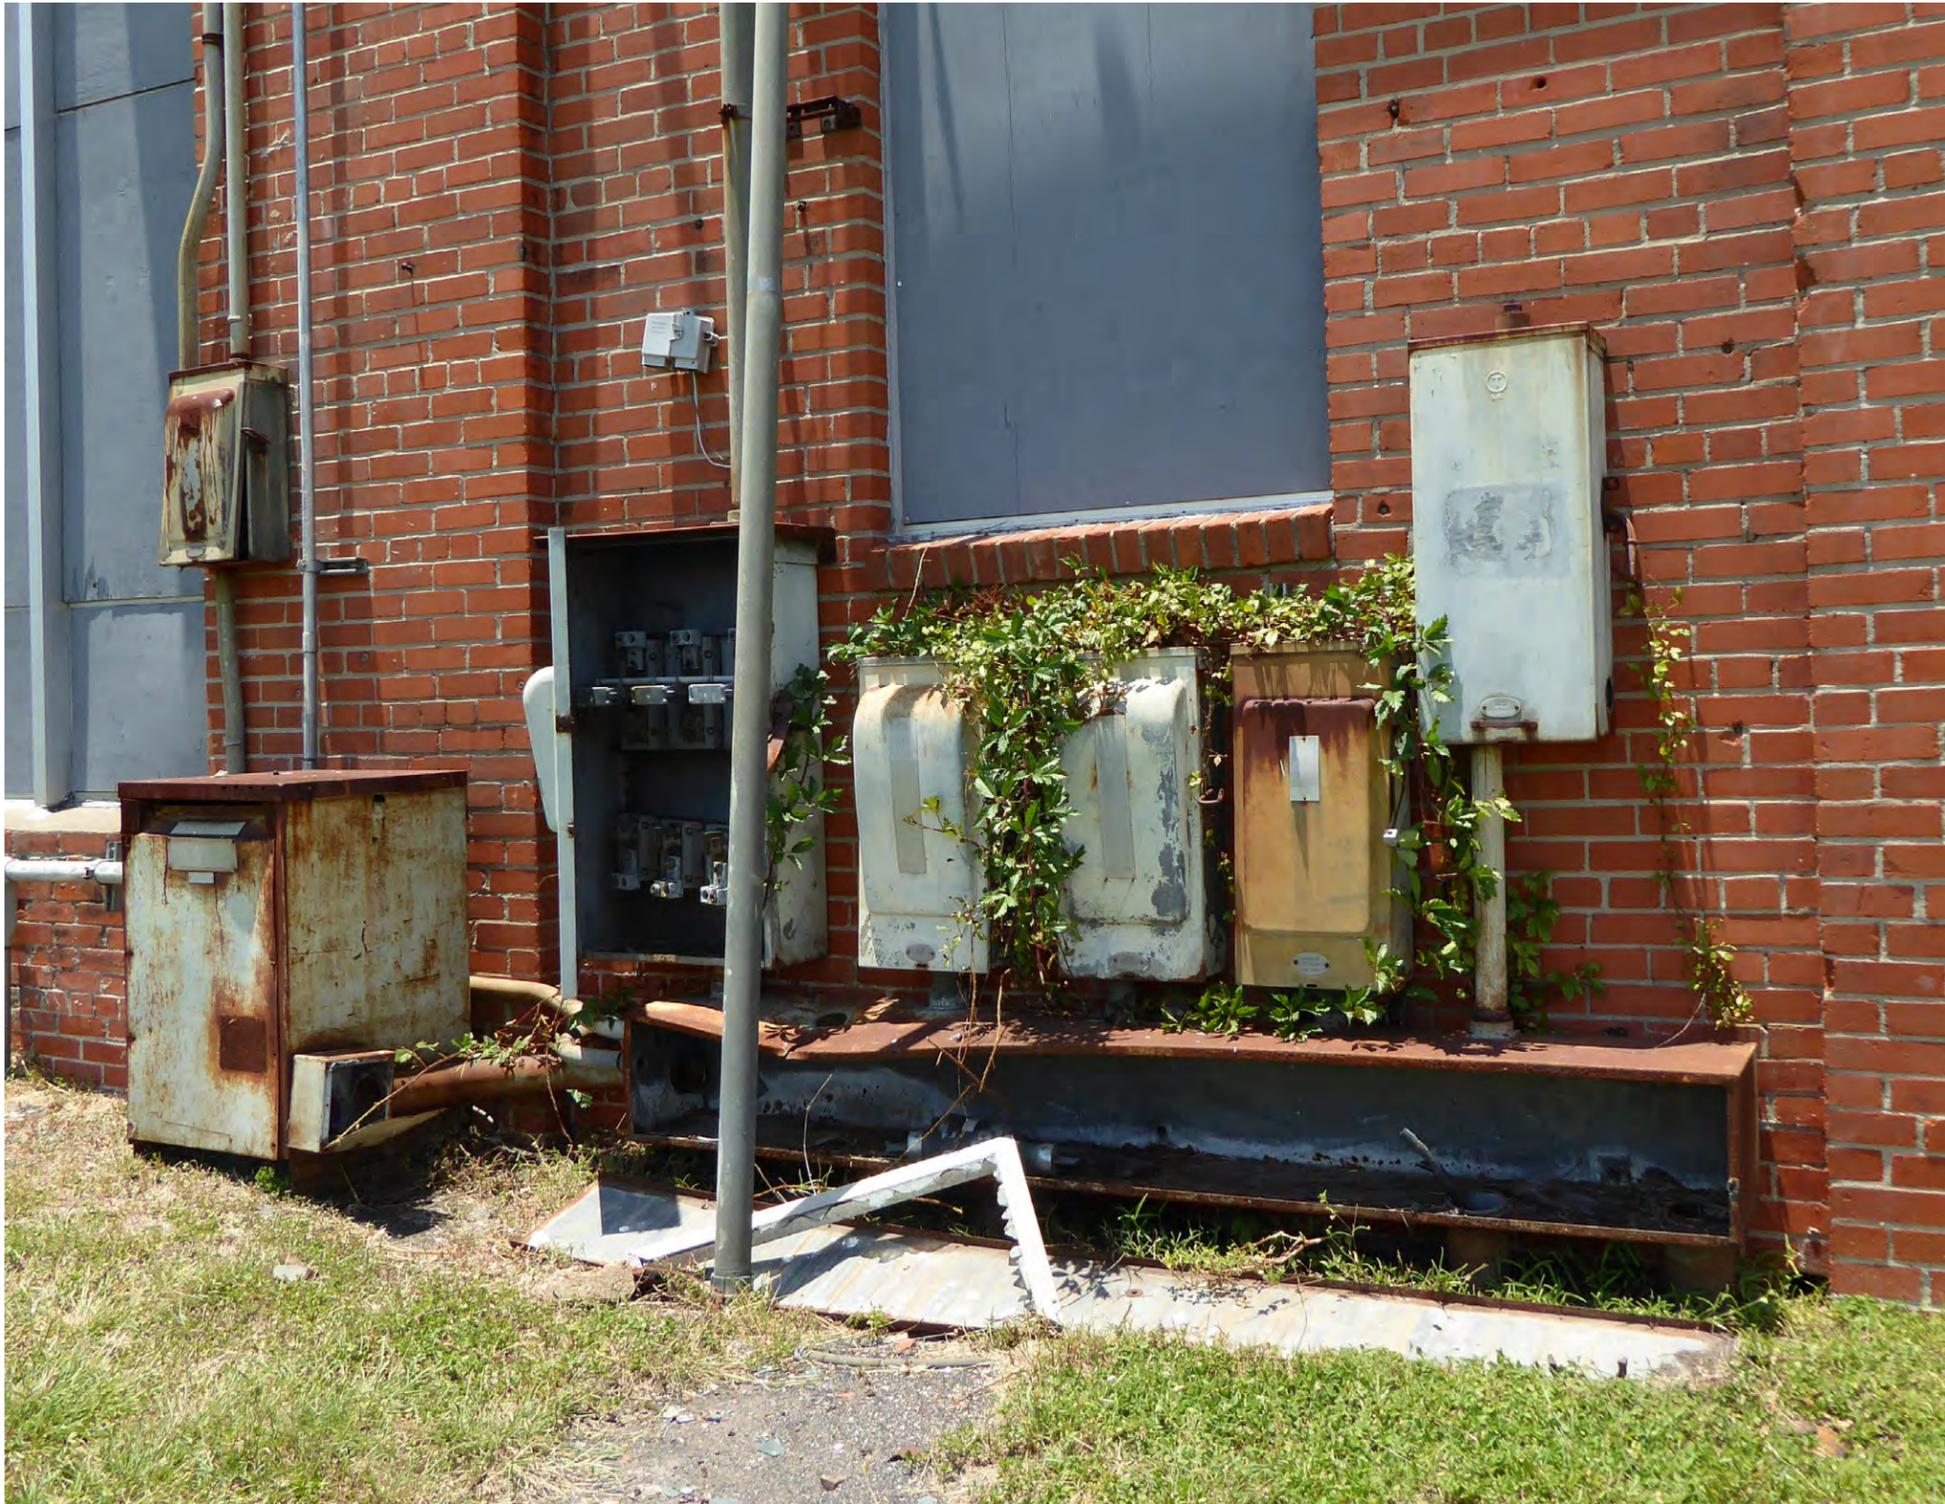
Existing electrical systems have been mostly removed or abandoned in place, such that they are no longer in a functional state. What remains of the main service gear is rusted and overgrown. An existing panel, several disconnects and a transformer, located on the 6th floor, are labeled as 'hot', but do not actually appear to be active. As best we could tell, power has been disconnected either elsewhere on the campus or at the utility connection. At one time, the building sign and some of the interior lighting appear to have been fed from the panel/disconnects on level 6, but most circuits are turned off, and as noted above, it is not clear that these panels are even active any longer. We understand the sign has been lit in recent memory, but could not see what looked like an active circuit serving it or any of the other lighting while on site. Minimal interior lighting fixtures were visible on site, but they did not appear to be operational, even if power were available. The existing elevator/lift does not appear to be in a functional state, even if power were available. Several existing fire alarm devices were noted on site, but like all other equipment and devices observed, they do not appear to be functional and are not expected to meet the current code requirements, even if they could be restored to a functional state.

EXISTING ELECTRICAL PANELS AT WEST FACADE

Repair or reuse of existing panels, disconnects, remaining feeders and conduits is not advised.

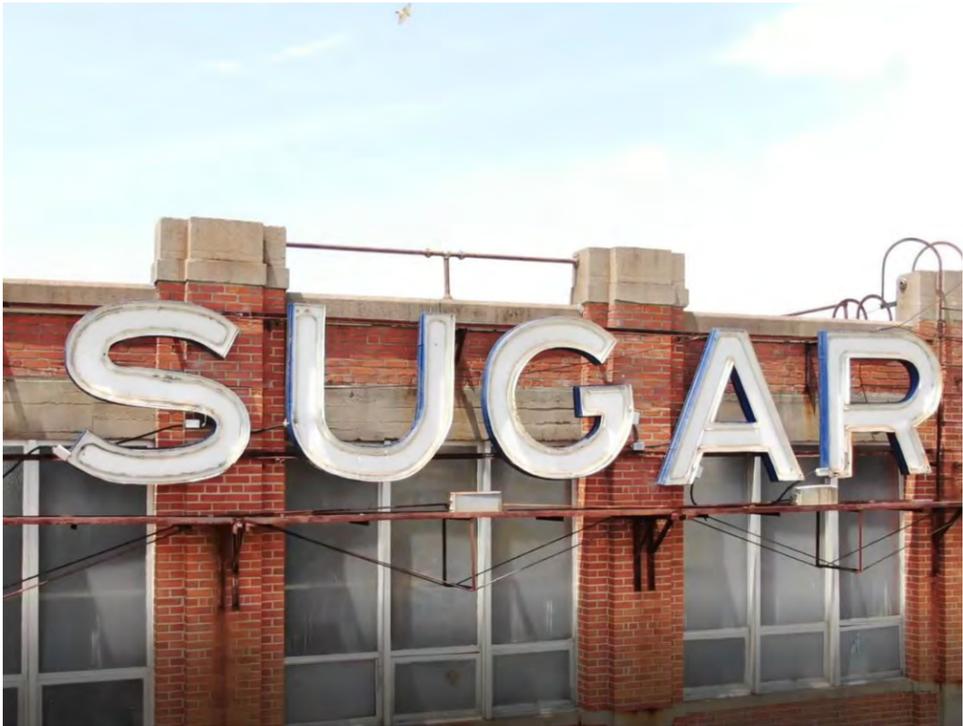
EXTERIOR SIGNAGE AT ROOF LEVEL

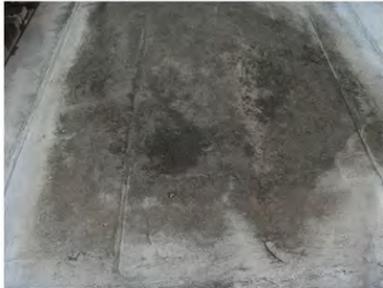
1. Staining was observed on the existing roof indicating that standing water may be present after weather events away from the existing roof drains (Photos 1.01-1.02). In addition, some areas of the roof showed signs of deterioration (Photo 1.03) and the temporary covers over some of the roof openings have become compromised (Photo 1.04). Although this is not an immediate structural concern, water infiltration into the structure can lead to corrosion of steel structural members or embedded steel reinforcement in the concrete. This in turn can affect the structural integrity of the building. We recommend that the client engage the services of a roofing consultant to survey the existing roof and provide recommendations for repair or replacement of the existing roofing materials. (Medium Priority)

Photo 1.01 Staining on roof deck possible area of standing water

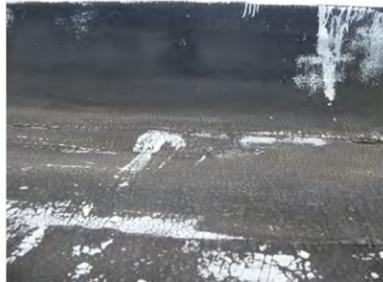
Photo 1.03 Deteriorated roofing material

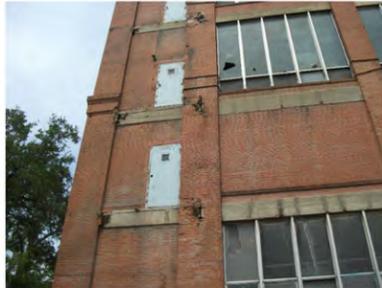
4. The fire exit doors near the front of the building open out to open air because the exit landings have been removed (Photos 4.01-4.02). This is a safety concern. We recommend that these doors be blocked off and marked. (High Priority)

Photo 4.02 Exterior view of unsafe fire exits

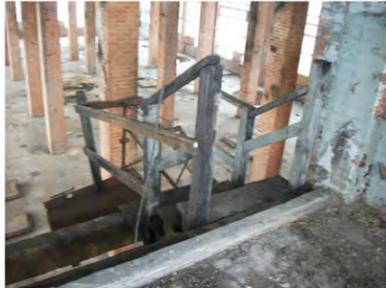
6. One of the stair accesses to the cantilevered area at the back of the building is unsafe (Photo 6.01). We recommend repairing or replacing this access. (Medium Priority)

Photo 6.01 Damaged access to cantilever portion of building

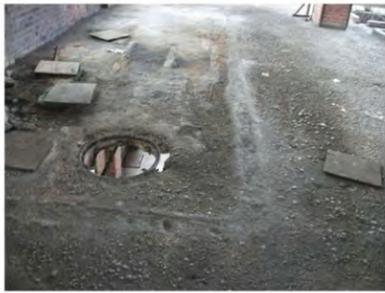
9. In several areas of the floor, the concrete appears to have been eroded by a caustic substance possibly from the manufacturing processes that used to take place within the building (Photos 9.01-9.03). This has reduced the overall thickness of the slab. Based on field measurements, the slab was originally approximately 4" thick. For areas where the concrete loss is minor (1/4" or less) no structural repairs are required, but the client may want to repair or replace the slab for aesthetic reasons. For areas where the concrete loss is more substantial, the slab should either be evaluated for strength or replaced with a new slab based on the final intended use. (Medium Priority)

Photo 9.03 Eroded concrete surface

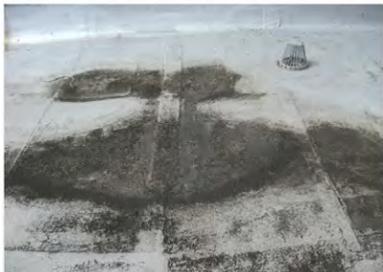
PHOTO 2.01 SEVERE DETERIORATION OF PENTHOUSE ROOF

2. The penthouse roof has severe deterioration (Photos 2.01-2.02). We recommend restricting access to this roof until repairs/reconstruction of this roof can be performed. (High Priority)

Photo 2.01 Severe deterioration of penthouse roof

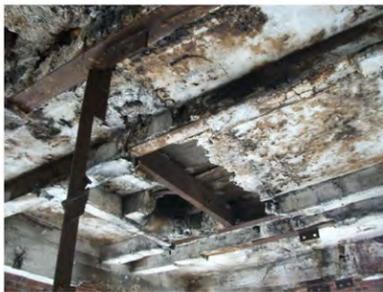
Photo 2.02 Severe deterioration of penthouse roof

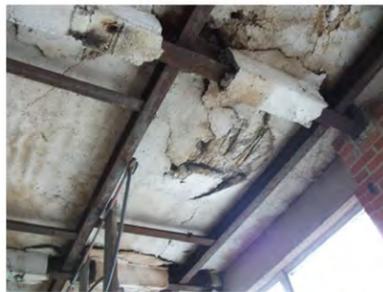
PHOTO 4.01 UNSAFE FIRE EXIT

Photo 4.01 Unsafe fire exit

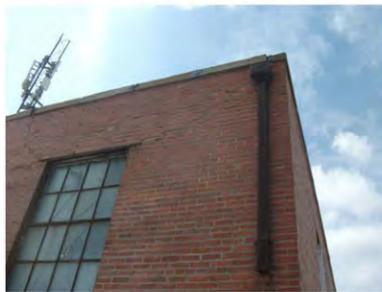
8. The masonry at the top of the windows in the penthouse is cracking (Photos 8.01-8.02). We believe this cracking may be due to corrosion of the steel lintel member over the window. We recommend removing the brick over the window in sections, cleaning and recoating the existing steel lintel member and then reinstalling the brick. If the steel lintel has lost significant section it may need to be replaced with a new lintel matching the original size. Once the lintel is repaired, the cracks in the wall shall be repointed. (Medium Priority)

Photo 8.02 Cracking above penthouse window

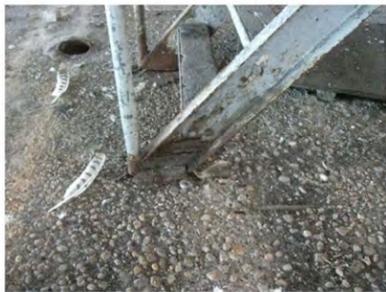
Photo 9.02 Eroded concrete surface

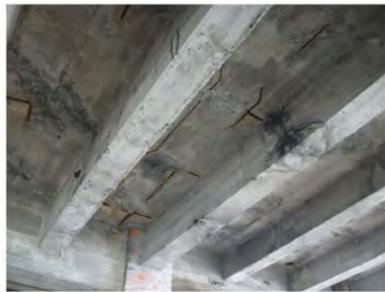
16. The second floor slab near the front of the building has diagonal cracking and some areas of the slab appear to have been damaged by the demolition work performed in the building (Photos 16.01-16.02). We recommend additional investigation and possible repairs in this area when the building is renovated. (Medium Priority)

Photo 16.01 Cracking and damage at second floor slab

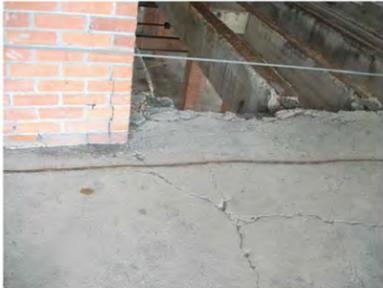
Photo 16.02 Cracking and damage at second floor slab

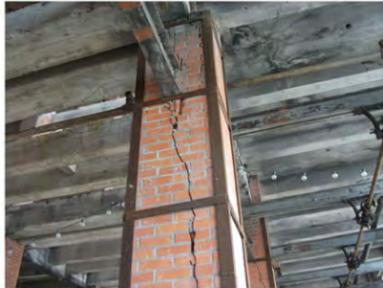
18. Cracking was observed in the masonry fire protection around the first floor columns (Photo 18.01). Steel banding has been added in some areas to contain the brick and prevent it from falling. Although this is not a structural concern, the client may want to repair this masonry for aesthetic purposes. (Non-structural)

Photo 18.01 Cracking in fire protection around first floor column

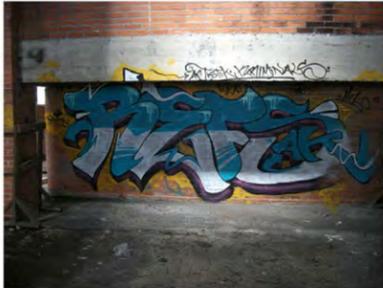
22. Corrosion was observed on the door frames to the main stair (Photo 22.01). (Non-structural)
23. Graffiti was observed in some areas of the building (Photo 23.01). (Non-structural)

Photo 23.01 Graffiti on level 8

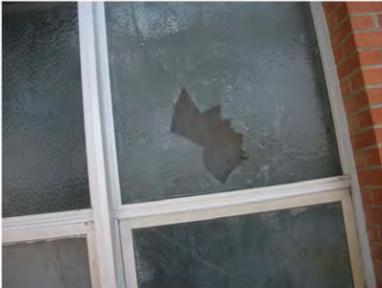
25. Several of the exterior windows in the building are broken (Photo 25.01). (Non-structural)
26. One of the plates surrounding the decorative cauldron in the front of the building has fallen (Photo 26.01). In addition, some of the masonry around the cauldron is loose (Photo 26.02). If this is an element that is going to be retained after the renovation, we recommend that the masonry be repointed (as required) and the plate be reinstalled and coated with a good quality rust inhibitive paint. (Non-structural)

Photo 25.01 Broken window

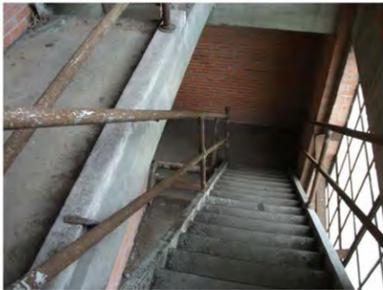
20. The handrails on the main stair for the building are showing signs of corrosion (Photo 20.01). We recommend cleaning and recoating the handrails. (Low Priority)

Photo 20.01 Corrosion on handrails in main stair

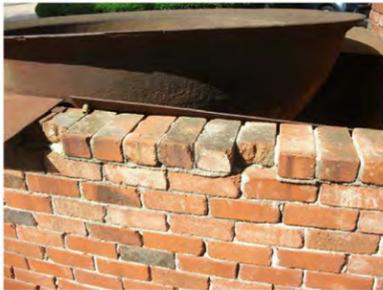
Photo 26.02 Loose masonry around cauldron

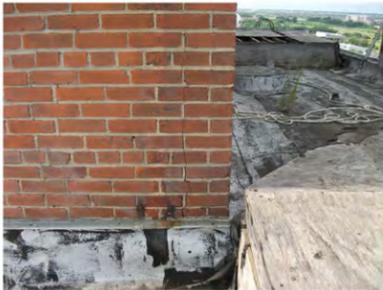
21. Vertical cracking was observed near some of the corners in the existing masonry (Photos 21.01-21.02). This cracking is likely due to thermal movement of the walls on either side of the corner. No action is required although the client may want to repair and repoint this area for aesthetic purposes. (Low Priority)

Photo 21.01 Vertical cracking at corner of masonry

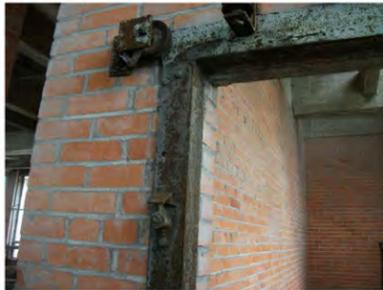
Photo 22.01 Corrosion on door frame at main stair
